# National Property Inspections

Mr. John Doe, 20 Ocean Blvd , Holden Beach, NC, 28462

Inspection Date:  
06/30/2018

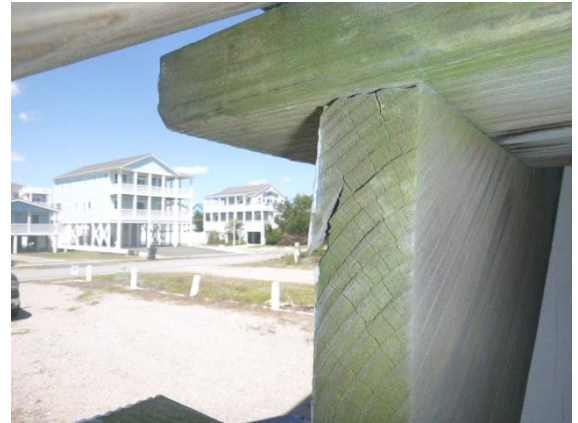
Walks / Steps: View of one location of cracked staircase stringers

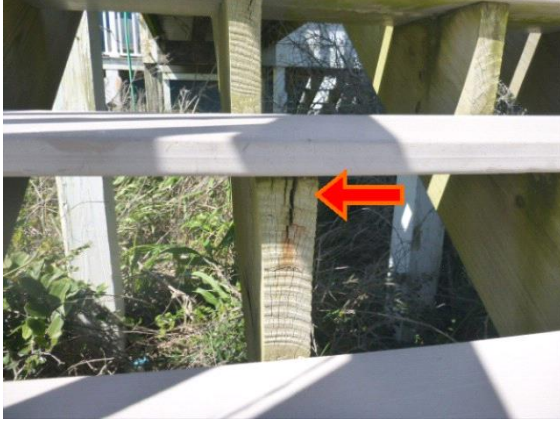
Walks / Steps: View of one location of cracked staircase stringers

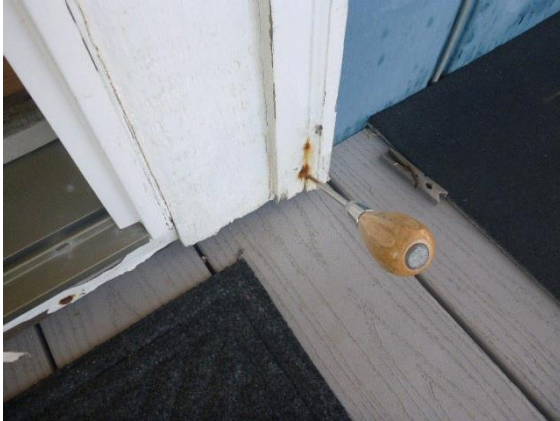
Exterior Doors: View of one location of soft wood present at rear entry door

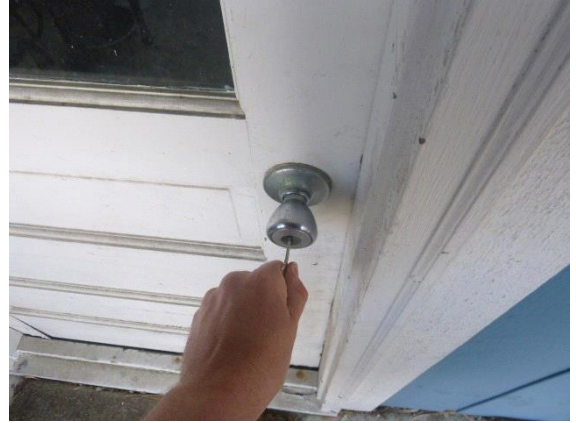
Carport/Under House: View of one location of ground floor entry doors that could not be accessed with key

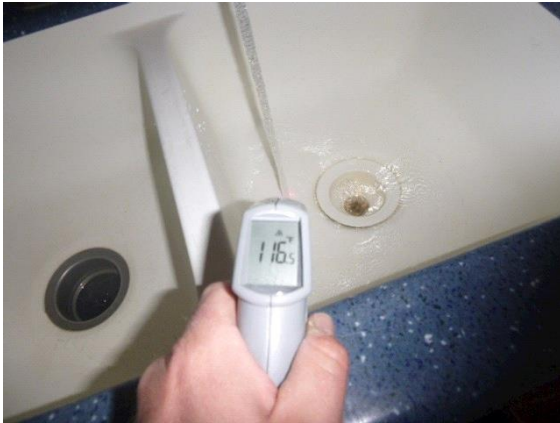
**LIMITATION:** The water heater could not be inspected because the unit is located in the ground floor storage area that could not be accessed at the time of inspection. Although the unit was operating, with a temperature of 116 at the kitchen sink, I recommend a licensed plumber access and fully evaluate the unit to determine its age and condition prior to settlement on the property.

Water Heater: View of water temperature at the kitchen sink

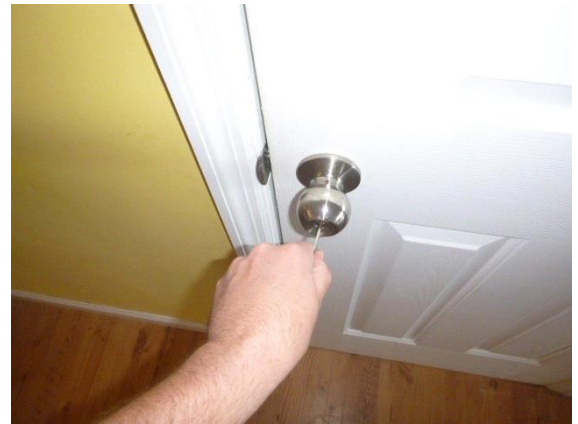
NOTE: The closet located in the dining area could not be inspected because the door was locked and the key provided did not access it. See Photo.

Dining Room: View of dining room closet that could not be accessed

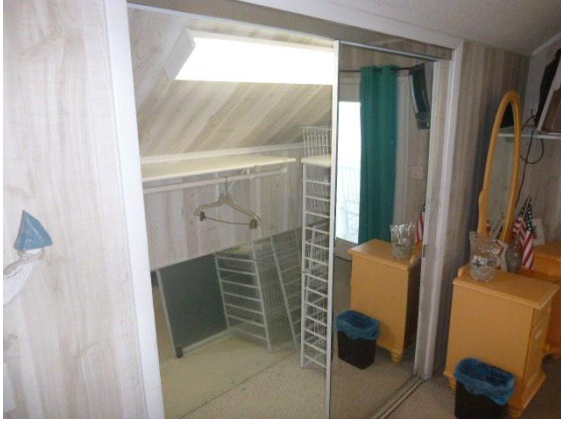
Bedroom #5 - 2nd Floor - Rear : View of one location of missing closet door

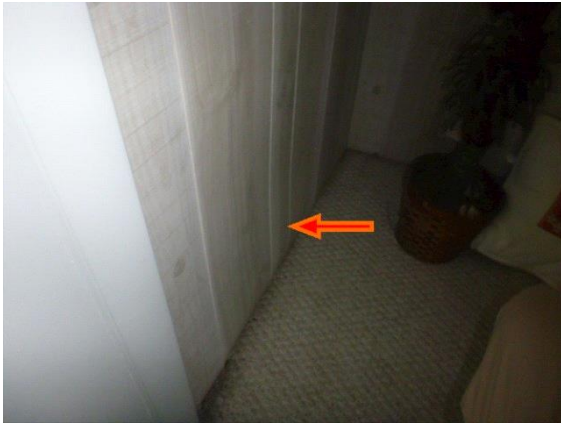
Bedroom #5 - 2nd Floor - Rear : View of one location of buckling in wall paneling
