Inspection Report

Property Address:
123 Your Street
Fort Worth TX

PROPERTY INSPECTION REPORT

By: Scott Hoenig TREC 21111 / National Property Inspections 1/24/2017
(Name and License Number of Inspector) (Date)

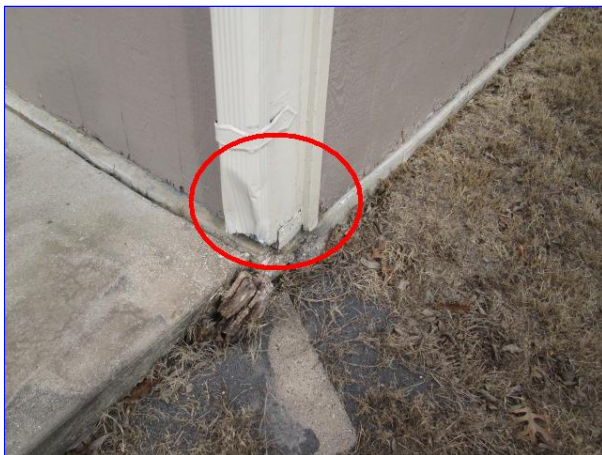
B. Item 1

Gutter system has damaged downspouts, need repairs.

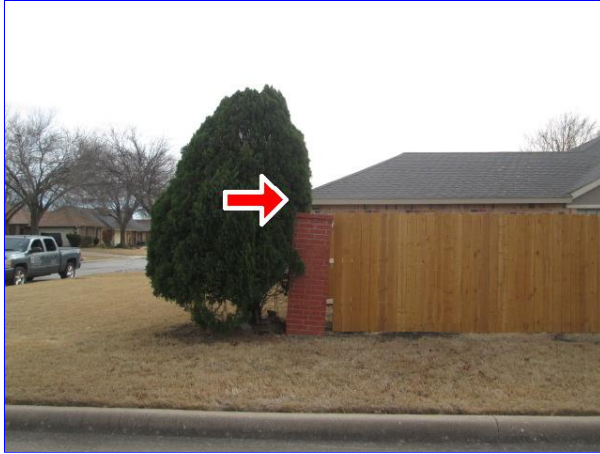
M. Item 1 front

(1) Brick column at right front, is leaning.

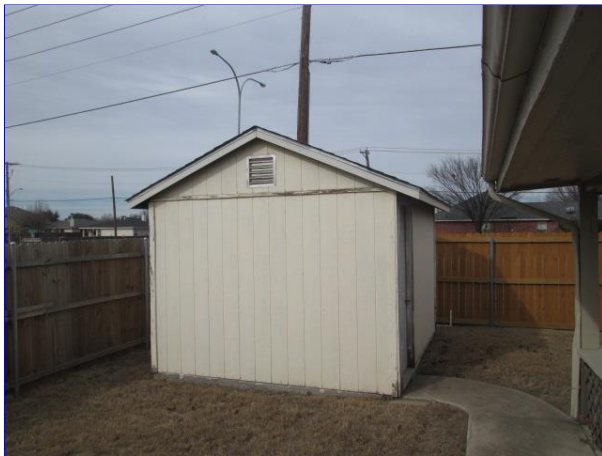
O. Item 1

Out building is not part of this home inspection or termite inspection.

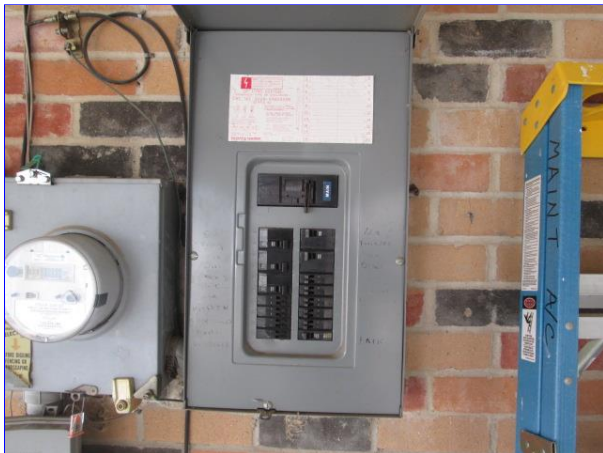
A. Item 1 poorly labelled

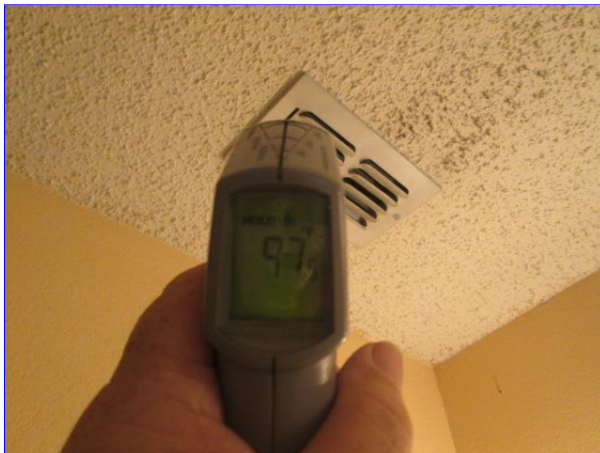
A. Item 1

Heating equipment is performing as intended.

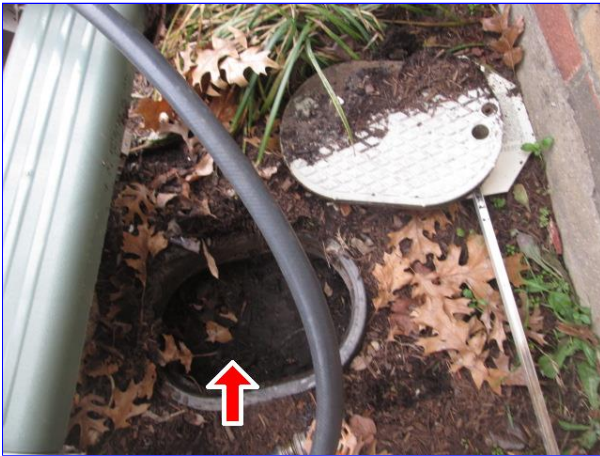
A. Item 1

(1) Water shutoff valve box is filled with debris. Trash/Dirt should be removed for proper access to valve.
