# Inspection Report

**Property Address:**  
111 Sample View Drive  
Mckinney Tx 75069

# PROPERTY INSPECTION REPORT

**By:** Earl Lanning Trec#8669 / National Property Inspections 1/13/2012  
\_\_\_\_\_  
(Name and License Number of Inspector) (Date)

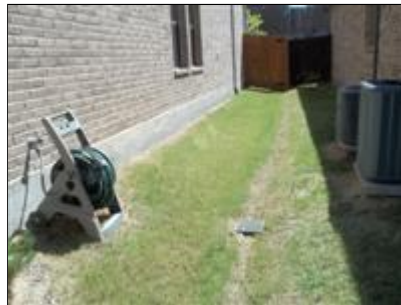
B. Picture 2

Inspected grading and drainage around home, noted excessive standing water at right front planting bed at main water valve area (Possible Leak ?), this condition can cause foundation issues (movement) in future. Recommend further evaluation and repair by qualified contractor.

Recommend to maintain slight positive grading away from foundation for proper drainage approximately 6 inch drop for 10 feet. Recommend to maintain soil line clearance of 4 - 6 inches from top of foundation. Recommend water to drain 3 - 5 feet away from foundation.

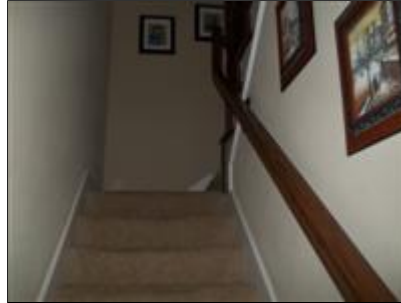
J. Picture 1

Found stairways and railings to be operating as designed at time of inspection.

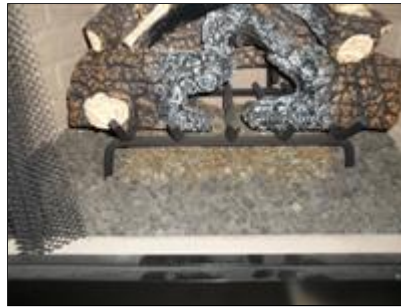
K. Picture 2

Noted lack of damper clamp, when artificial gas logs are installed in a firebox with a damper, the damper should be permanently blocked open with a damper clamp to prevent accidental spillage of carbon monoxide into the living space. Recommend installing damper clamp assembly. There were gas logs installed in the firebox at the time of this inspection. I was unable to view the floor of the firebox at the time of this inspection. All visual components were found to be in satisfactory condition at time of inspection.

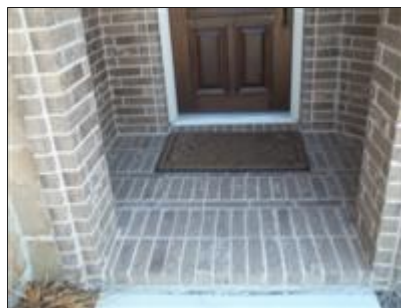
M. Picture 1

Porch area appeared to be operating as designed at time of inspection.

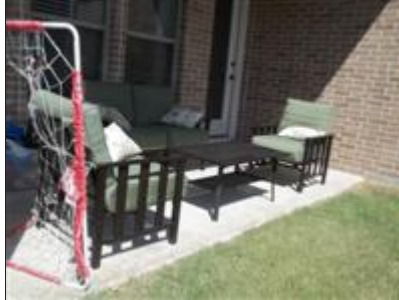
O. Picture 1

Patio appears to be operating as designed at time of inspection

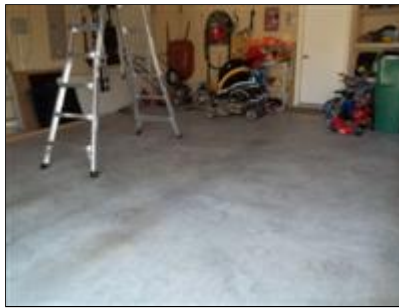
P. Picture 1

Garage floor appears to be operating as designed at time of inspection.

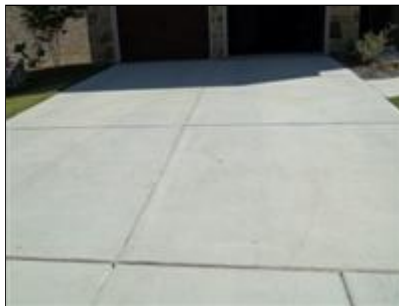
Q. Picture 1

Driveway appears to be operating as designed at time of inspection.

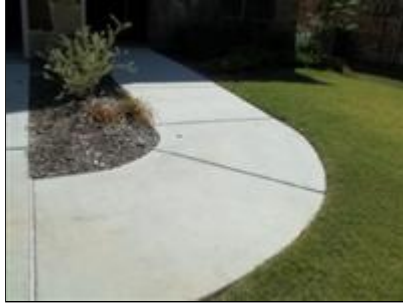
R. Picture 1

Walkways appear to be operating as designed at time of inspection.

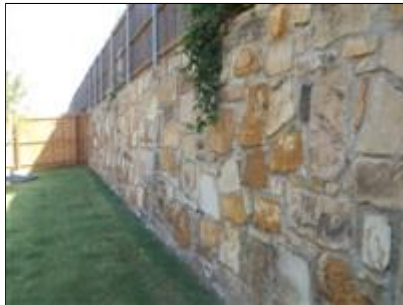
S. Picture 1

Retaining wall appears to be operating as designed at time of inspection.

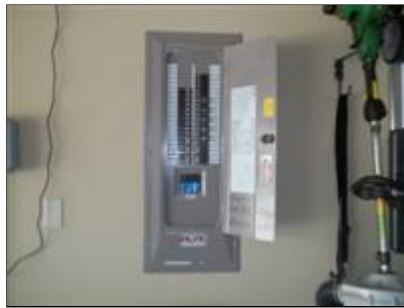
A. Picture 2

(2) Main panel assembly is located in garage and appears to be operating as designed.

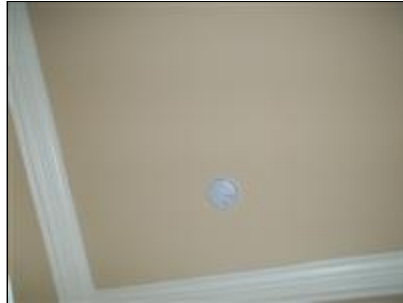
C. Picture 1

All components were found to be in satisfactory condition at time of inspection. Note: Due to location,height or conditions out of control of the inspector,one or more of the smoke alarms/detectors were inaccessible and could not be tested at time of inspection.

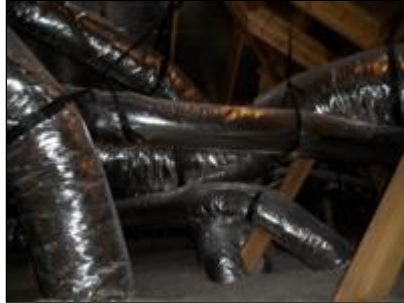
C. Picture 1

Inspected insulated duct system, noted no obvious signs of deterioration or open areas at time of inspection.

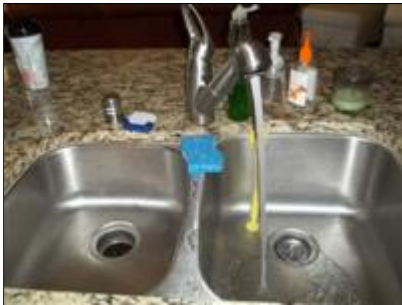
A. Picture 2

(2) Inspected a representative amount of fixtures and flushed all toilets found fixtures and toilets appeared to operate as designed at time of inspection.

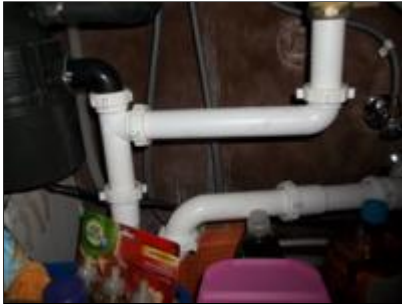
C. Picture 1

Inspected drains and found no leaks at time of inspection and all drains appear to be operating and draining as designed at time of inspection.

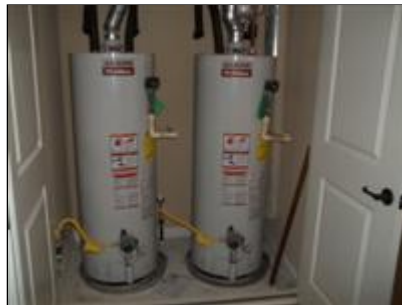
D. Picture 1

(1) Inspected two separate gas water heaters, both water heaters appeared recently replaced dated 10-2011, water heater system appears to be operating as designed at time of inspection.

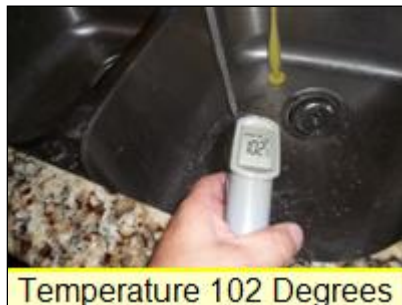
D. Picture 2

(2) Noted water temperature at 102 degrees and within TREC standards.

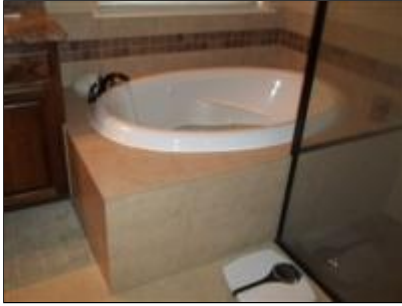
E. Picture 1

Performance test hydro tub operation, system appeared to be operating as designed at time of inspection and noted GFCI located at lower wall at toilet room area, also noted pump motor access area located at exterior bathroom wall.

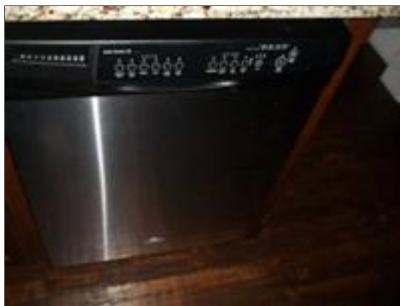
A. Picture 1

Performance tested dishwasher in normal cycle mode, dishwasher appeared to operate as designed at time of inspection.

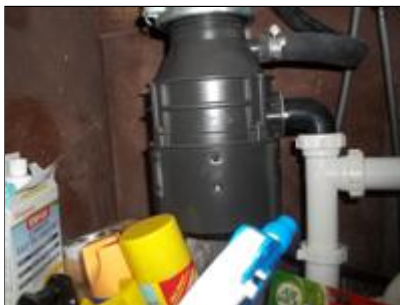
B. Picture 1

Disposal appears to operate as designed at time of inspection.

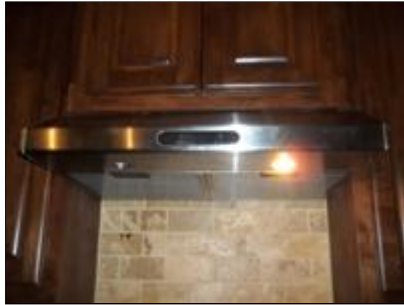
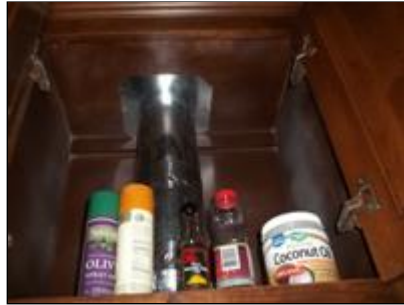
Range vent and light assembly appeared operational as designed at time of inspection.

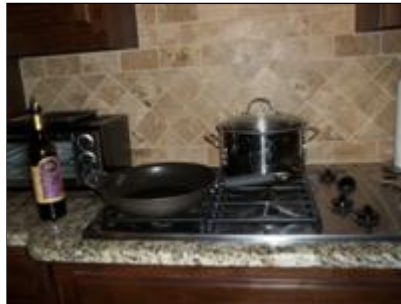
D. Picture 1

(1) Cook top appears to operate as designed at time of inspection.

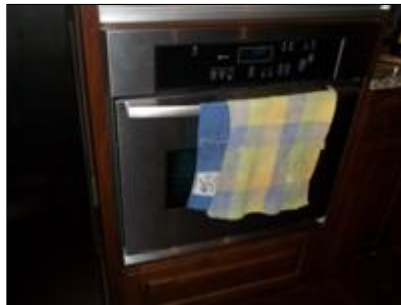
D. Picture 2

(2) Performance tested oven operation at 350 degrees, oven appears to operate as designed at time of inspection.

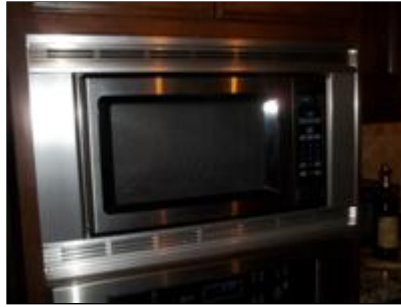
E. Picture 1

Microwave appeared to operate as designed at time of inspection.

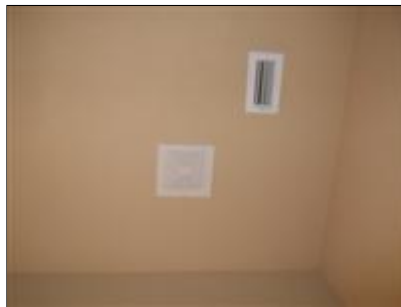
H. Picture 1

All exhaust fans appeared to operate as designed at time of inspection.

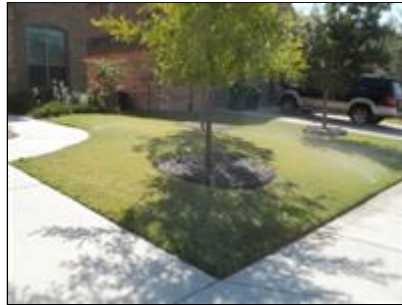
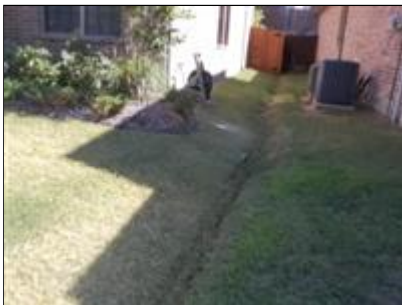
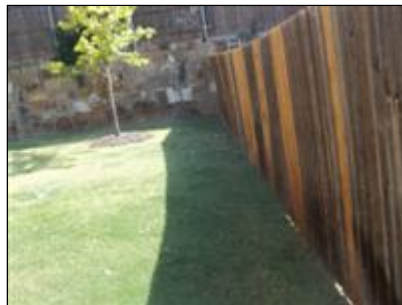
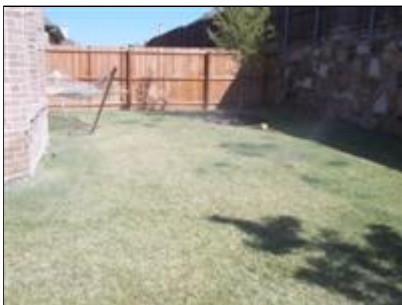
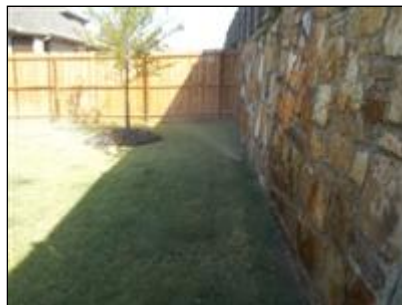
Performance tested sprinkler system, noted poor spray at left front corner of driveway zone #9. Recommend further evaluation and possible cleaning/repair by qualified professional. Also recommend periodic monitoring for complete and consistent coverage and minimal over spray on home exterior areas.

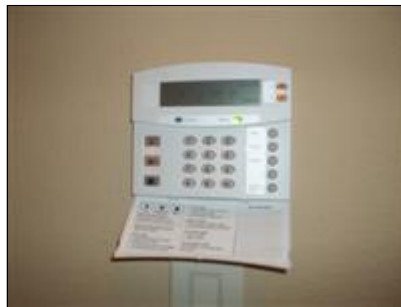
C. Picture 1

We do not evaluate or perform alarm testing.
