Property Condition Report

Date Inspected: 4/5/2023

Property Address: [REDACTED]
Mukwonago, WI 53149

Prepared by: *Quality Inspections L.L.C. dba*
National Property Inspections
8330 Corporate Dr
Mt Pleasant, WI. 53406

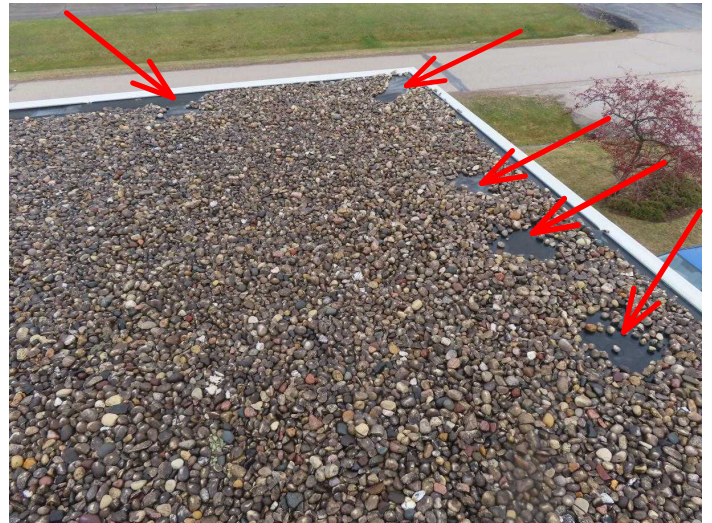
Thin Ballast

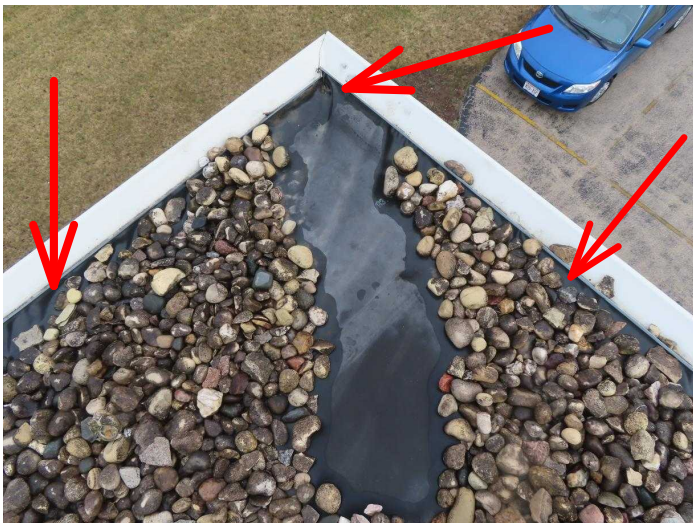
Membrane Possibly Pulling Away

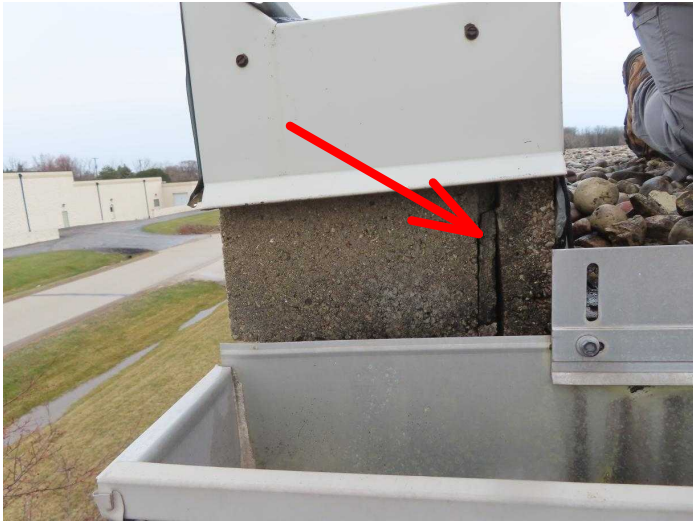
Tuck Point Maintenance Required

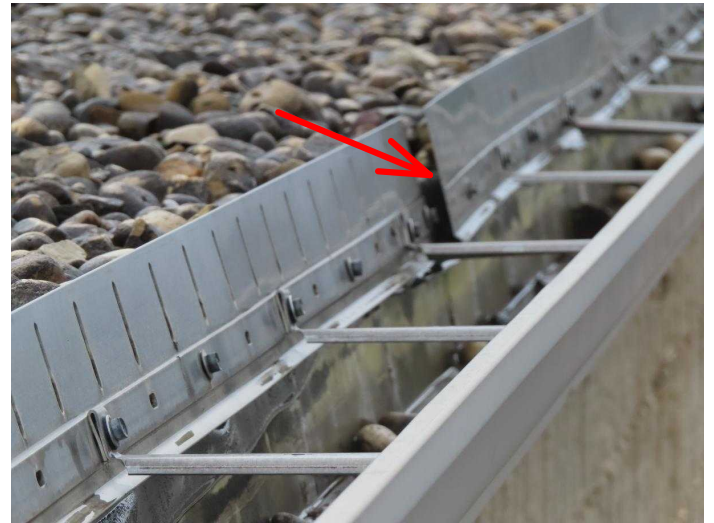
Possible Water Behind Gutter

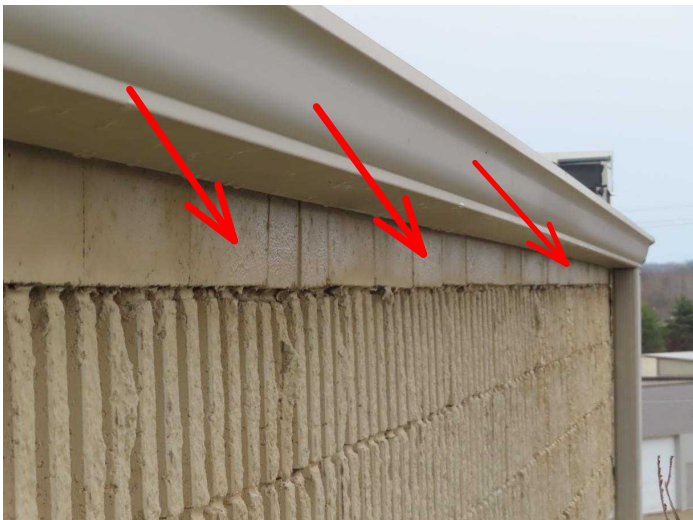
Possible Water Behind Gutter

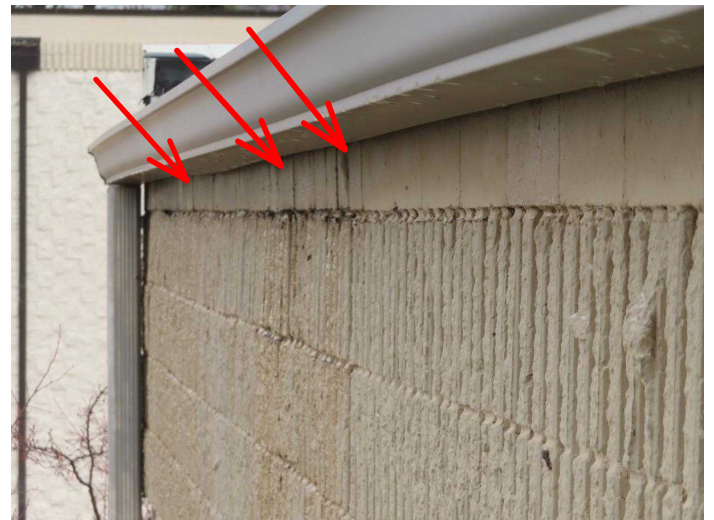
Possible Water Behind Gutter

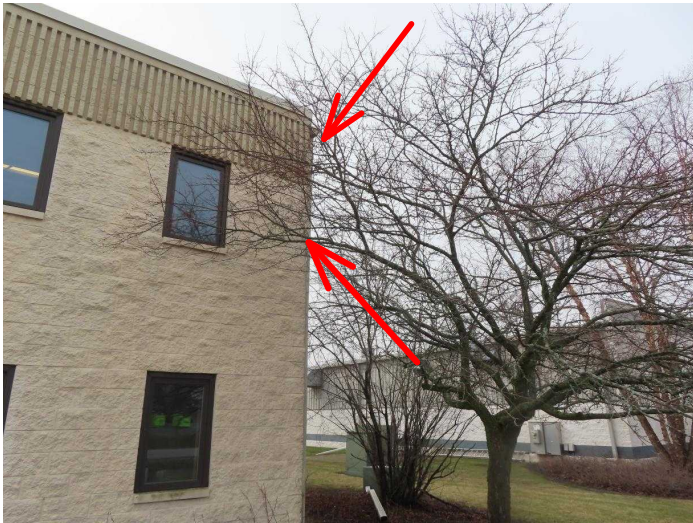
Trees At Building

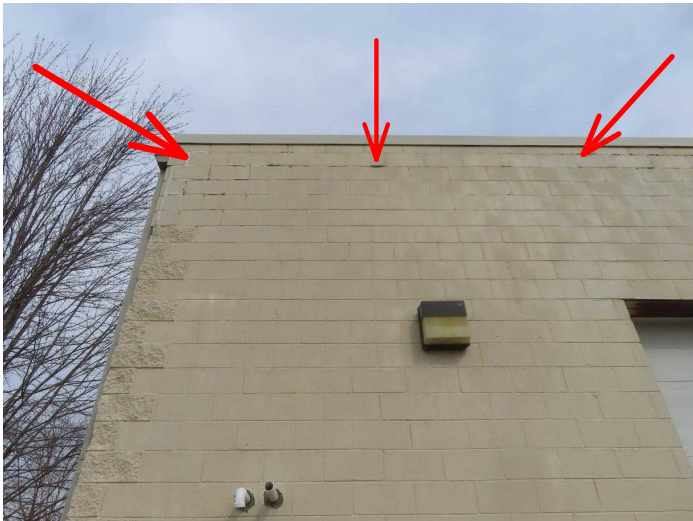
SW Block Discoloration

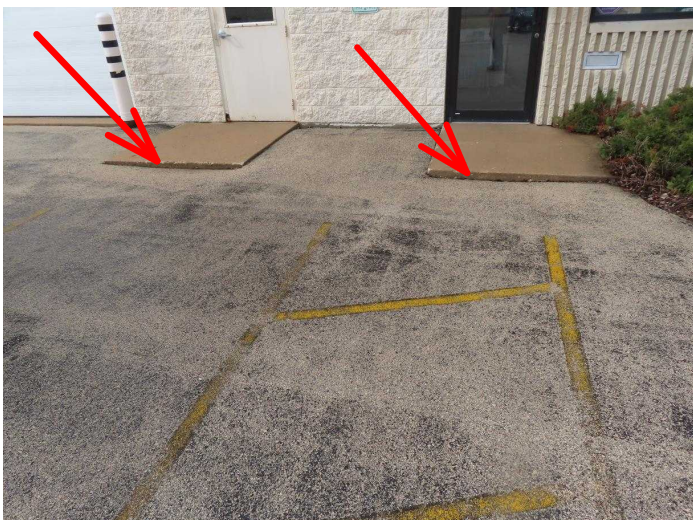
East Lot Trip Hazzards

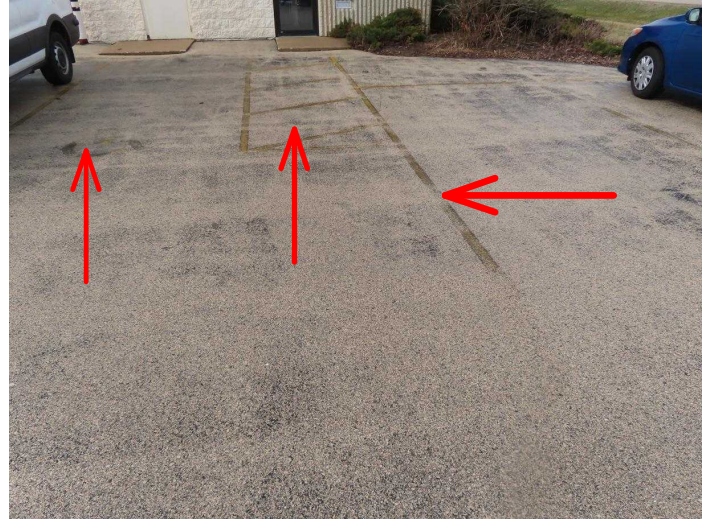
East Parking Lot Faded Striping

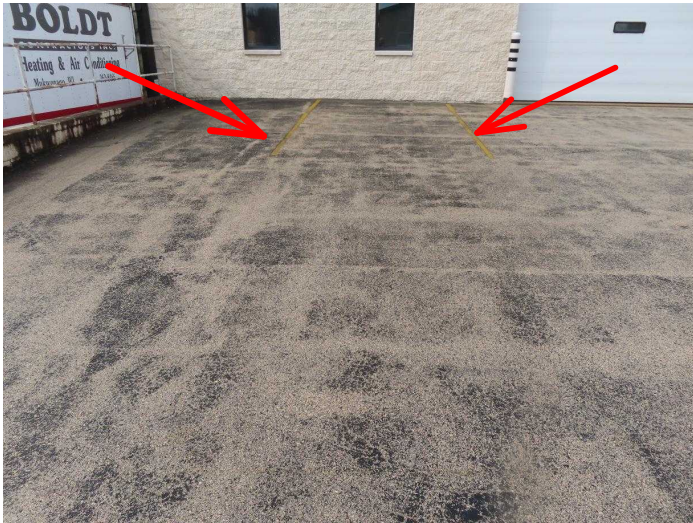
East Parking Lot Faded Striping

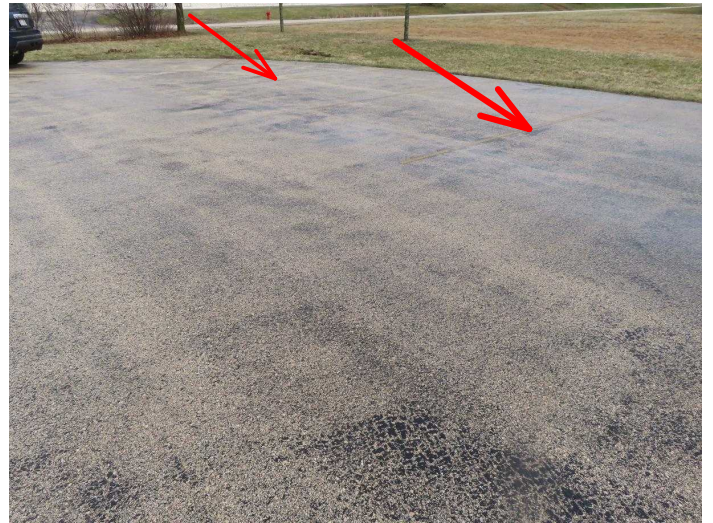
East Parking Lot Faded Striping

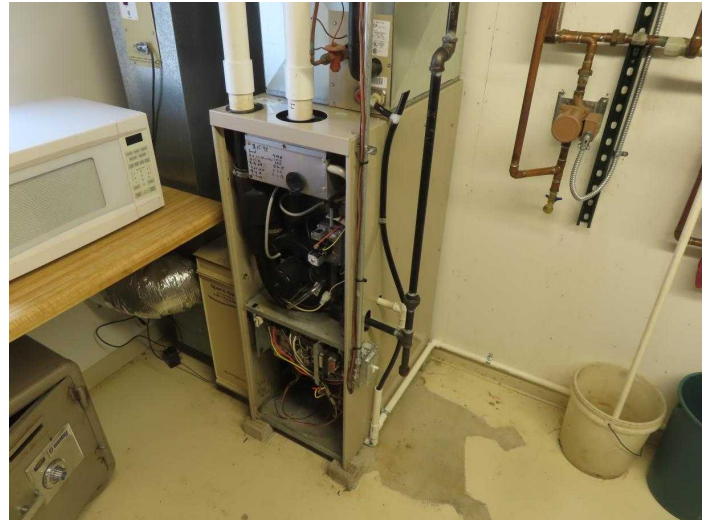
Maintenance Room Furnace

- Recommend seal exhaust vents at exterior.
- The units were not tested for function at the time of inspection.
- The three forced air furnaces appear to be original to the building. Recommend budget for replacement.
- There is PEX present for the hydronic heating under the concrete.

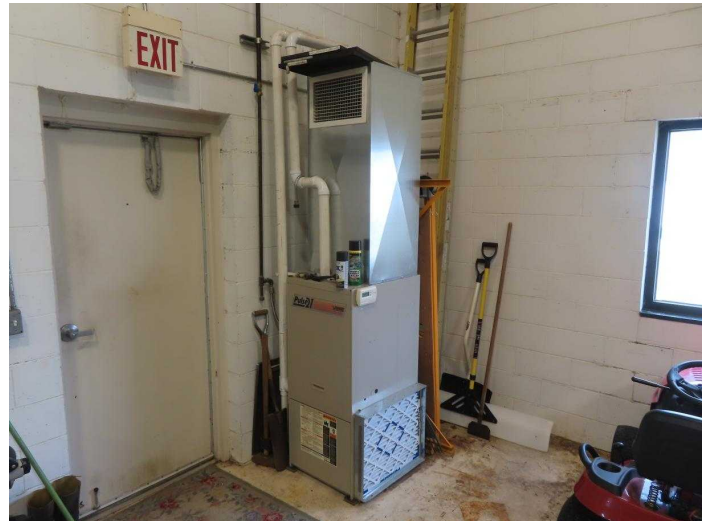
Shop Furnace

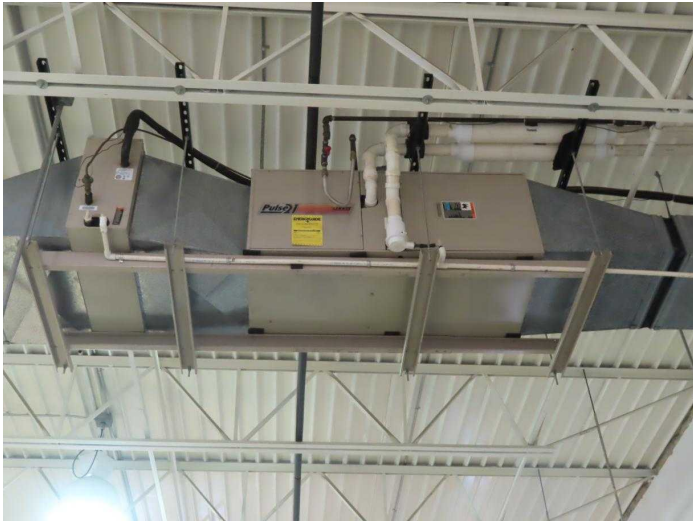
Shop Furnace
