NATIONAL PROPERTY INSPECTIONS | SAN DIEGO

RESIDENTIAL INSPECTION

1234 Main St.
La Jolla, ca 92037

Buyer Name
05/27/2019 9:00AM

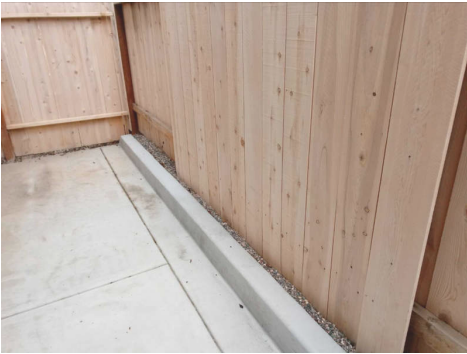
4.3.1 Siding, Flashing & Trim

POOR EARTH TO SIDING CLEARANCE

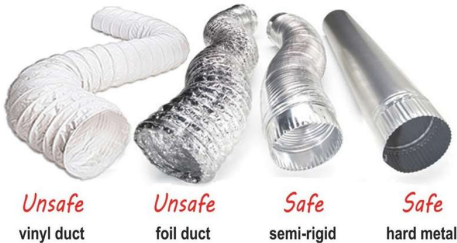
Examples of Safe & Unsafe Dryer Vents

Foil Ducting Present
