INSPECTION REPORT

123 Sample Drive
Sometown, AR

INSPECTION DATE
Tuesday, April 8, 2025

Report No. 1139

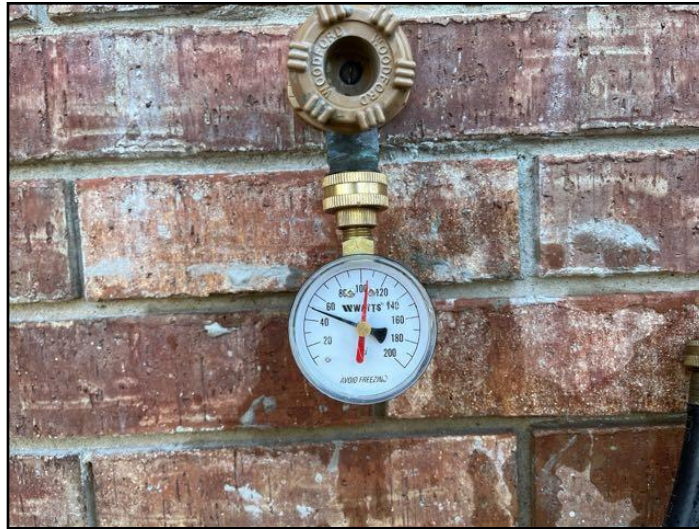
48 PSI. Recommended range is 40-80 PSI.

50. Functional
