**Southshore/Manatee Property Inspections DBA
National Property Inspections**

Christian Brothers Automotive Corp, 128 Harbor Village Lane, Apollo Beach, FL, 33572

Friday, January 8, 2021
Inspector
Greg Suhre
941.254.1583
greg.suhre@npiinspect.com
HI12972

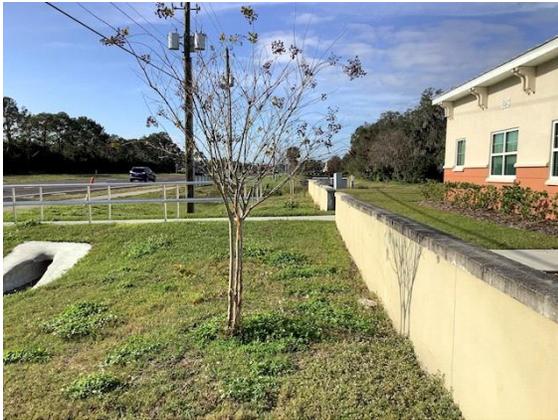
Property has been graded with a slope to encourage drainage away from the foundation. A culvert exists at the left side of the property.

Grading / Drainage: Culver side of the entrance

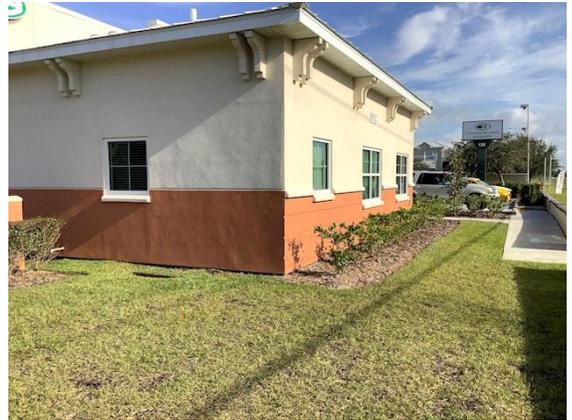
Grading / Drainage: View from rear left of property shows grading away from foundation.

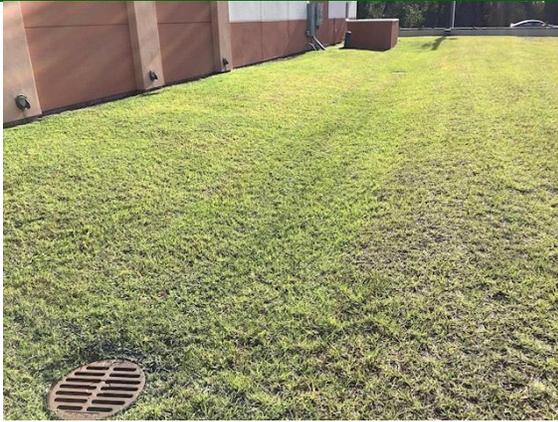
- Drainage in swale in rear is covered with a substance and blocked in the bottom. Repair is recommended for proper drainage.

Grading / Drainage: Drainage in swale

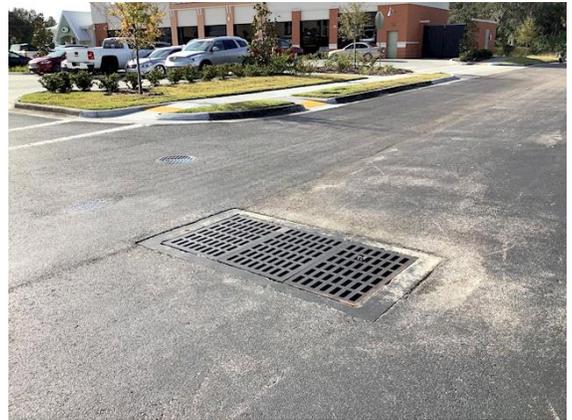
Grading / Drainage: Sewer drain entrance

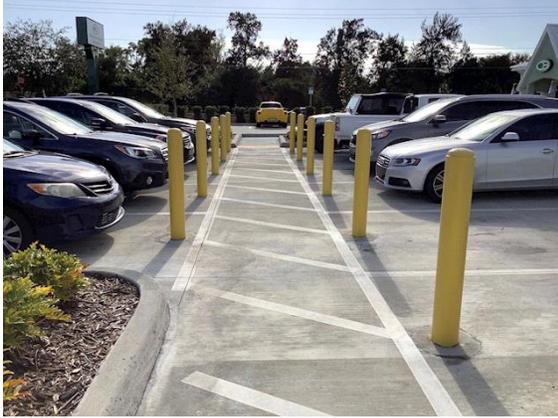
Parking Lot: Front parking lot/walkway between vehicles

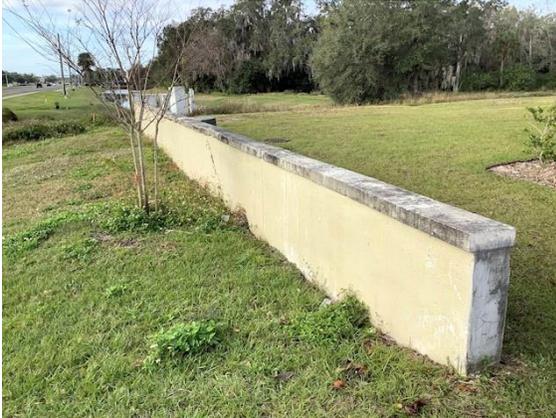
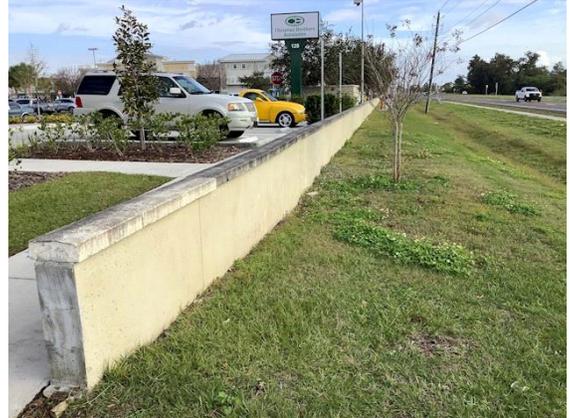
- There is damage to the wall that fronts the strip mall. Not sure who is responsible for it's upkeep; most likely the owner of the strip mall. The pictures are provided as a courtesy as the aesthetics of the front of the property is compromised.

Lots & Grounds Misc Item: Front wall of strip-mall

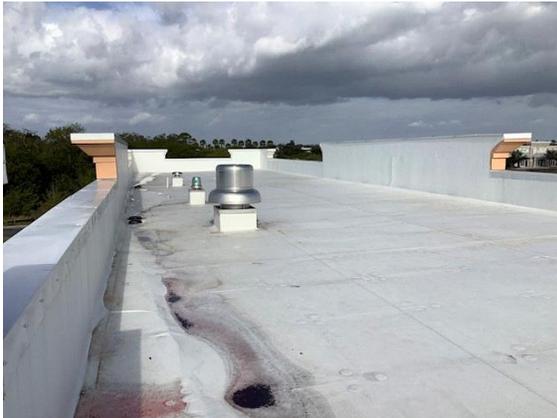
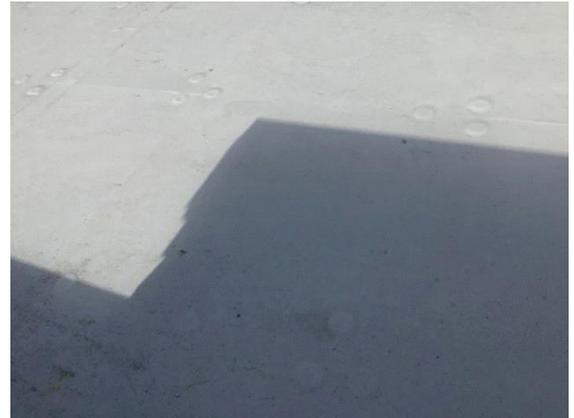
Roofing system over garage structure consists of TPO. Roofing system over the un-conditioned side storage room consists of rolled asphalt material. Roofing system over the office is metal. All roofing types are in fairly new condition without any observed cracks, blisters, or visible damage.

Roofing: TPO roofing over garage bays

Roofing: TPO roofing

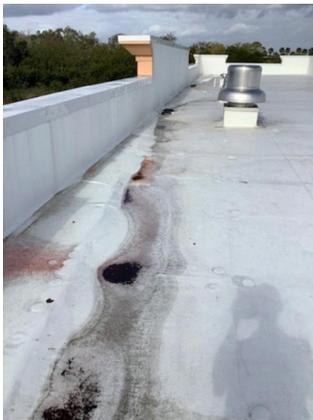
Roofing: Heavy rains from prior night

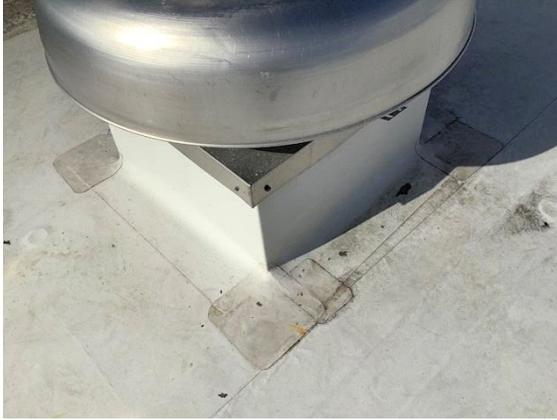
Flashing/Valleys: Typical flashing over garage area appears properly installed

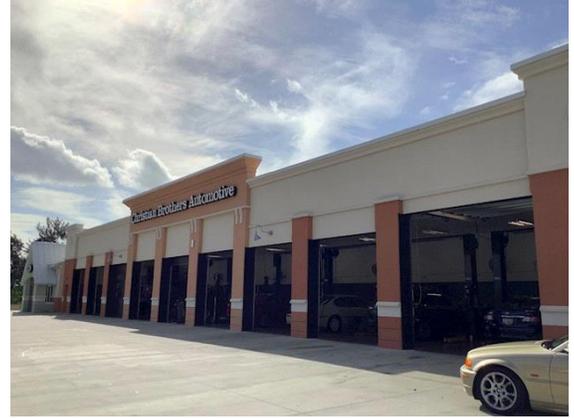
Roof over garage bays have a built-in drainage system. The roof over the side storage room and office do not have a gutter system and drains to the concrete surface below.

Gutters/Down Spouts: None over front bays

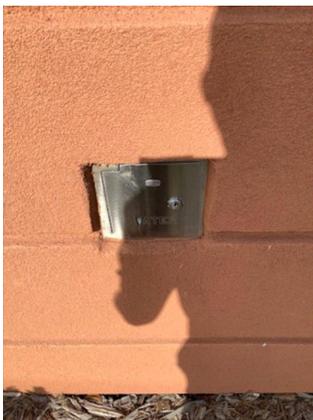
No exterior faucets were observed. Water access panels were present.

Exterior Surface: No exterior faucets were observed. A water panel was located instead.

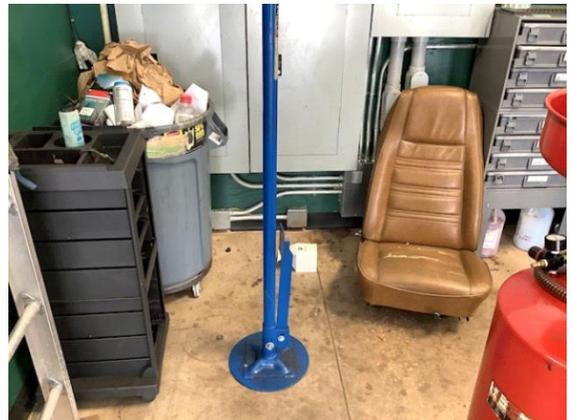
Electrical: Sub panels located on left wall of garage. No clear workspace marked along the floor in front and adjacent to the panels.

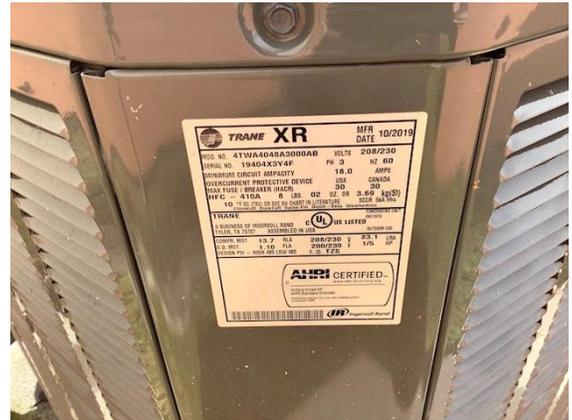
Cooling: Data tag

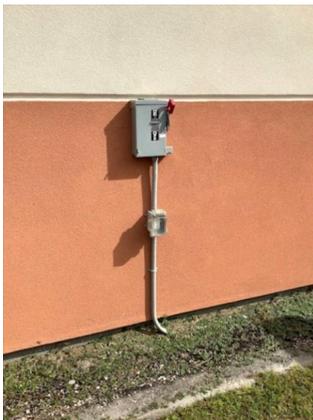
Cooling: Shut-off

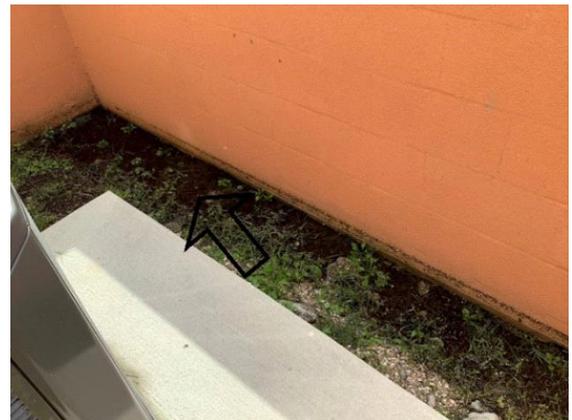
Cooling: Water cannot escape condenser enclosure. Weep holes needed or clogged.

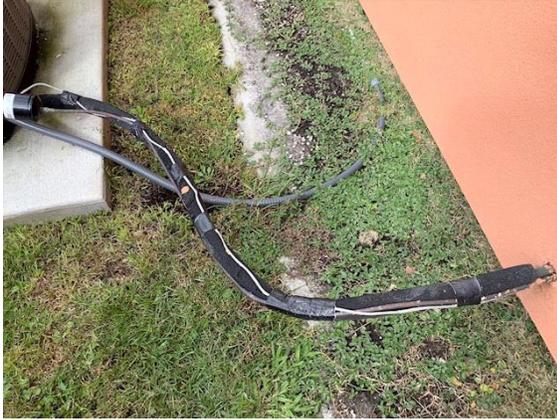
Cooling: Refrigerant lines appear properly insulated

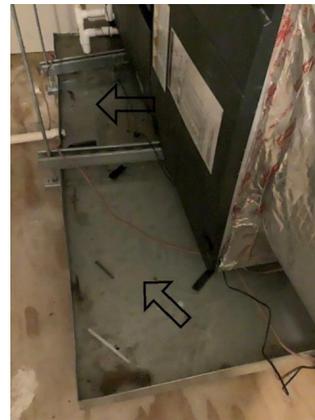
- Emergency catch pan under unit was full of water. Unit was not draining condensation properly. Water has overflow previously, saturating the floor, and flowing behind the drywall down into and around the supply vent above the office. The picture shows what appears to be microbial growth around the supply vent as well as ceiling stains and sagging. A qualified heating and cooling contractor should evaluate and repair as necessary.

Cooling: Pan filled with water and overflowing in attic

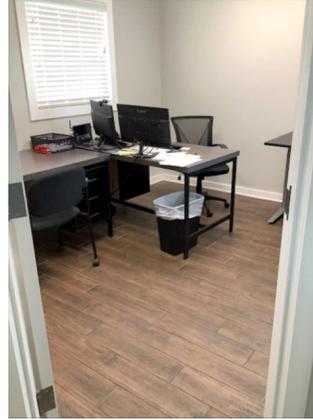
Interior Room: Back room

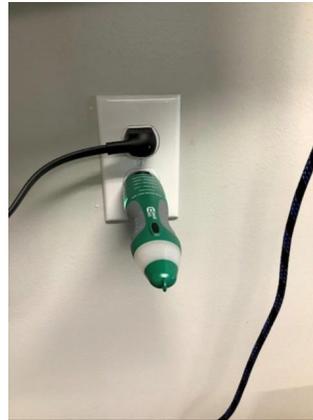
Interior Room: Electrical working properly

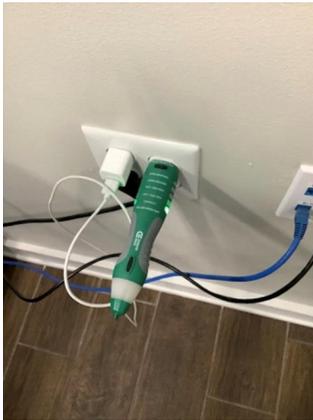
Interior Room: Electrical working properly

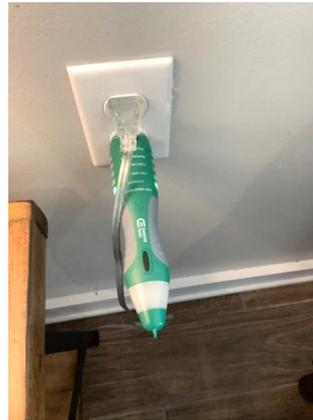
Interior Room: Electrical working properly

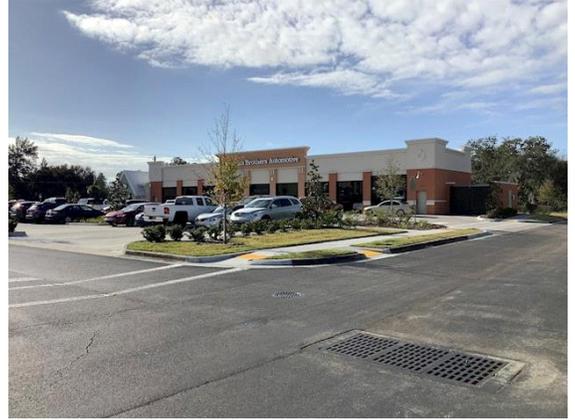
2

Drainage

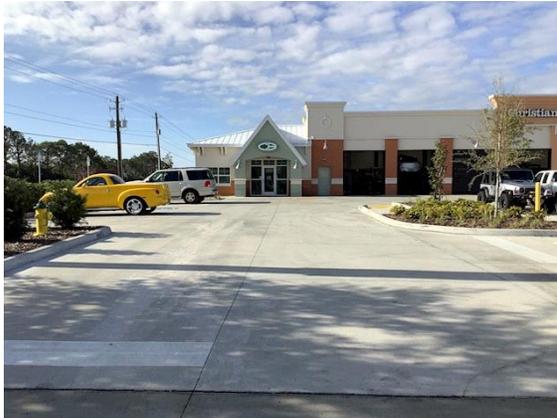
3

Drainage away from structure and lot

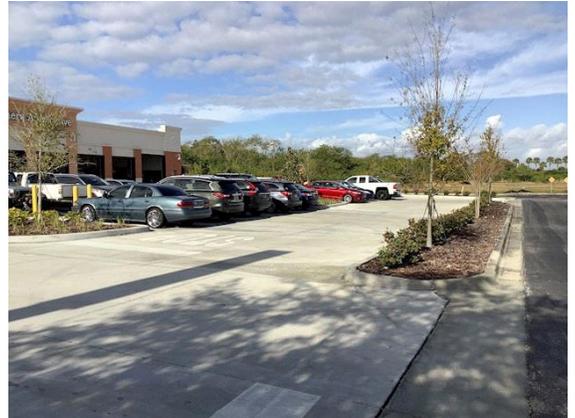
4

Drainage away from structure and lot

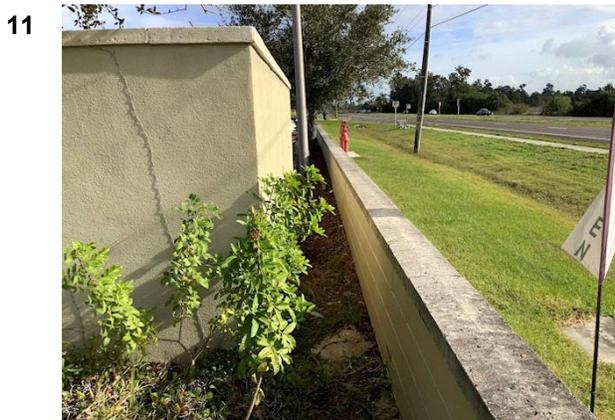
Front strip mall wall

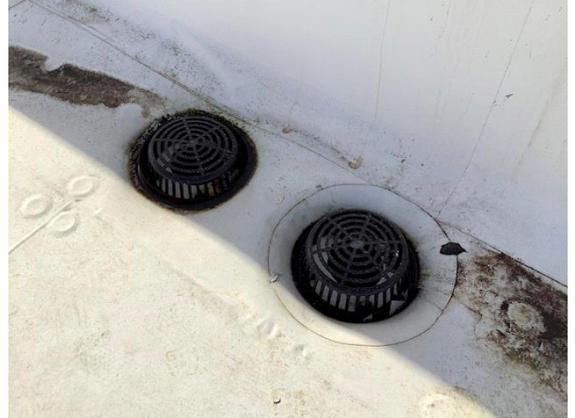
14

Built-in drainage

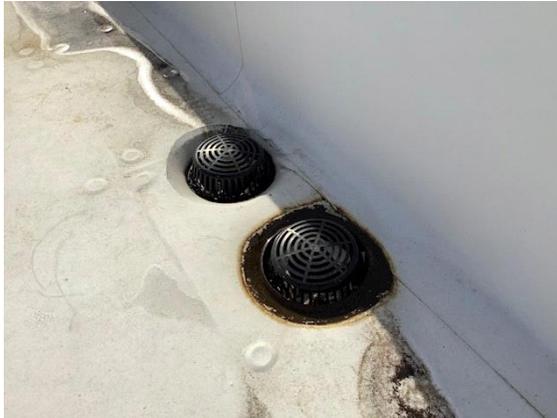
15

Built-in drainage

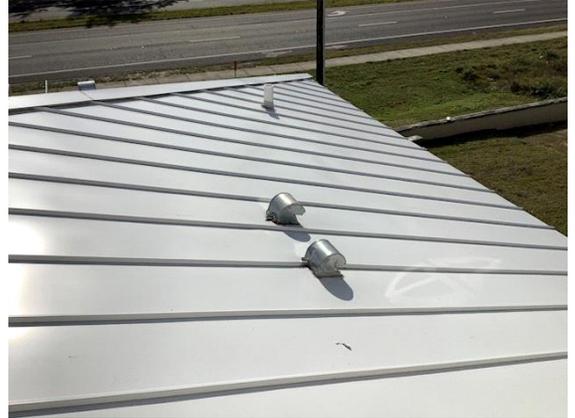
20

Could not walk on metal roof

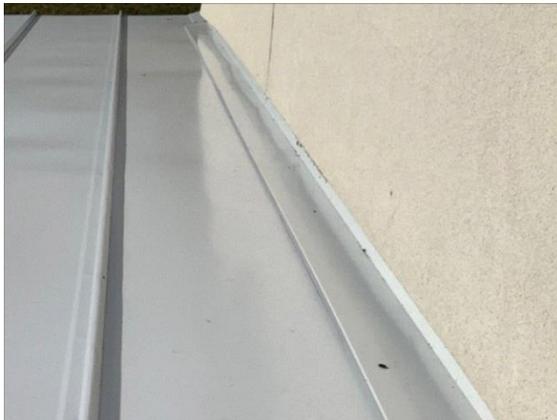
21

Proper intersection clearance where wall meets roof

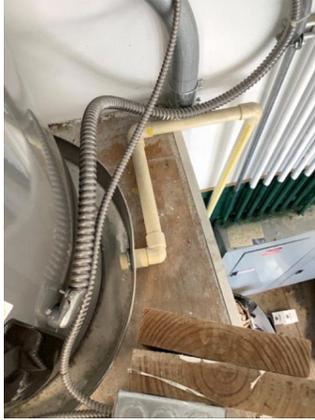
23

Water heater located above the garage bathroom

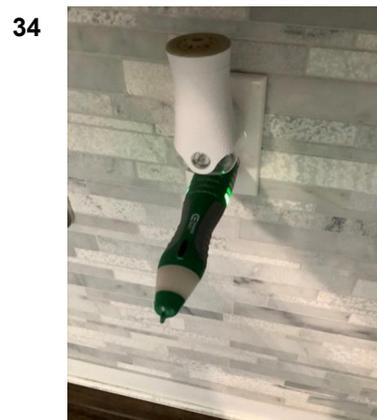
Electrical working properly

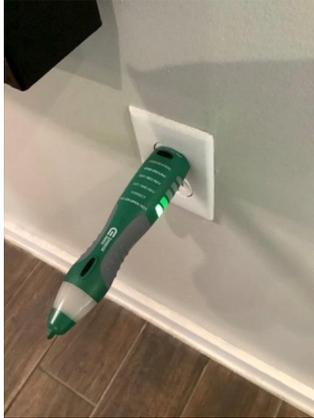
35

Electrical working properly

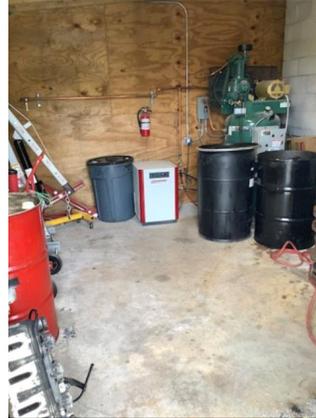
36

Storage room

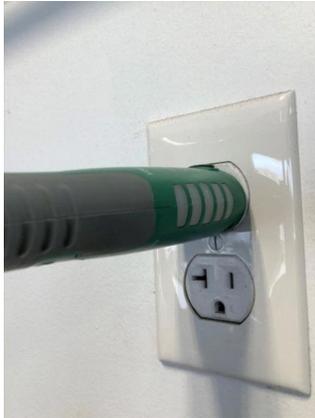
43

No power

- One fan receptacle in garage has no power so a receptacle below is being used instead. Recommend further evaluation by a certified electrical contractor.

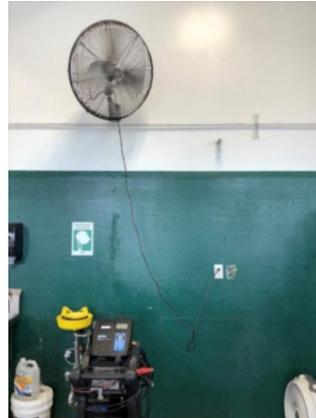
44

No power to receptacle fan so using receptacle below

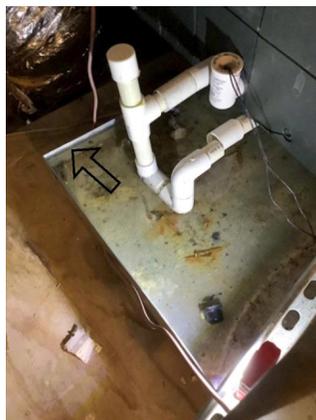
51

Pan filled with water

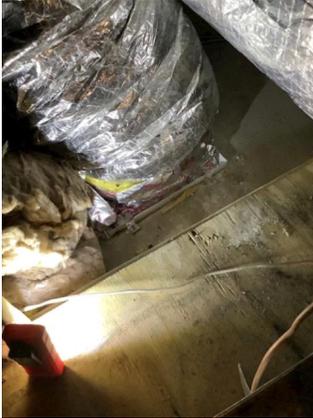
52

Water flowed into and around supply vent previously
