# National Property Inspections

705 Sample Report, Key Largo, Fl, 33037

Thursday, March 27, 2025

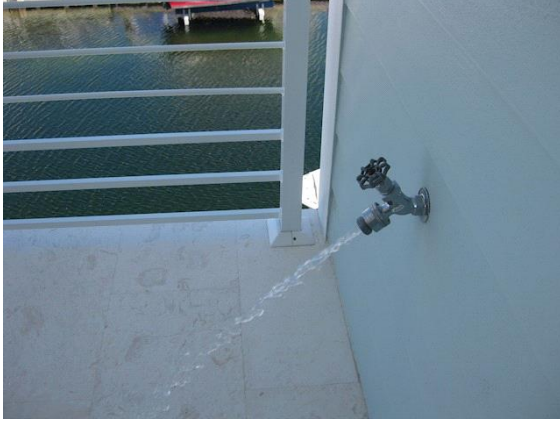
## 2ND FLOOR BALCONY

Balcony and all related components appeared to be acceptable at time of inspection.

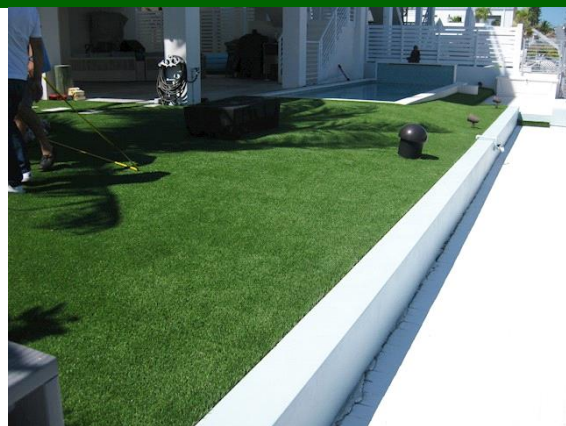
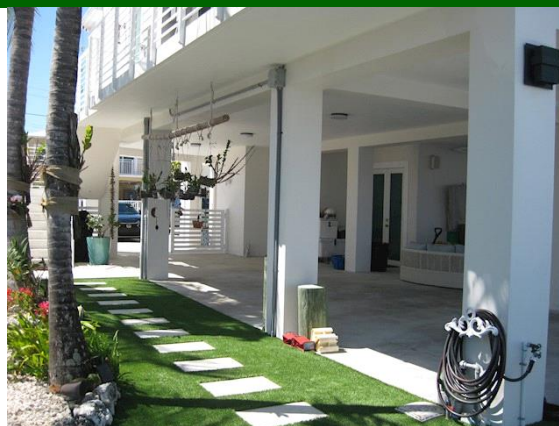
## FENCES / GATES

Metal fence was in generally good condition with operational gate(s).

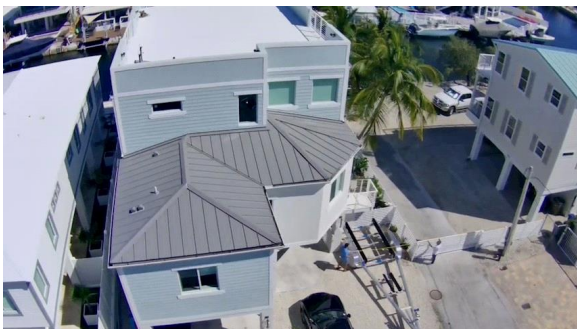
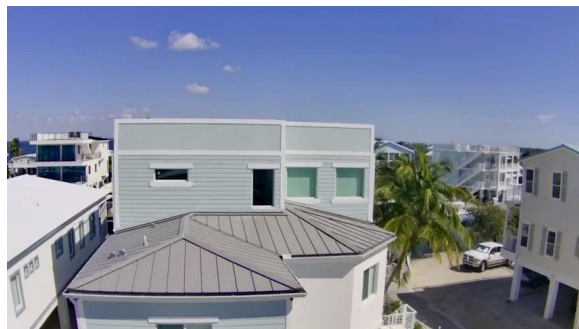
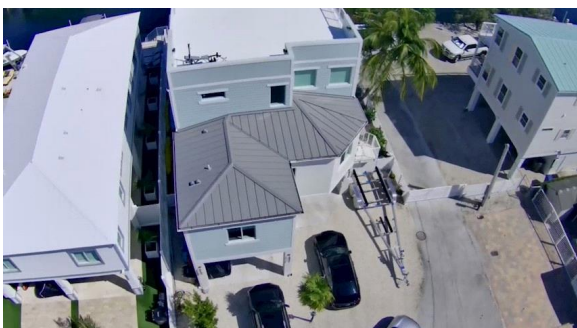
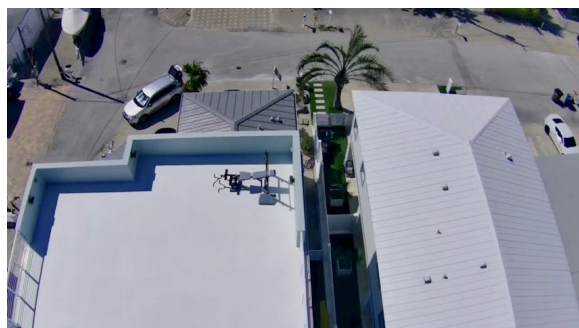
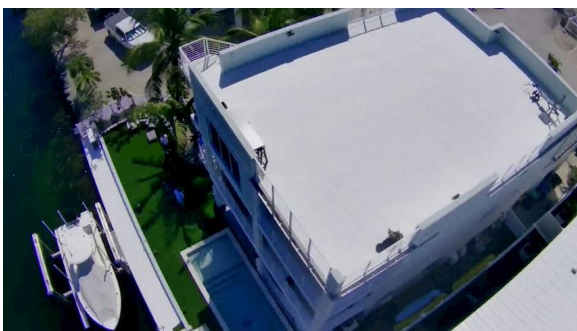
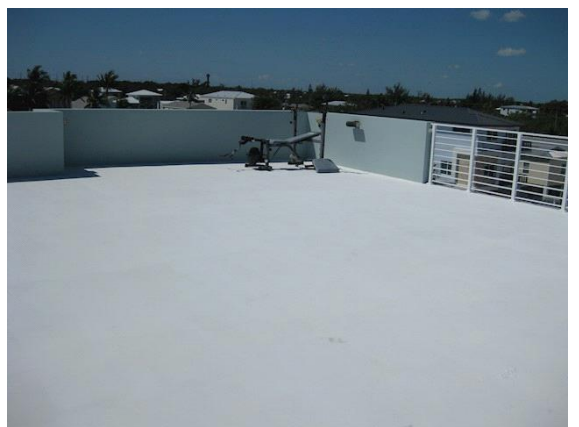
Gutter downspouts were crushed, recommend repair to allow proper water flow

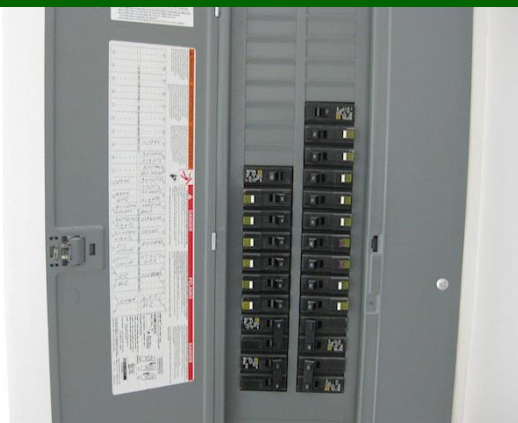
Primary electrical panel located on third floor next to main bedroom

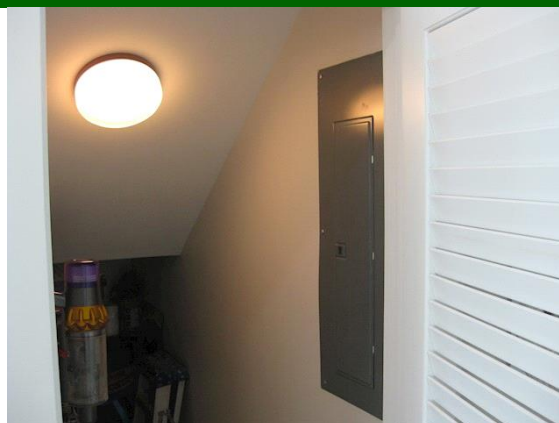
Second electrical panel in storage closet under stairs

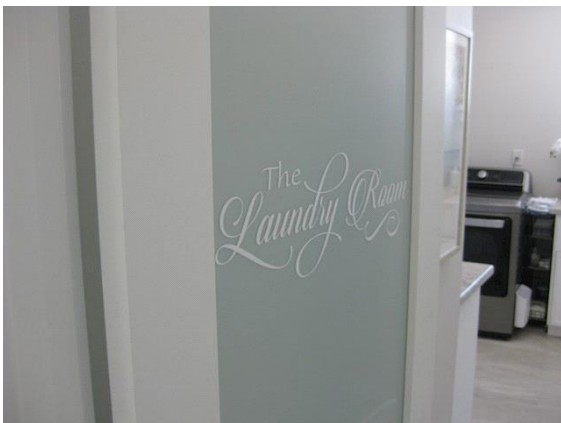
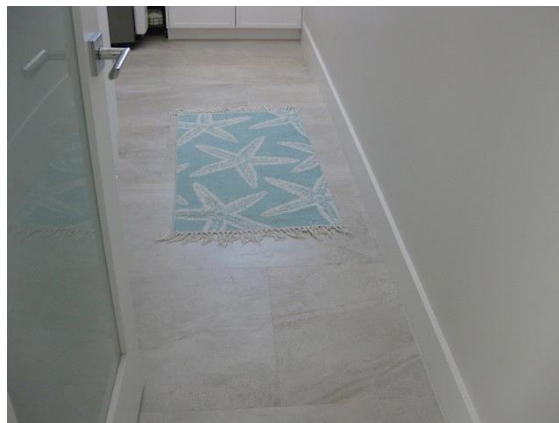
The washer was run through a short cycle to test the drain capability. There were no issue at the time of the inspection. The dryer was tested and ran and vented properly at the time of the inspection. All components in laundry room were acceptable at time of inspection.

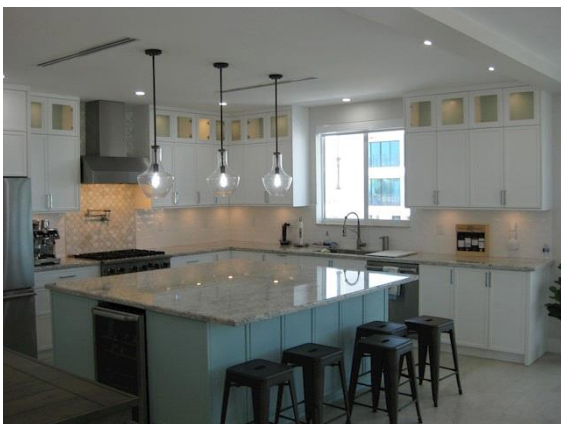
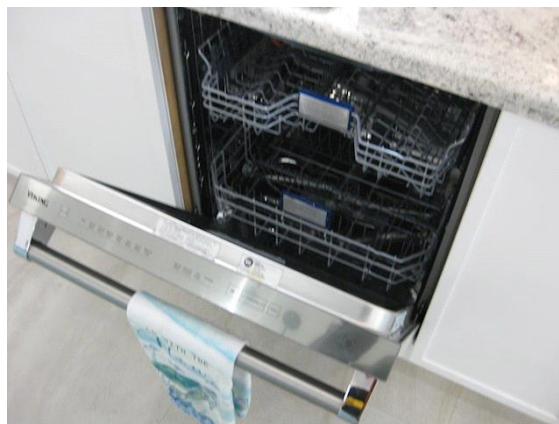
All components in kitchen were acceptable at time of inspection.

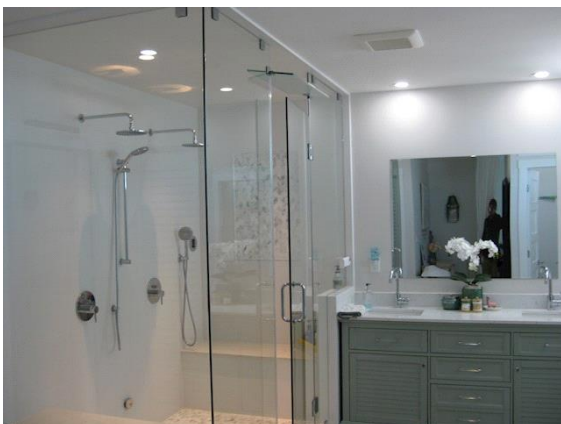
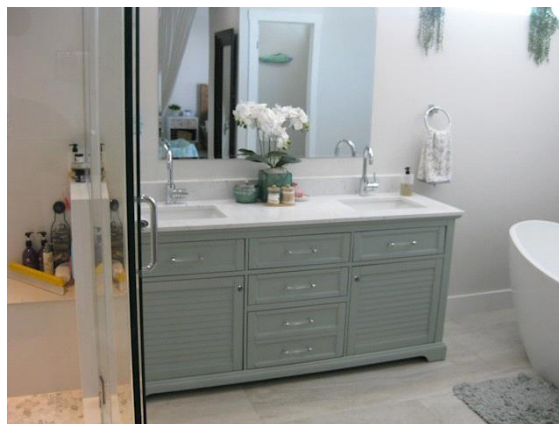
All components in bathroom were acceptable at time of inspection.

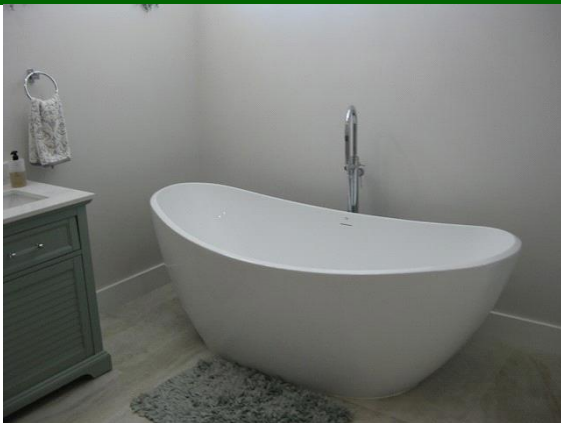
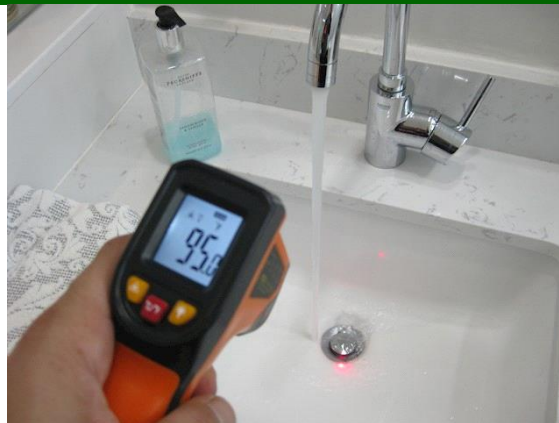
Water heater delivering hot water at time of inspection

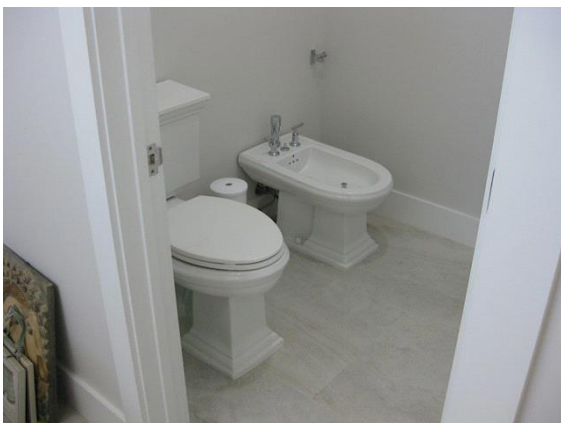
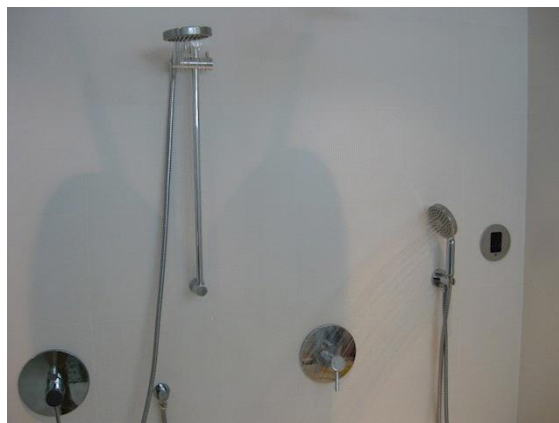
Acceptable water flow in shower

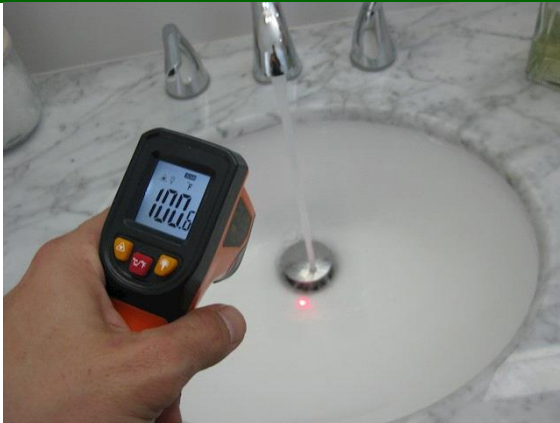
Water heater delivering hot water at time of inspection

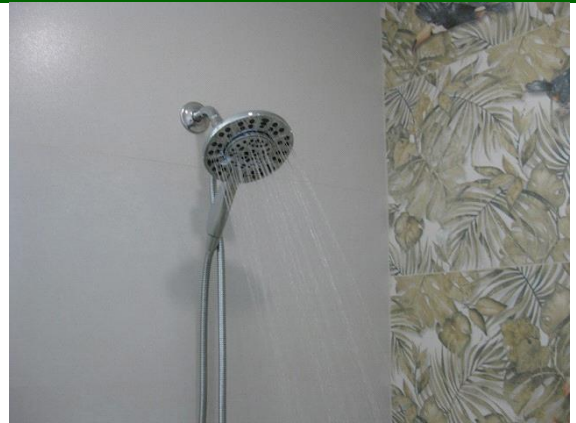
Acceptable water flow in shower

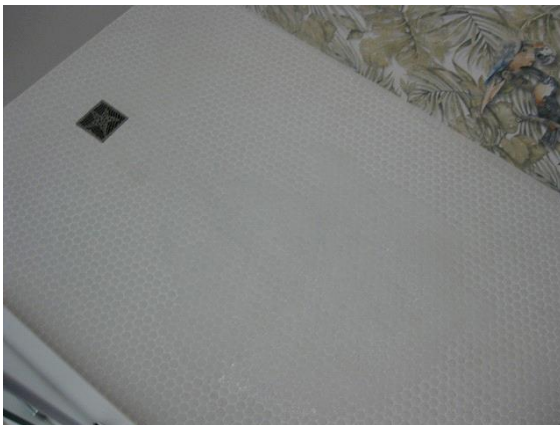
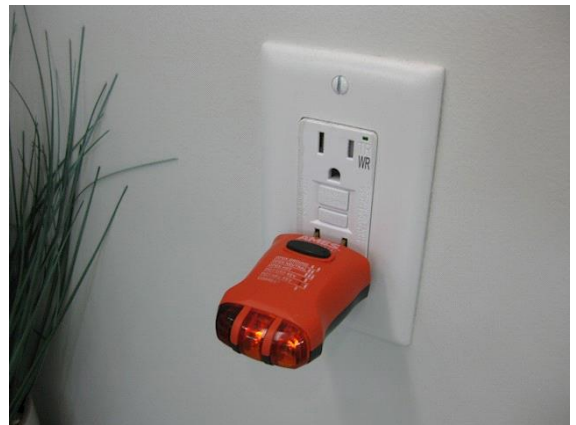
Outlets properly wired in this area

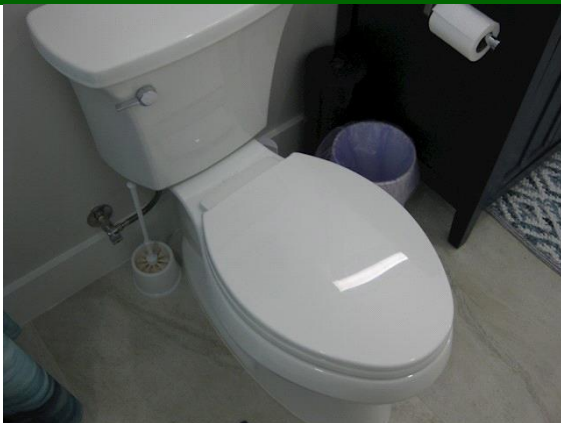
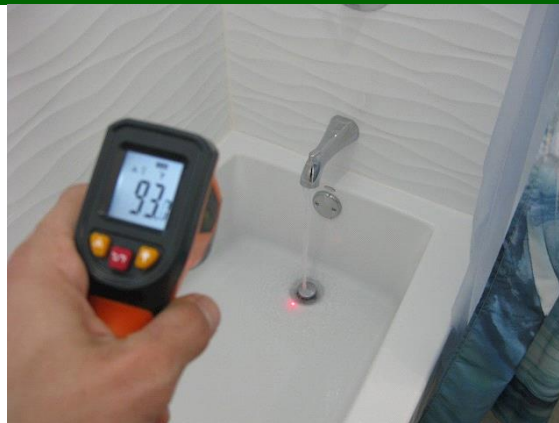
Water heater delivering hot water at time of inspection

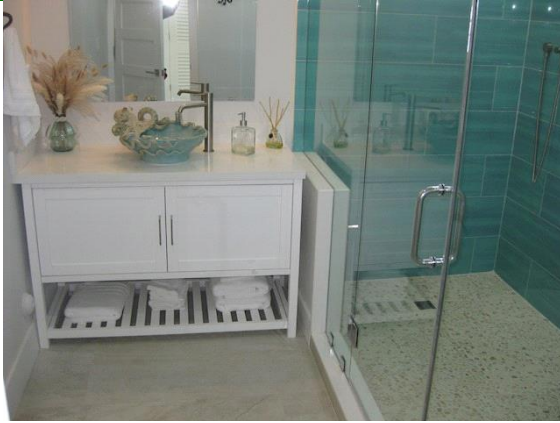
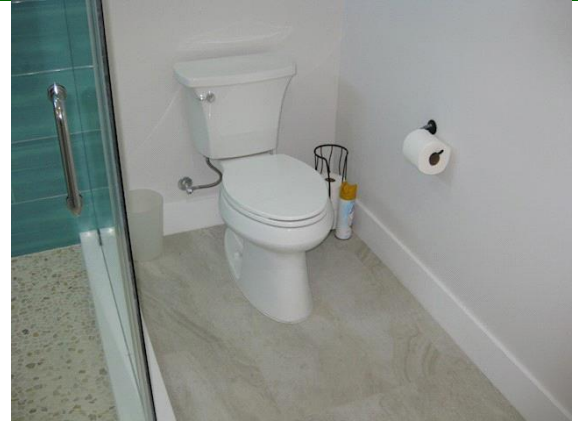
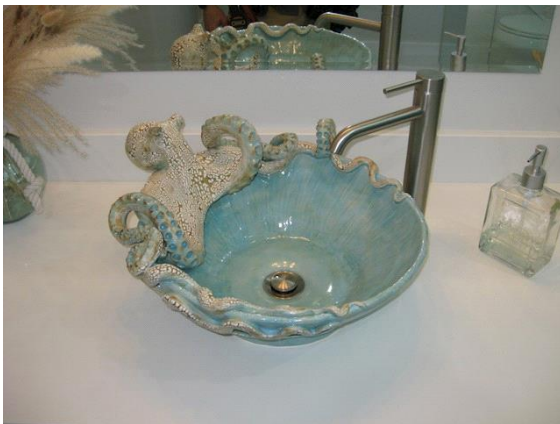
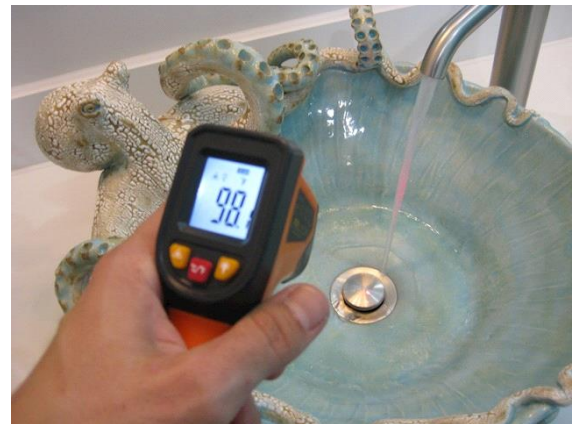
Water heater delivering hot water at time of inspection

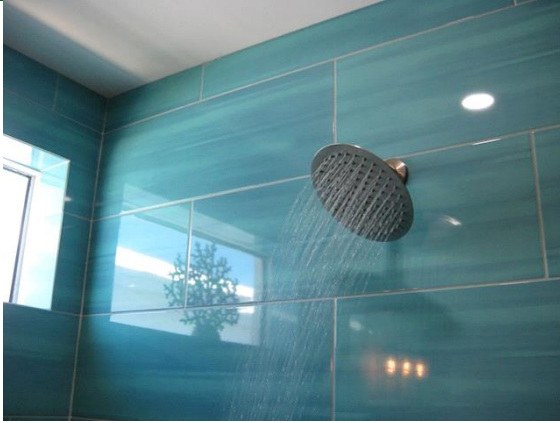
Acceptable water flow in shower

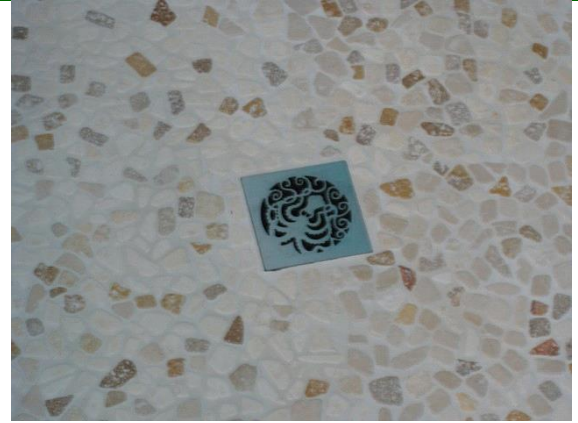
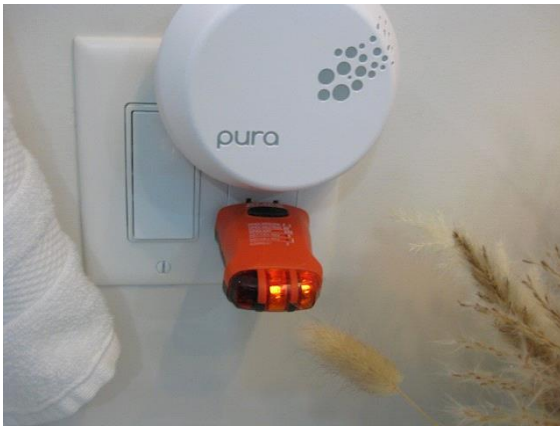
Outlets properly wired in this area

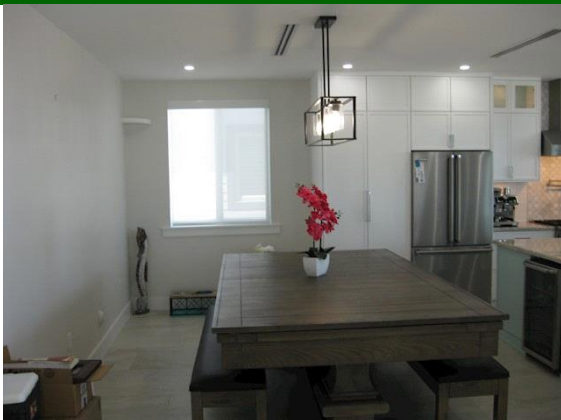
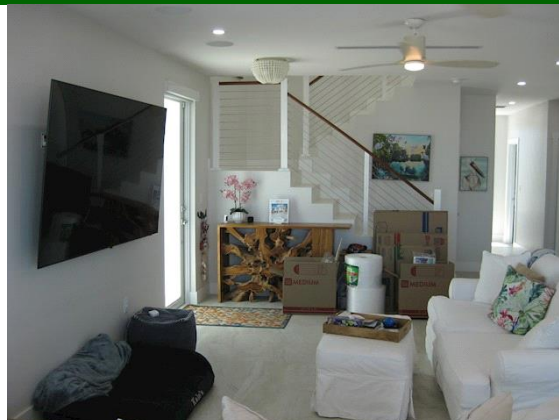
### 1ST FLOOR LOUNGE AREA

Ceiling and walls were free of cracks. Receptacles and lights were wired correctly.

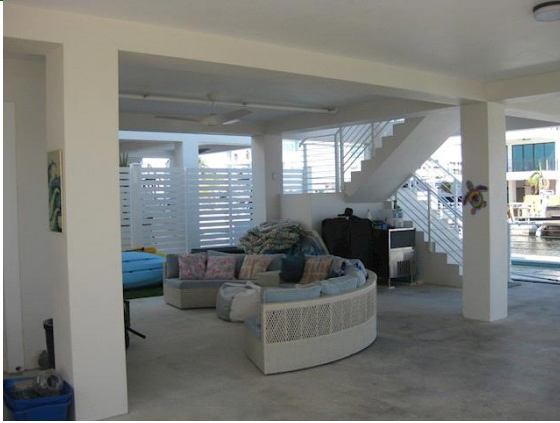
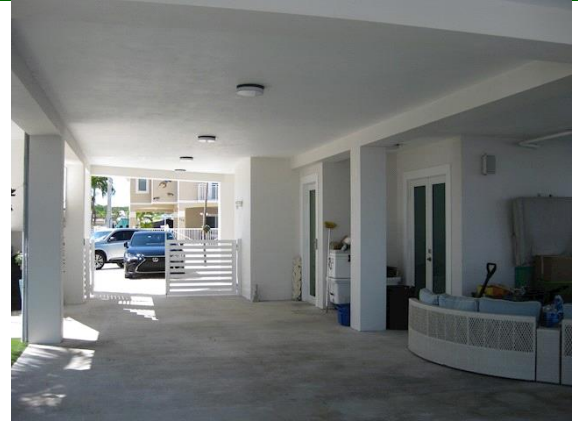
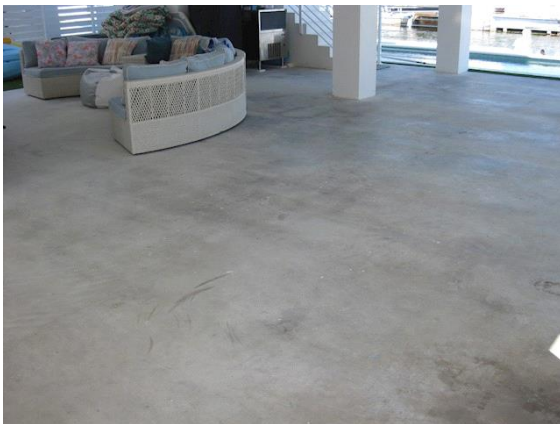
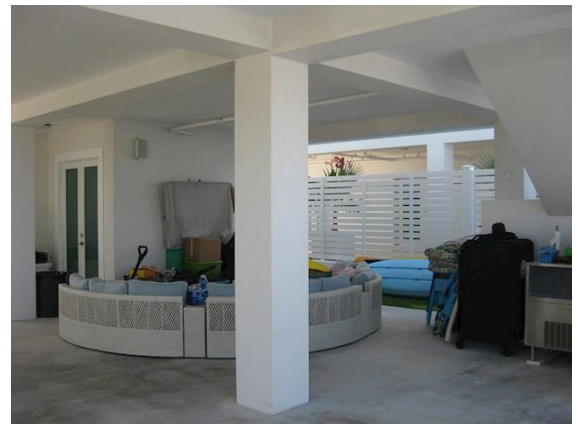
## STORAGE ROOM

Storage room functional at time of inspection, no evidence of damage noted to structures

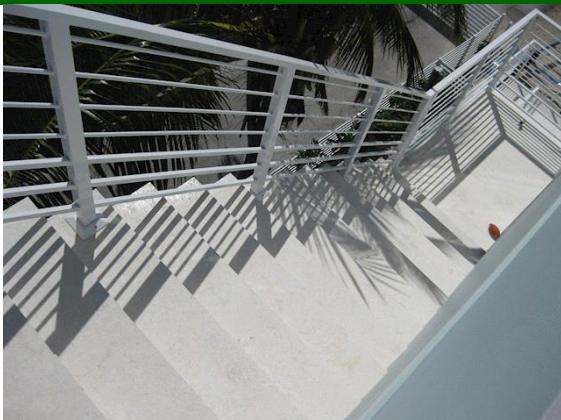
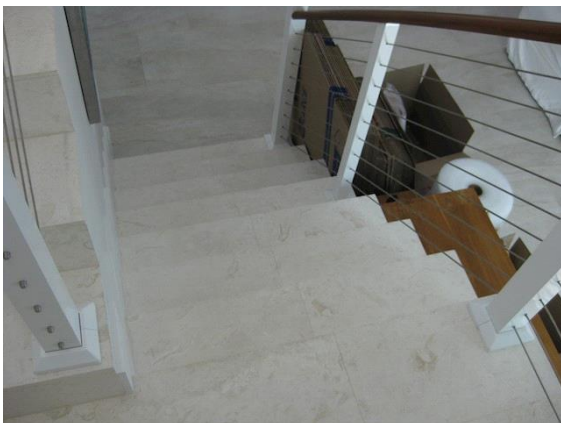
## STAIRS / RAILINGS - INTERIOR OF HOME

Stairs and Railings were acceptable at time of inspection

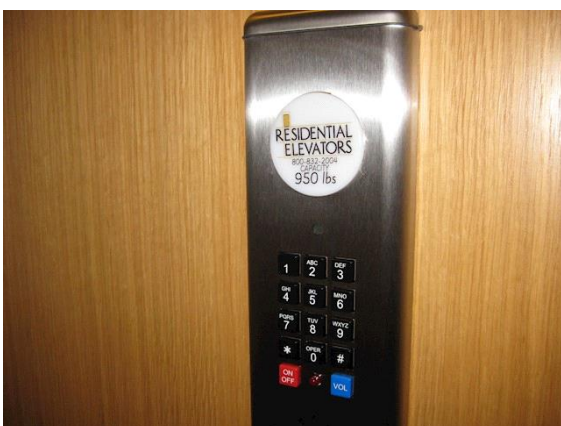
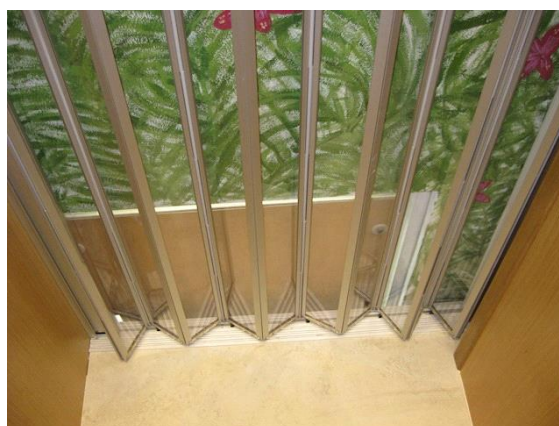
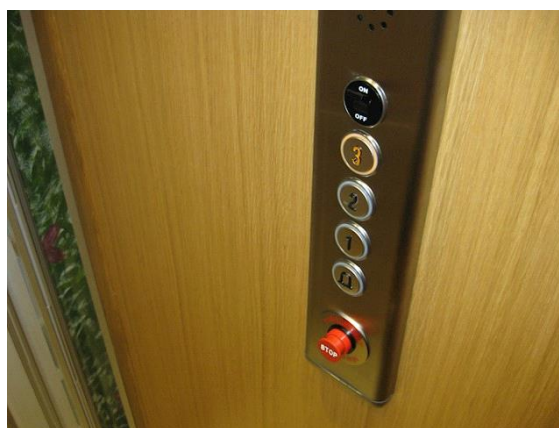
The elevator functioned and went up and down the floors with ease. The elevator arrived at the floor called when called.

Review all safety features regarding this device before operation

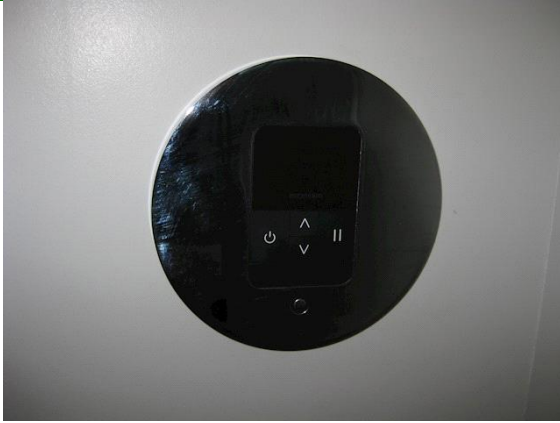
Control panel for steamer in shower

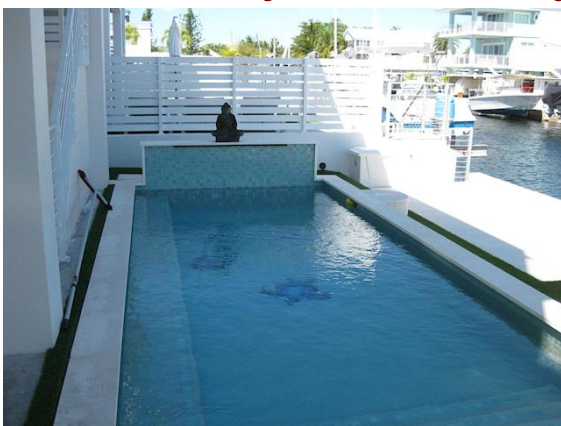
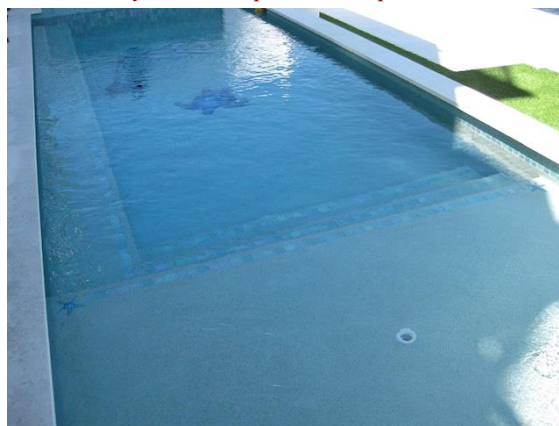
Luminaries worked properly at time of inspection.

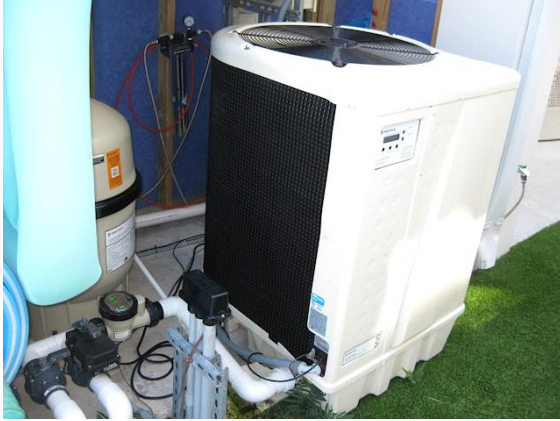
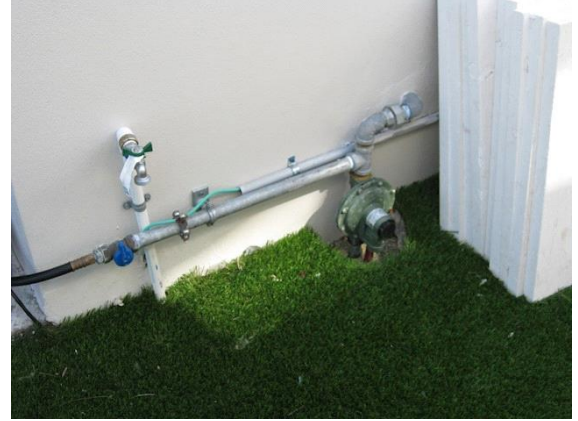
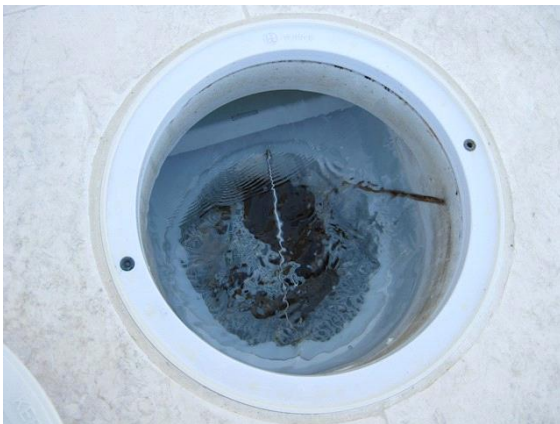
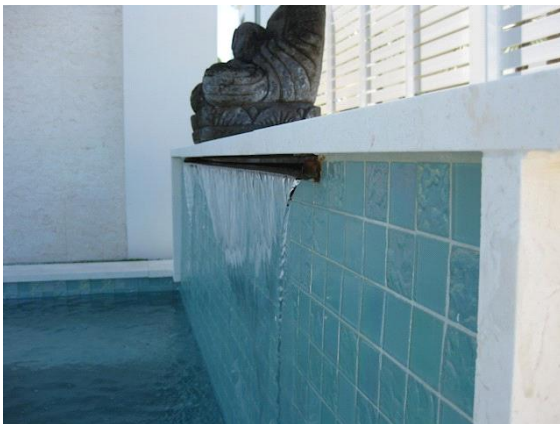
Pool heater was turned on remotely and was observed to be working at time of inspection
