Benny Paneto DBA
National Property Inspections

Jane Smith, 10961 Fawn Rd, Cali, CA, 92250

Inspection Date:
05/15/2023

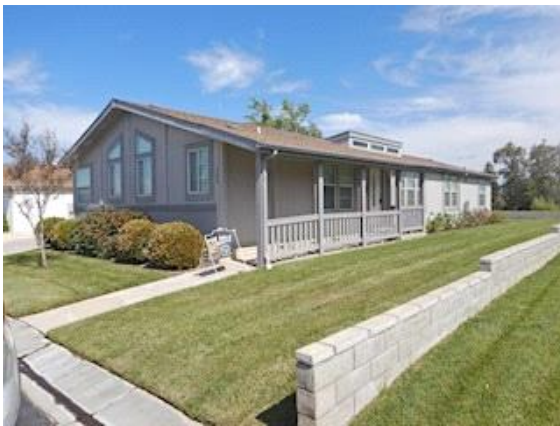
Grading/drainage appeared to be a positive slope around all sides of the home.

Grading / Drainage: front

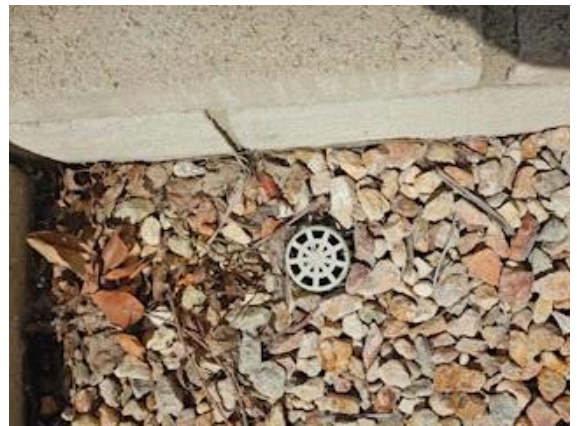
Grading / Drainage: front drain

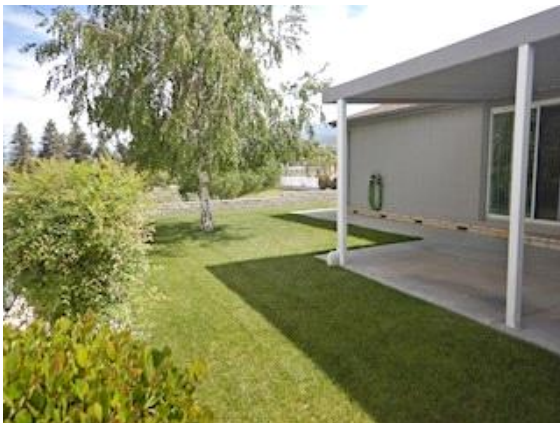
Grading / Drainage: backyard

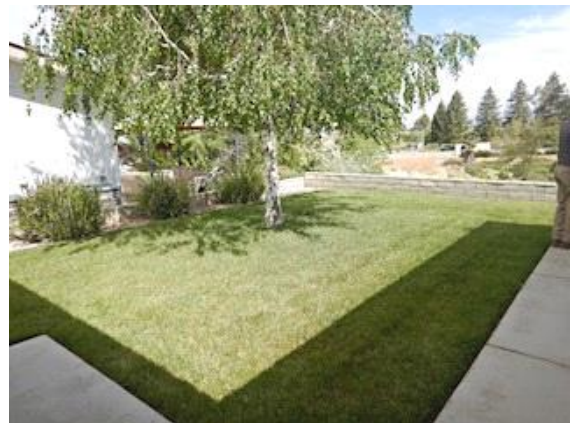
Grading / Drainage: backyard

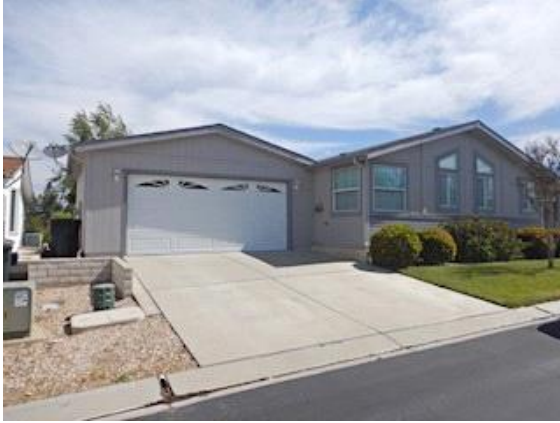
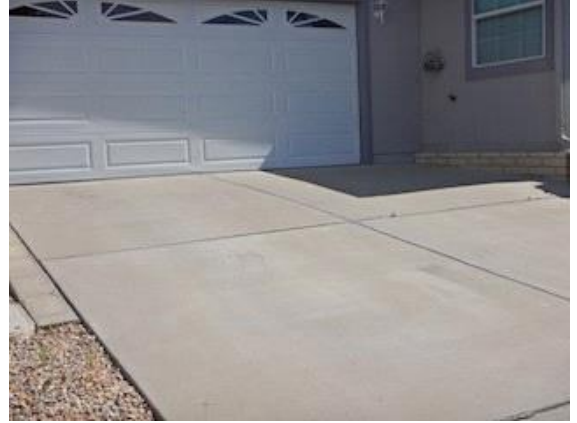
The driveway was in generally good condition with minor cracks, no settlement and had an acceptable surface.

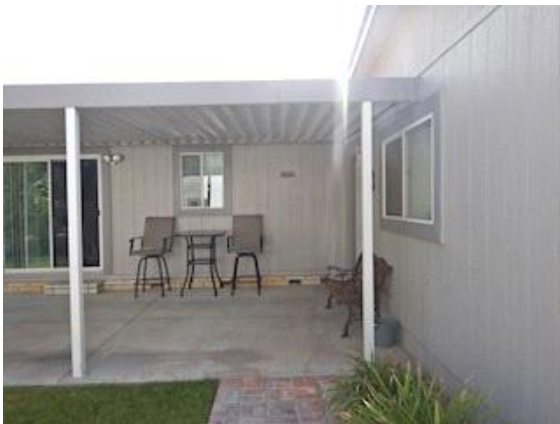
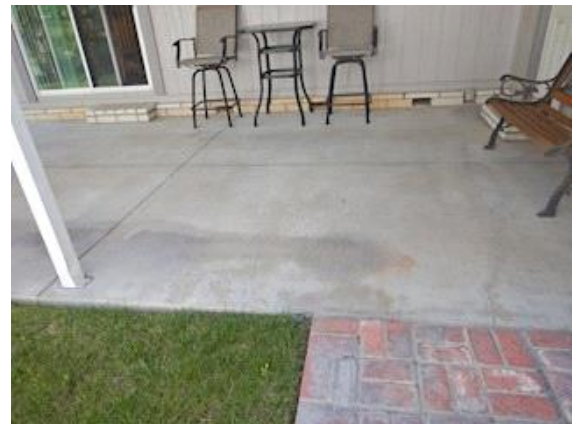
Patio has general deterioration present. No major defects noted.

The metal patio side molding has evidence of cracked sealant on the seam. Recommend further evaluation/repair by qualified contractor(s).

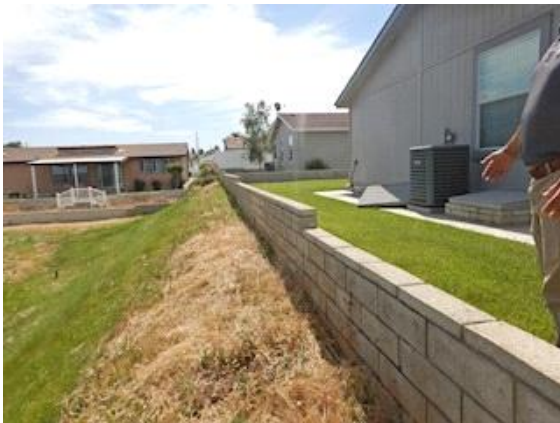
Comments:
Masonry wall was in generally good condition.

Fences / Gates: backyard masonry wall

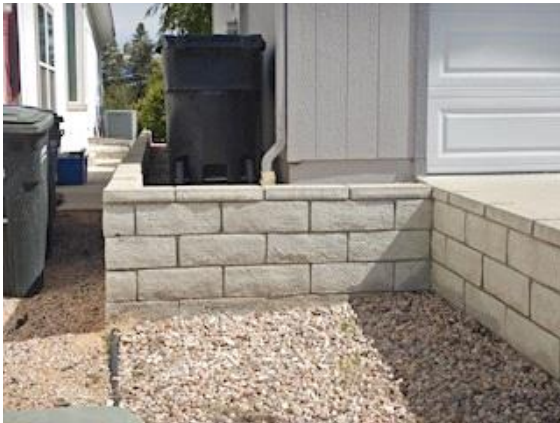
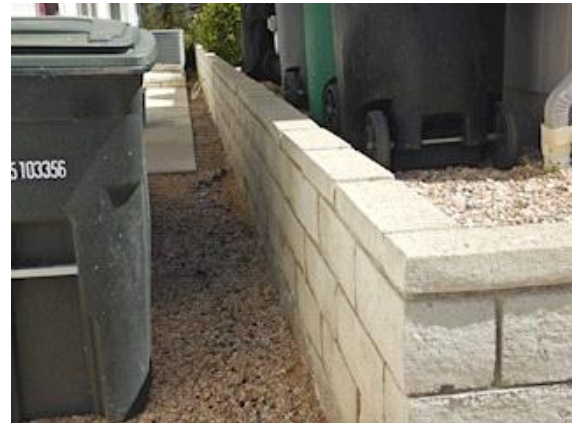
Retaining wall appeared to be functioning as designed and is in good shape at time of inspection.

Retaining Walls: left front

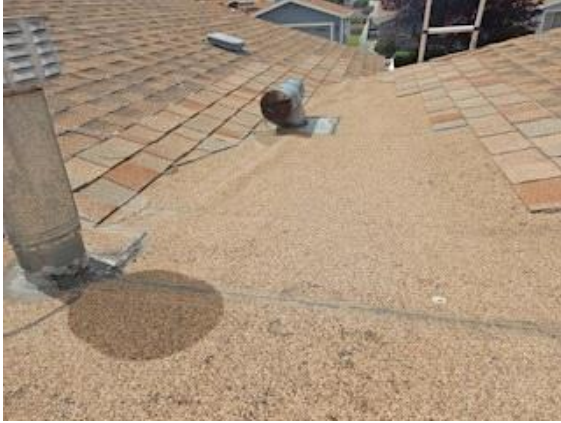
Observed multiple areas on the roof with evidence of missing granules. Noted evidence of pooling water on the main roof valley. Recommend further evaluation/repair by qualified roofing contractor(s).

Roofing 1: roof valley

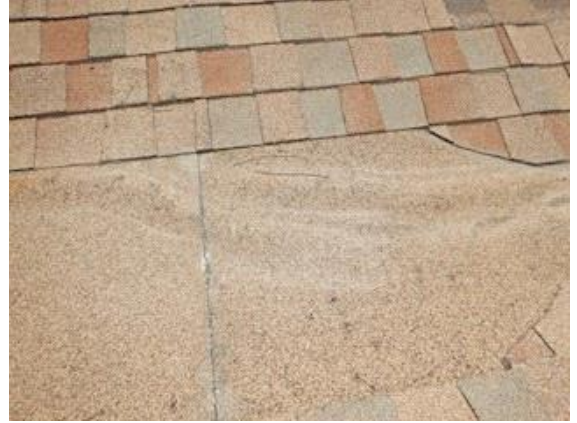
Roofing 1: roof valley shows evidence of pooling water and wrinkled rolled on asphalt roofing material

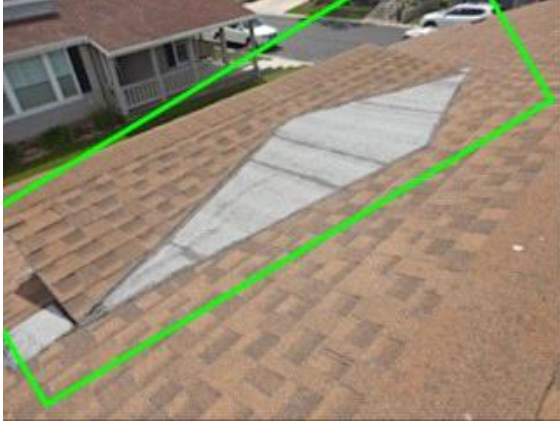
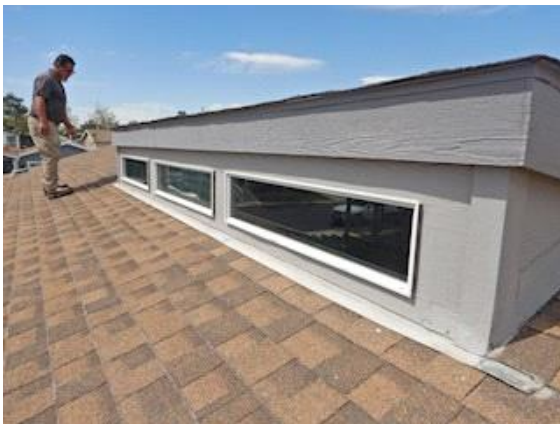
The roof dormer had cracked sealant in several areas. Recommend further evaluation/repair by qualified roofing contractor(s).

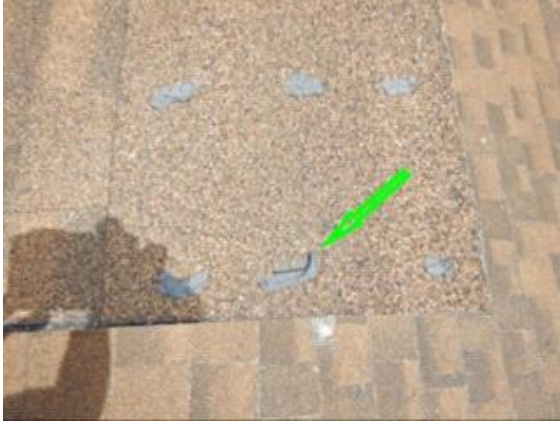
Roofing Dormer over the living room: exposed roof staples

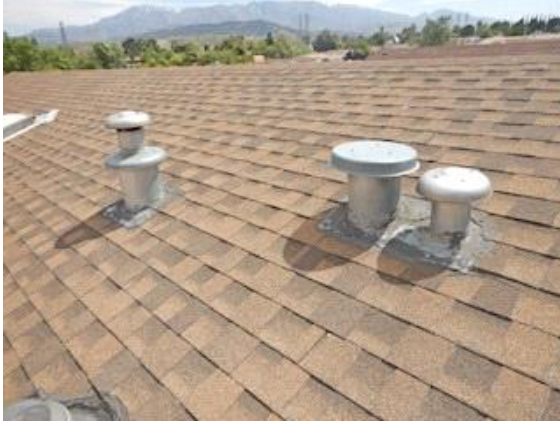
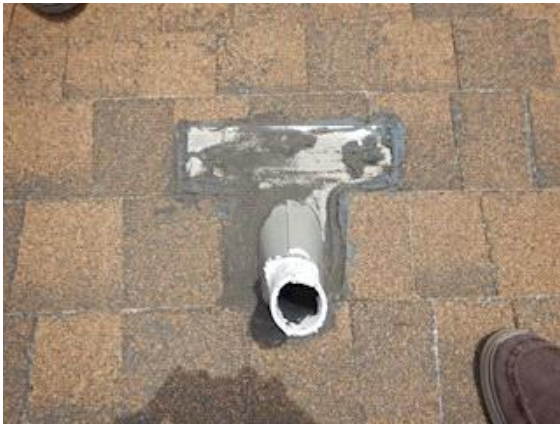
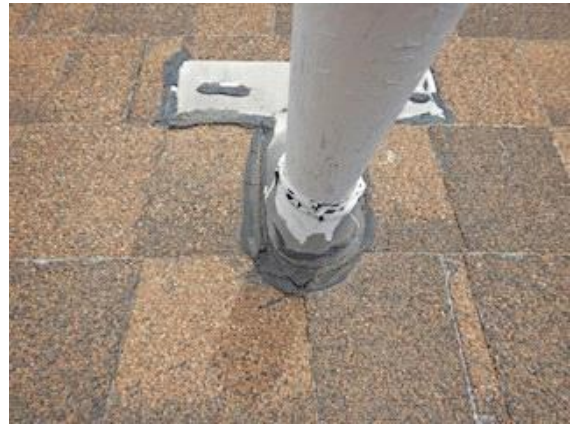
Observed several metal flashings with cracked sealant around the base. Recommend further evaluation/repair by qualified contractor(s).

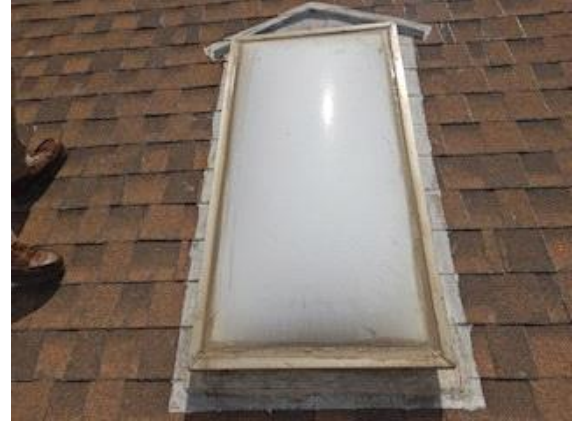
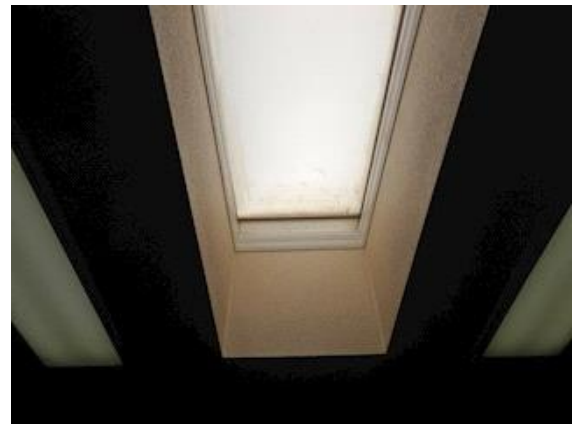
Both skylights show evidence of cracked sealant around the base. Recommend further evaluation/repair by qualified roofing contractor(s).

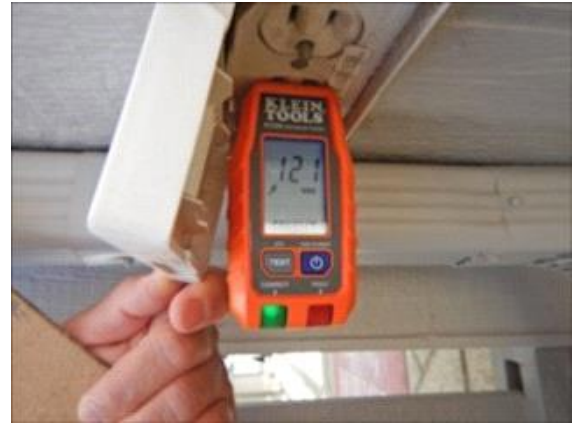
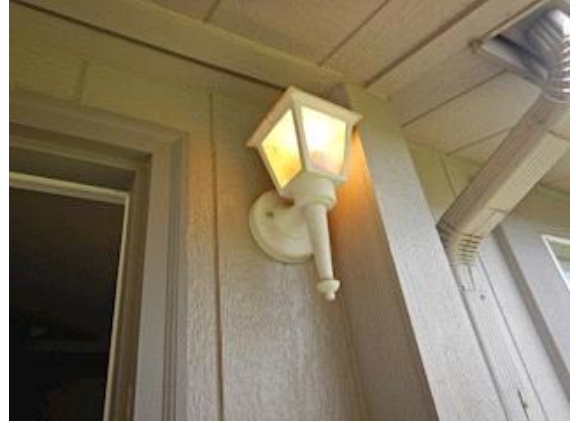
Noted wood rot on the porch on several areas of the composite trim. Recommend further evaluation/repair by qualified contractor(s).

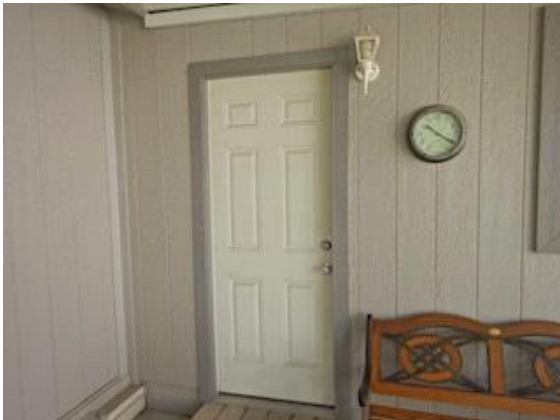
Exterior Doors: garage exit door

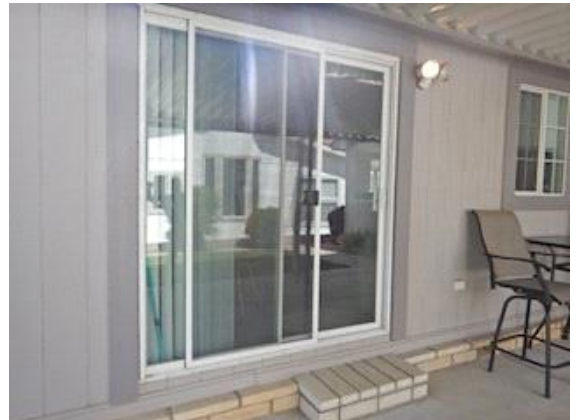
Exterior Doors: patio sliding door

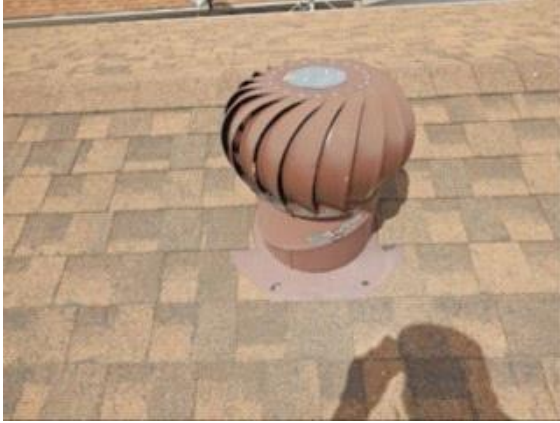
The garage turbine vent is not turning. Recommend further evaluation/repair by qualified contractor(s).

Garage/Carport: the garage turbine vent is not turning

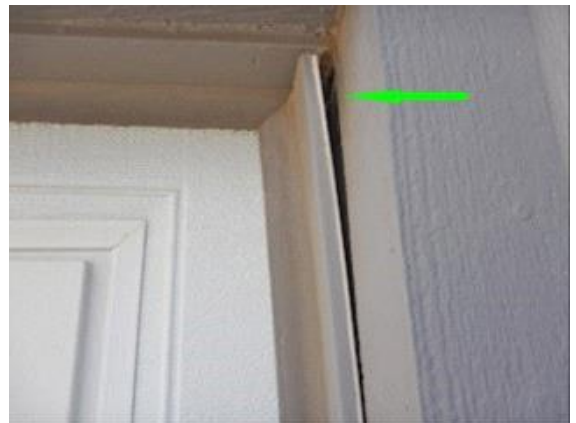
The upper right garage door molding is not attached. The automatic garage door opener had an inoperable or out of adjustment automatic-reverse feature. Auto reverse is a safety feature that stops the door from closing when it hits an object. Recommend a garage door technician review the operation of the garage door and make repairs/adjustments needed for the door to operate in a safe manner.

Overhead Garage Doors: the upper right garage door molding is not attached

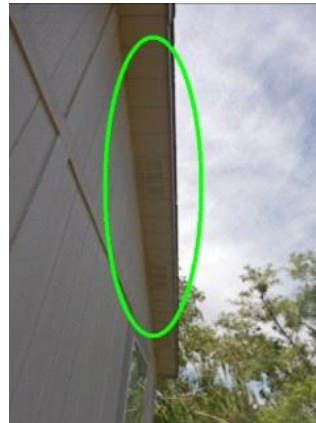
Attic Ventilation: rear attic vents

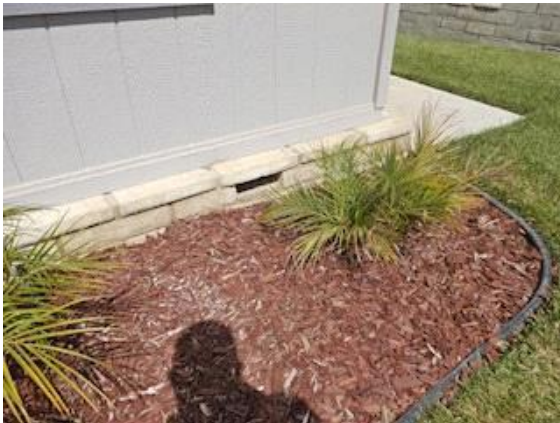
Crawl Space: crawl space vents

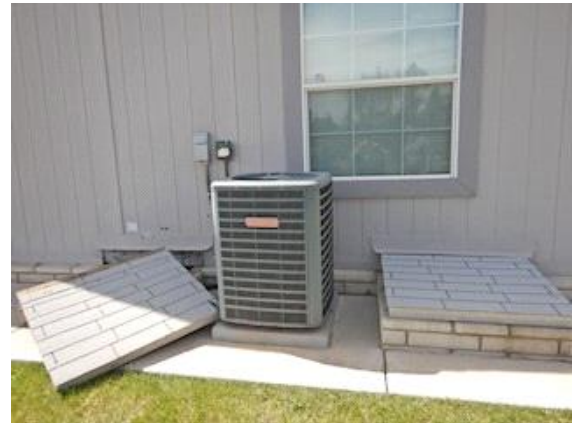
Crawl Space: two crawl space access

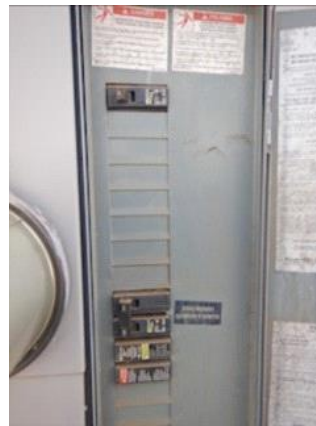
The left front electrical panel breakers are not labeled for safety. Recommend to have a licensed electrician further evaluate and make the necessary of the repairs.

Electrical: left side electrical panel breakers are not labeled for safety

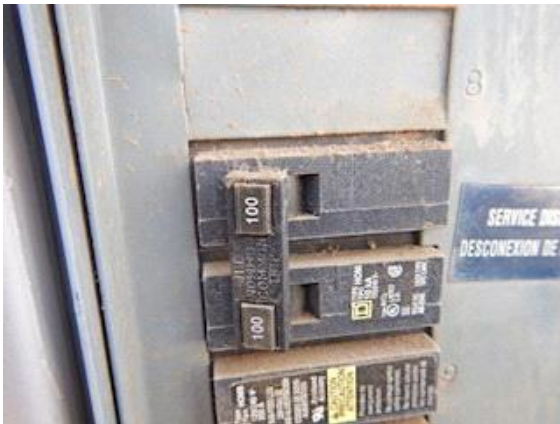
Electrical: main breaker 1

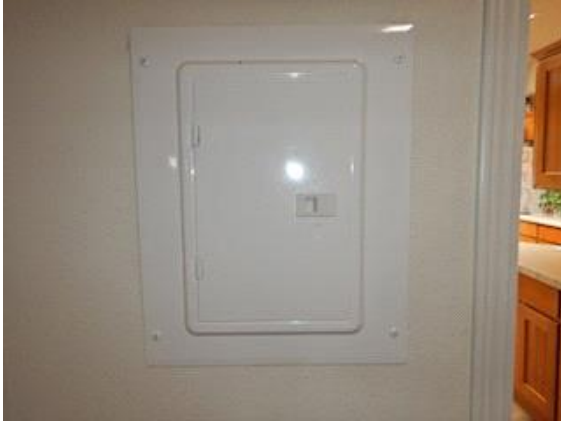
Electrical: the branch electrical panel located in the laundry room

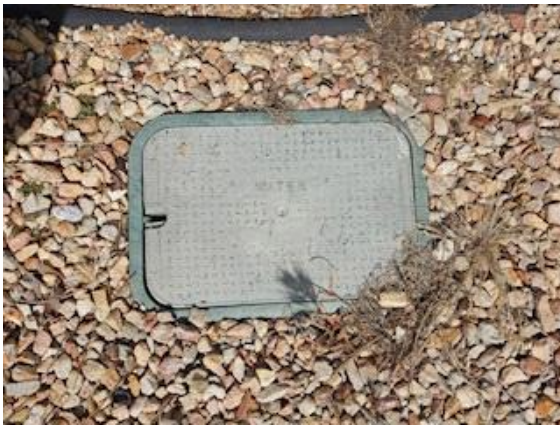
Plumbing: water meter

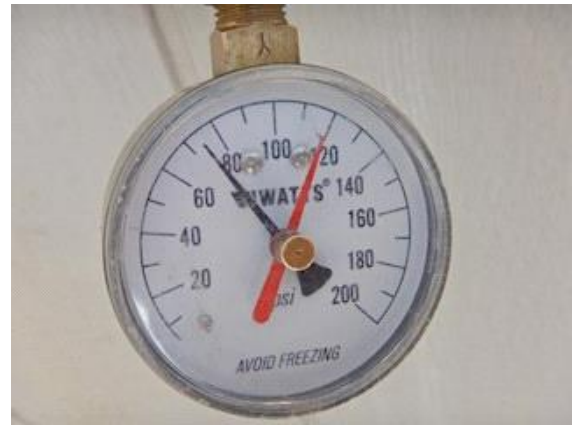
Plumbing: 70 psi

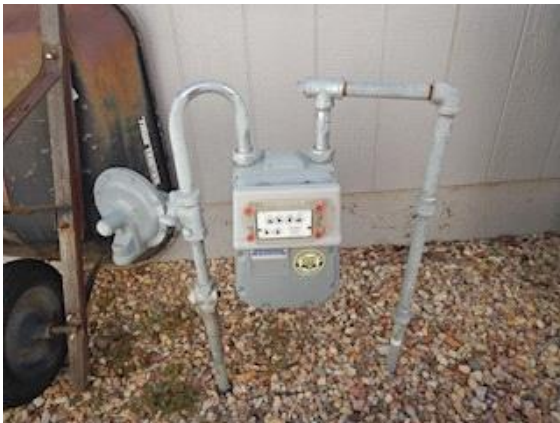
Plumbing: gas meter

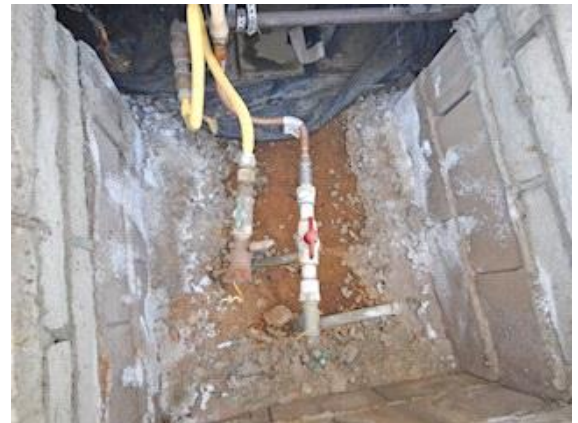
Plumbing: main water shut off

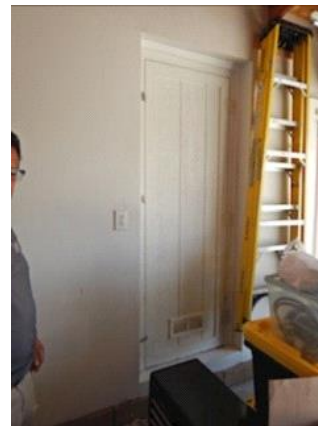
Water Heater: water heater closet

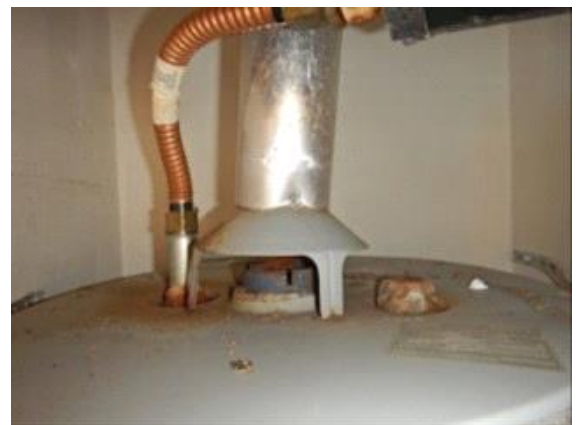
Most water heaters have a life span of ten to twelve years. Unit was functional, but was rated marginal due to its age. Ultimately, you should consider budgeting for replacement of the hot water heater in the foreseeable future.

Water Heater:

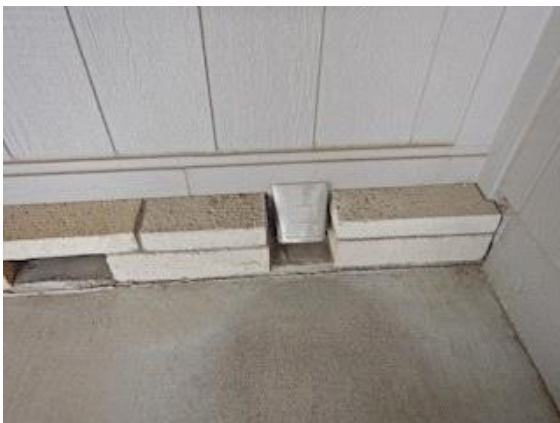
Laundry Facilities: dryer exhaust pipe

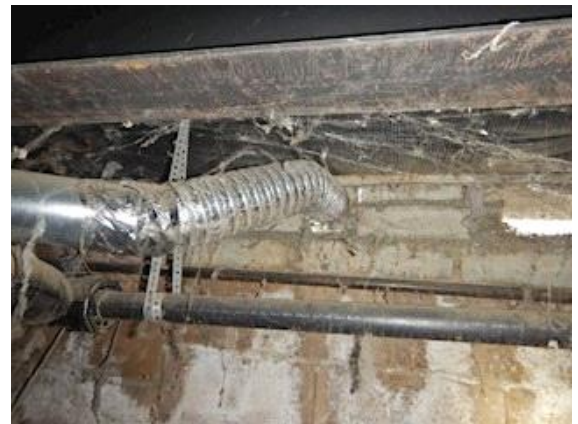
Laundry Facilities: dryer exhaust pipe

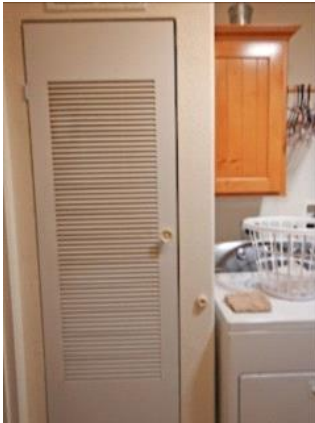
Heating: home heating closet located in the laundry facilities room

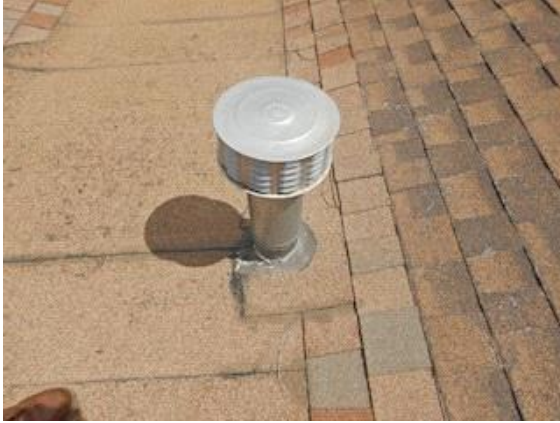
Draft Control/Vent: home heating unit

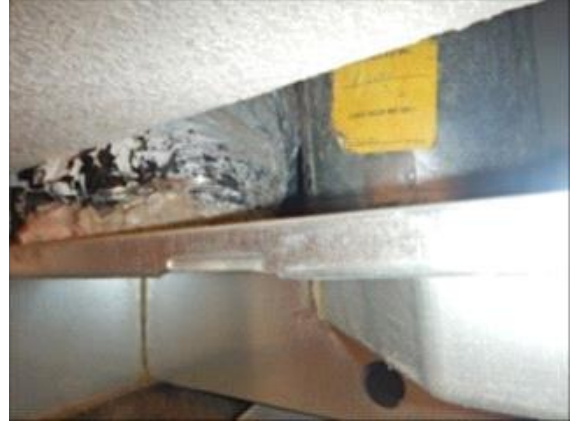
Draft Control/Vent: home heating vent pipe

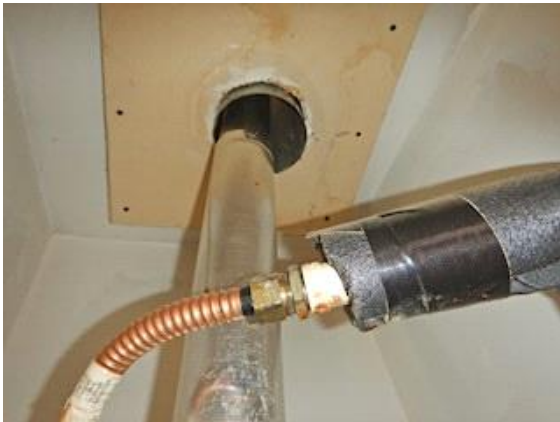
Draft Control/Vent: water heater vent pipe

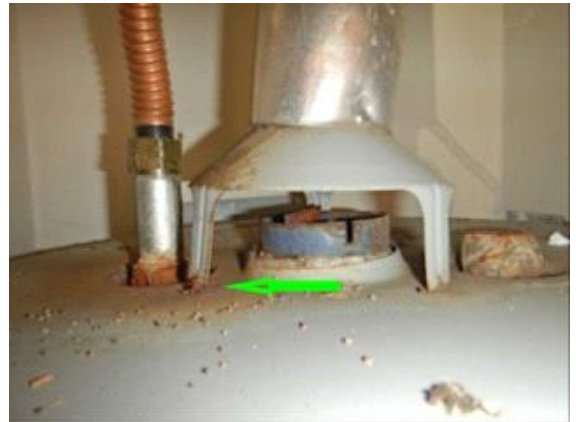
The water heater vent hood is not installed correctly, the left leg is not inserted. Recommend further evaluation/repair by qualified contractor(s).

Draft Control/Vent: The water heater vent hood is not installed correctly, the left leg is not inserted

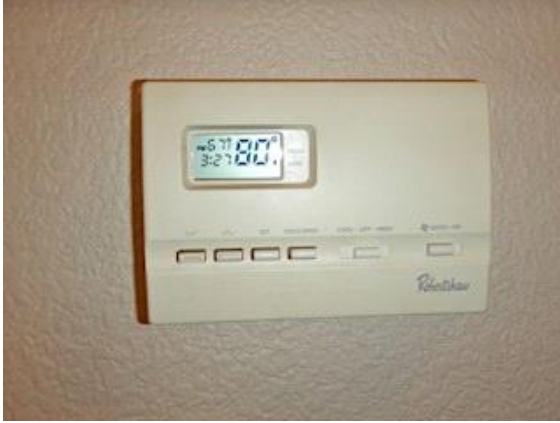
Heating Distribution: thermostat is located in the hallway

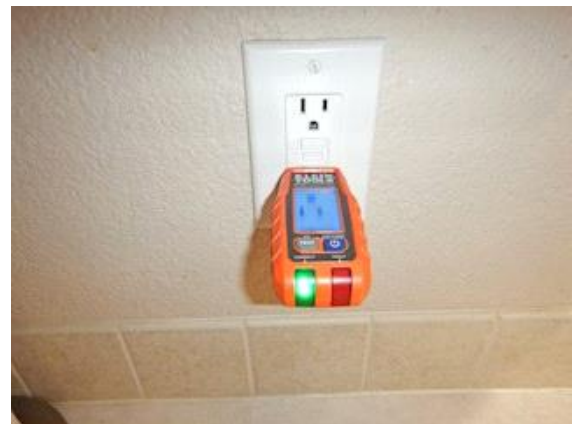
Kitchen: the GFCI is functioning as designed

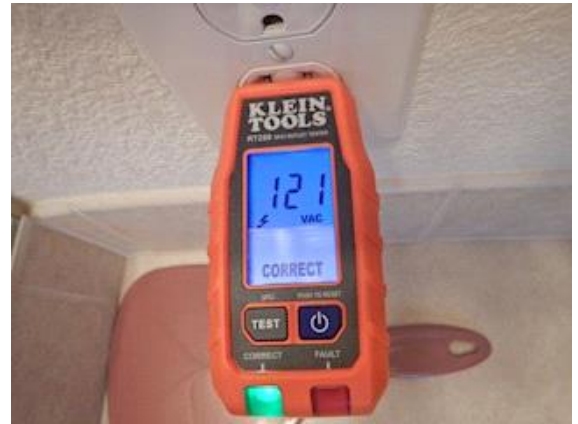
Bathroom 1: the outlet is GFCI protected

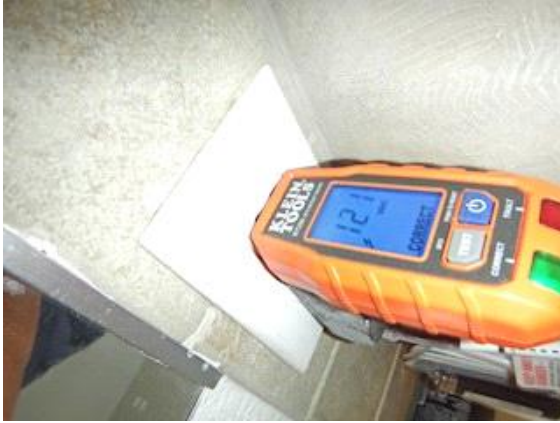
Bathroom 2: outlet is GFCI protected

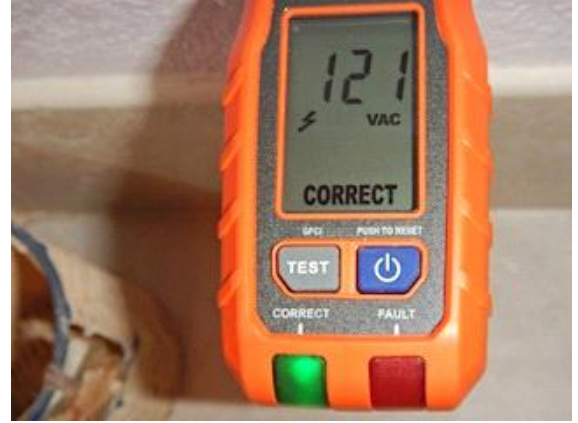
Bathroom 3: GFCI is functioning as designed

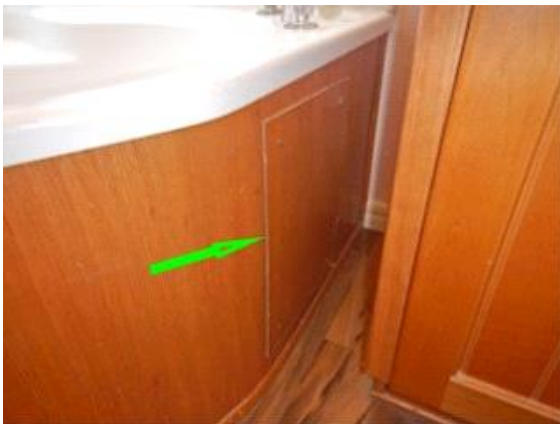
Bathroom 3: tub plumbing access panel

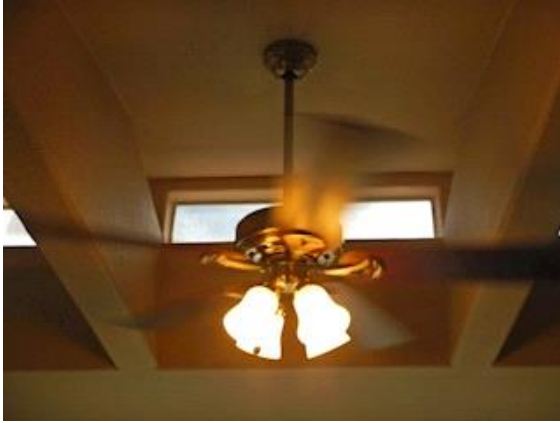
The outlet is showing an open hot. The ceiling fan is wobbling, needs adjustment. Recommend further evaluation/repair by a licensed electrician.

Living room: the ceiling fan is wobbling, needs adjustment

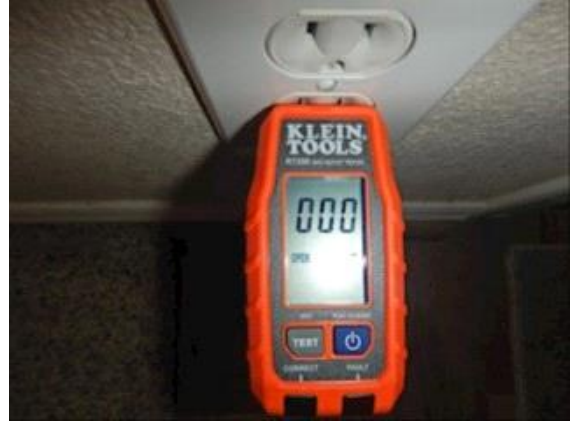
Living room: the outlet is showing an open hot
