Benny Paneto DBA
National Property Inspections

Dan Blanco, 2661 W Daw Ct, Ranger, CA, 92699

Friday, March 31, 2023

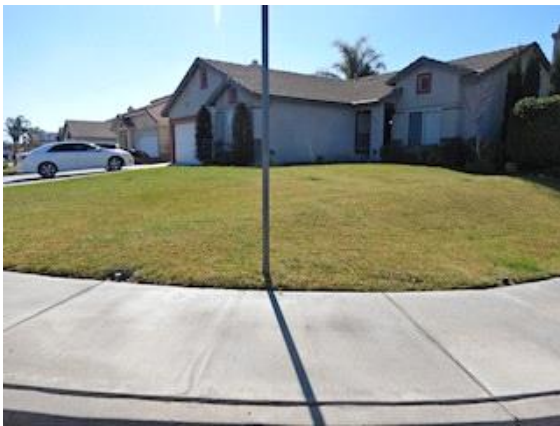
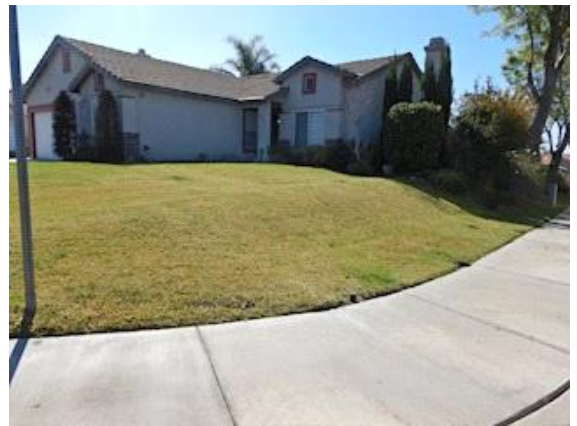
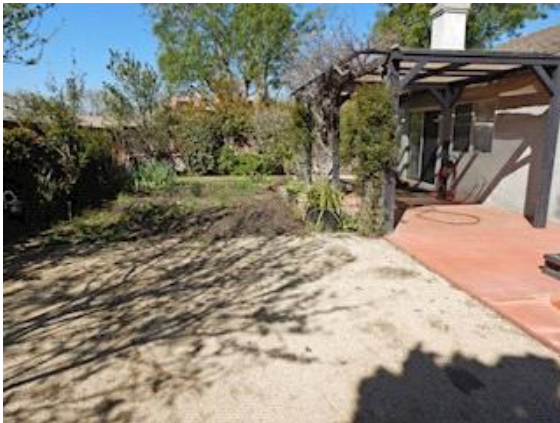
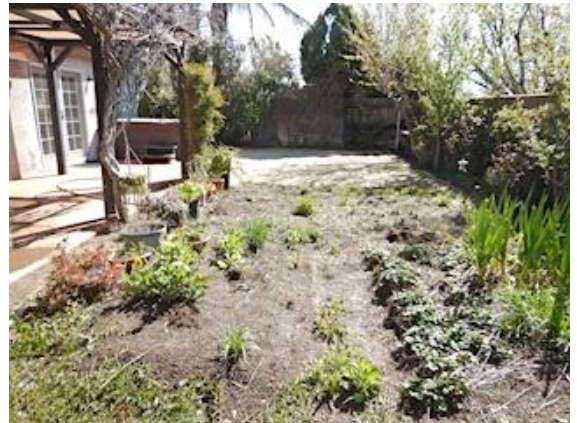
Grading/drainage appeared to be a positive slope around all sides of the home.

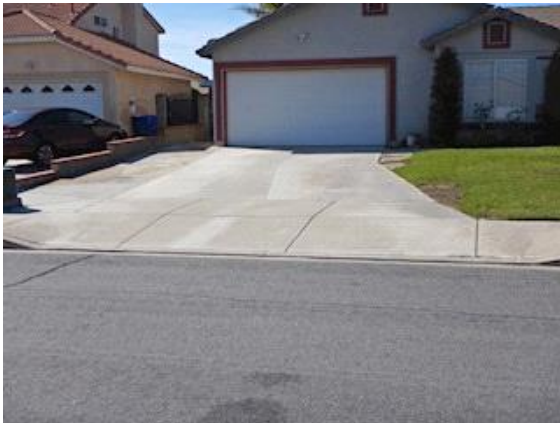
Driveway:

The driveway was in generally good condition with minor cracks, no settlement and had an acceptable surface.

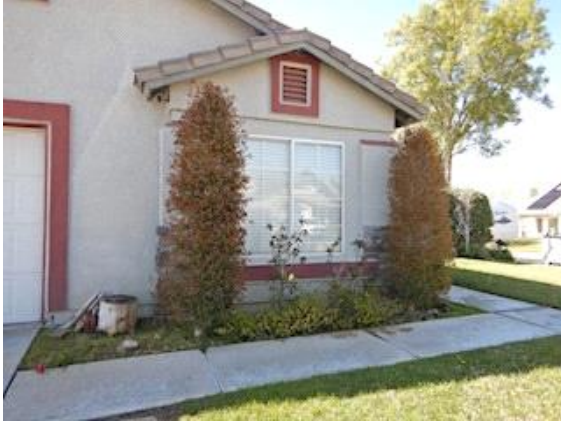
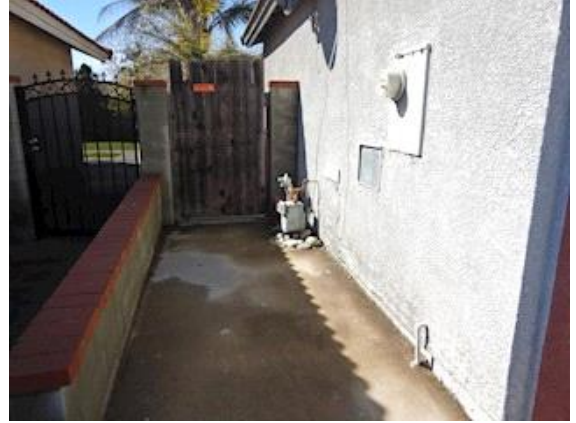
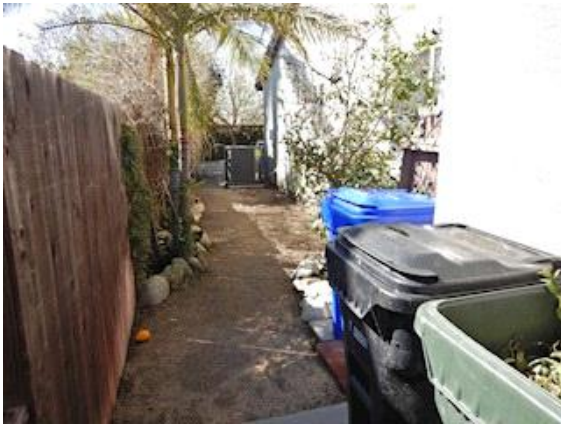
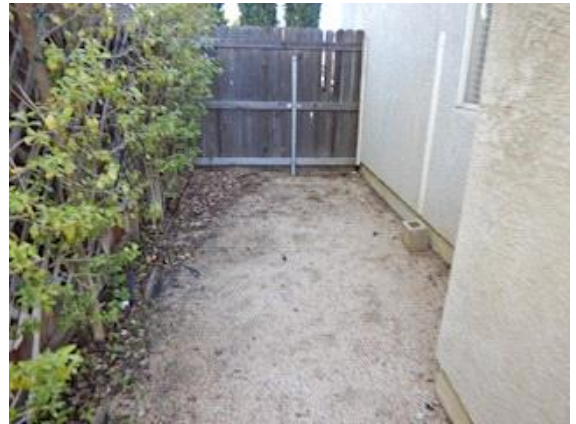
Walkways/steps to the house and around the property were in good condition at time of the inspection.

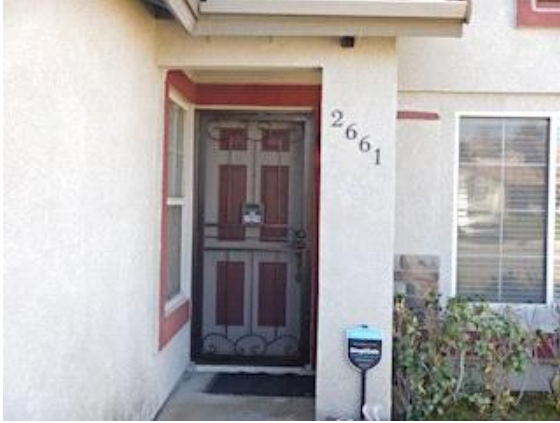
Porches / Stoops:

Porch was functional at time of inspection with no major defects noted.

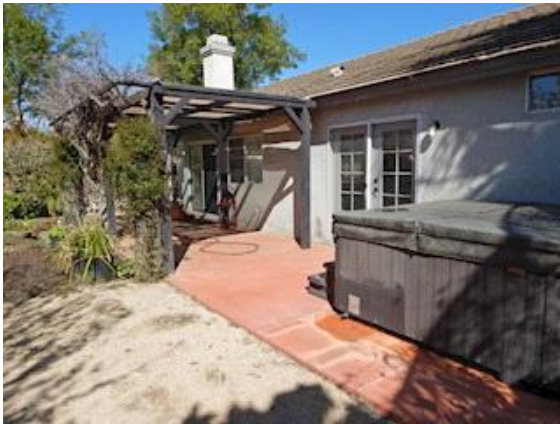
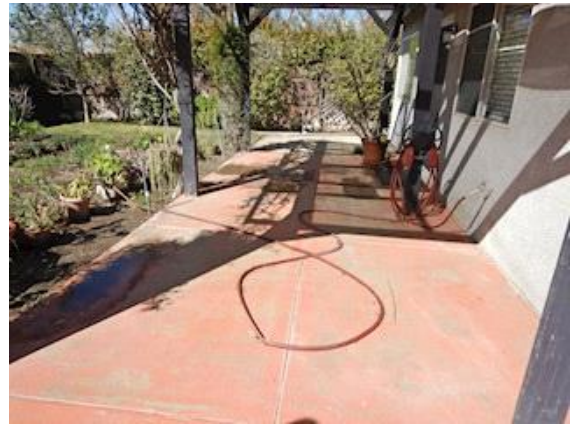
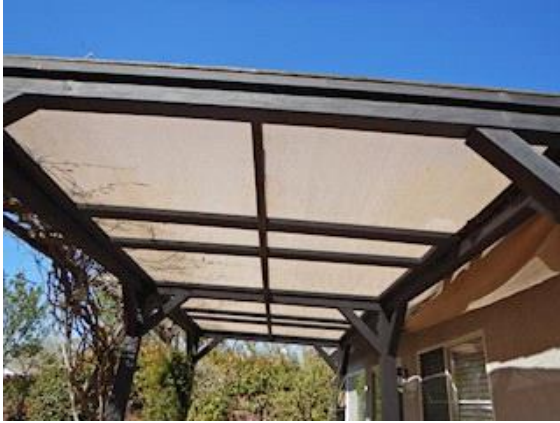
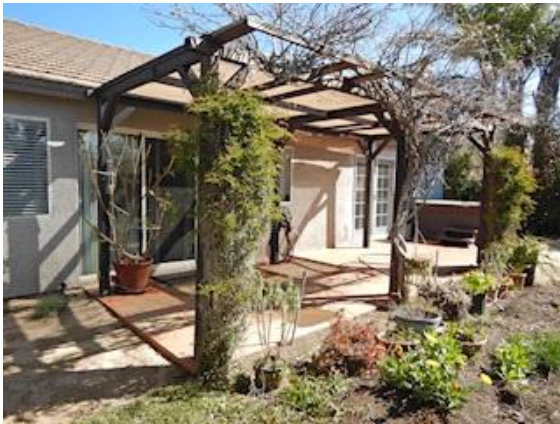
Observed wood rot on several areas of the patio wood trim. Recommend further evaluation/repair by qualified contractor(s).

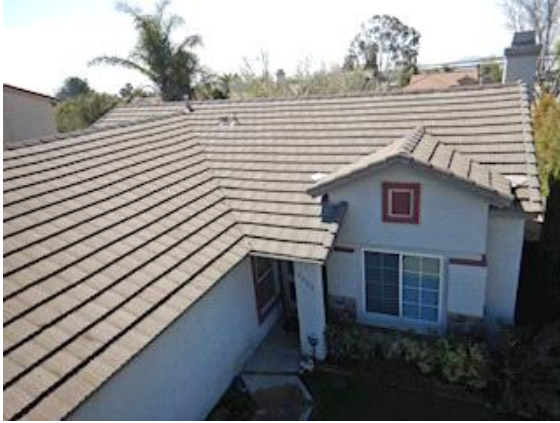
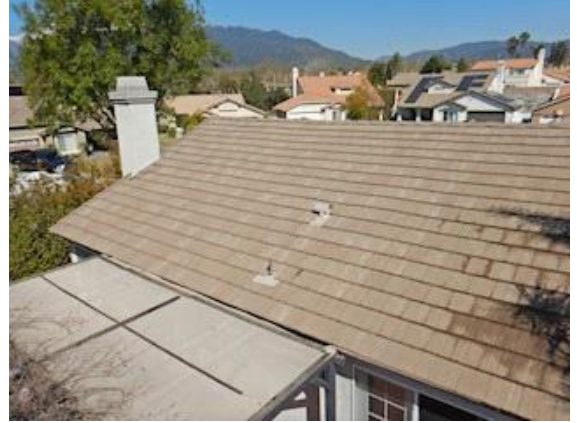
Observed a missing piece of a roof tile located on a rear metal flashing cover, the piece is still on the roof. Recommend further evaluation/repair by qualified roofing contractor(s).

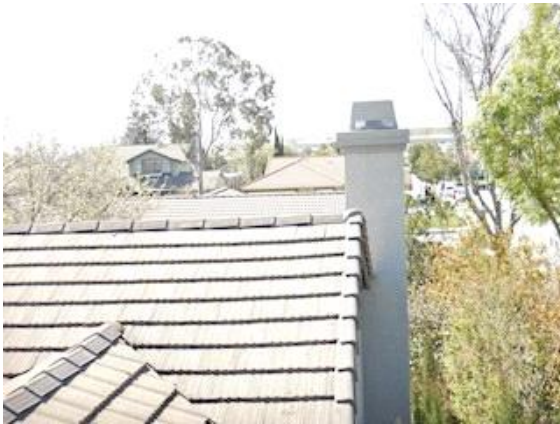
Chimney:

Comments:
Chimney appeared in good condition with rain cap present.

Flue not inspected. Annual cleaning is recommended.

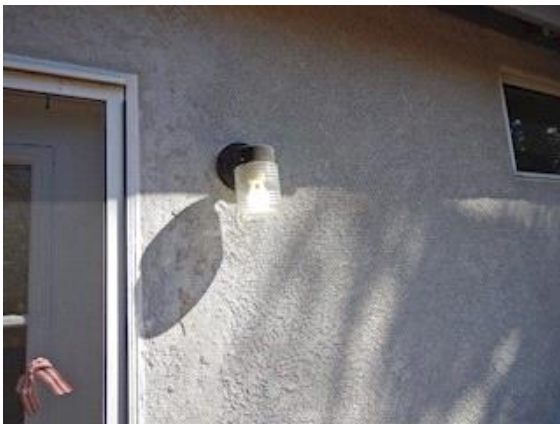
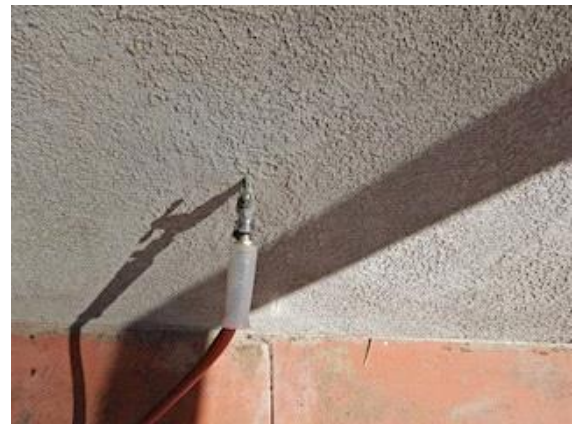
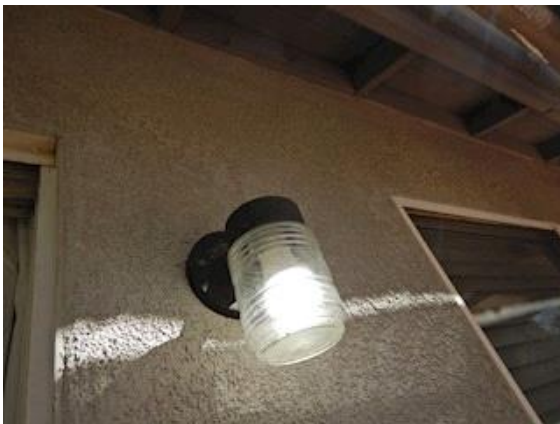
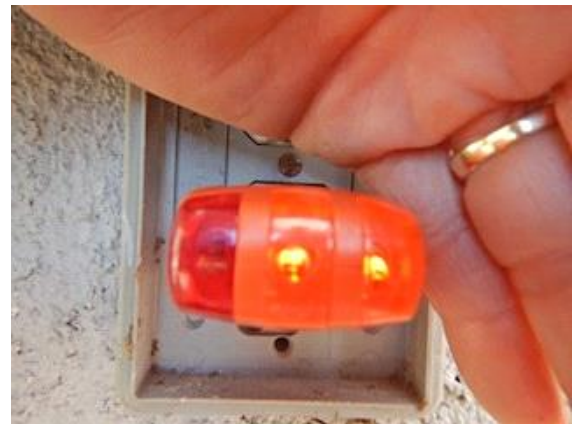
Exterior siding and trim appeared to be in good condition at time of this inspection.

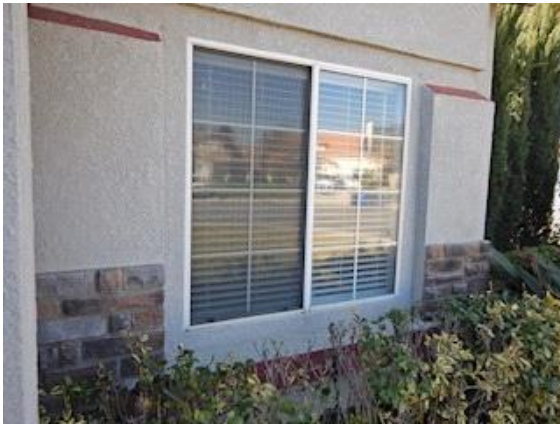
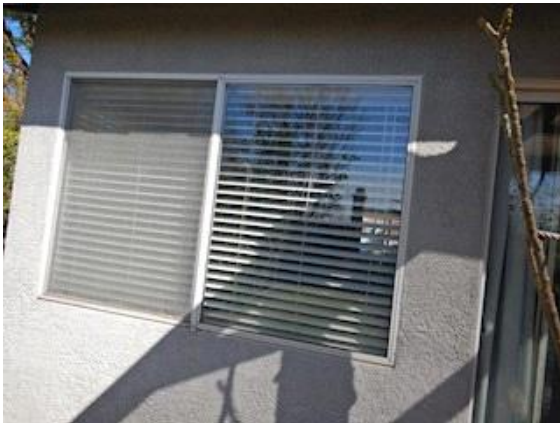
Two windows are missing their screen. Recommend further evaluation/repair by qualified contractor(s).

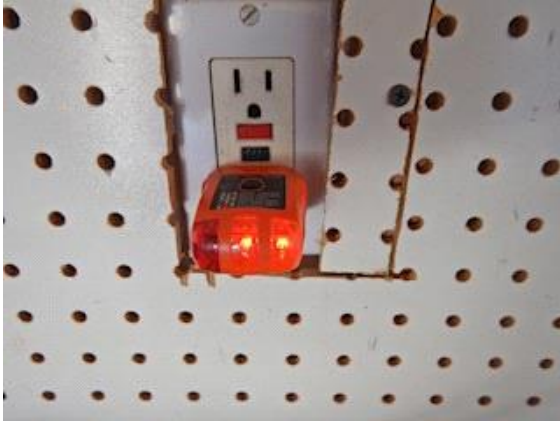
Garage/Carport: garage GFCI outlet protects both bathrooms

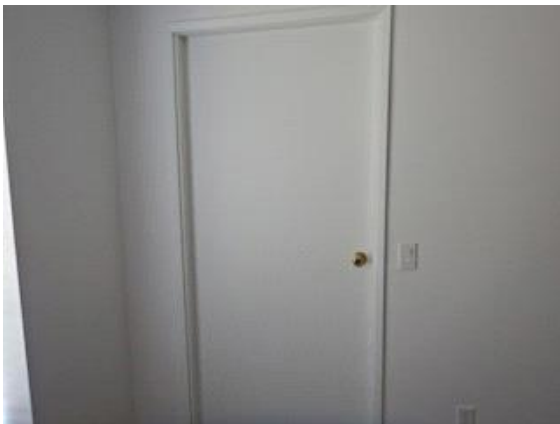
Garage Pedestrian Door into House: pedestrian door in bedroom one is sealed (cannot be used)

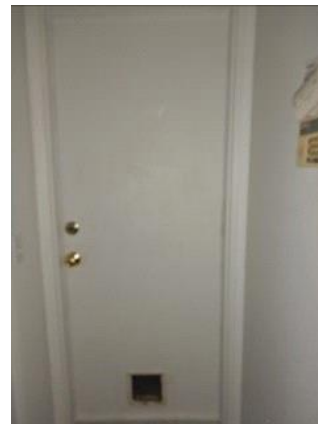
Pet doors are not permitted in fire rated doors. This concern compromises the electivity of the fire door. Recommend further evaluation/repair by qualified contractor(s).

Garage Pedestrian Door into House: garage fire door with a pet access door

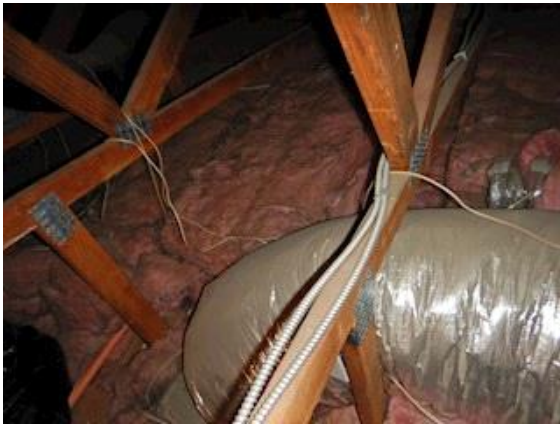
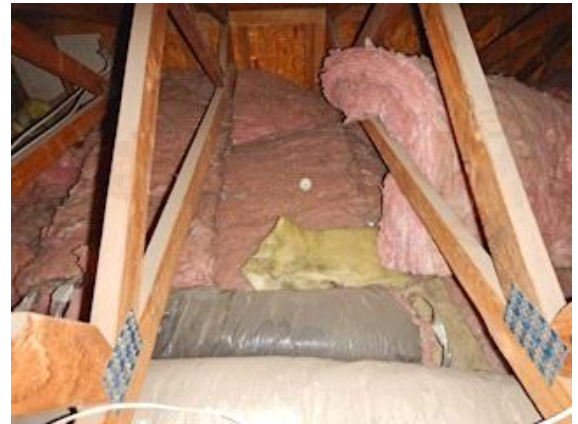
Attic insulation thickness was 10-12 inches = aprox R32. This was acceptable when the house was built. The modern recommended value is 14-16 inches = aprox . R32.

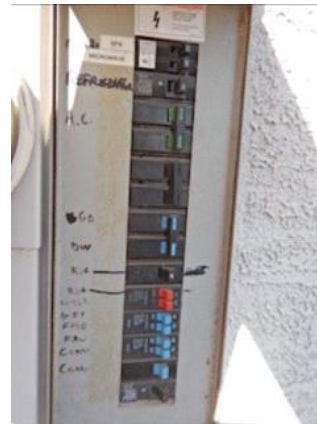
Front cover on sub-panel not clearly labeled to identify what breakers supply what circuits. For additional safety, recommend identification and labeling of all specific breaker functions. Recommend to have a licensed electrician further evaluate this concern.

Electrical: not all breakers are clearly labeled

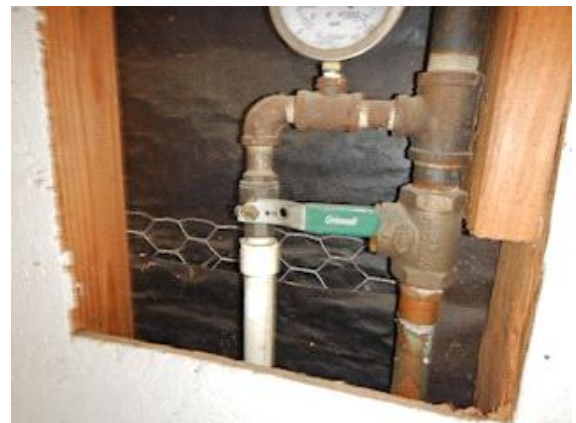
Plumbing: the fire sprinkler valve is on the off position

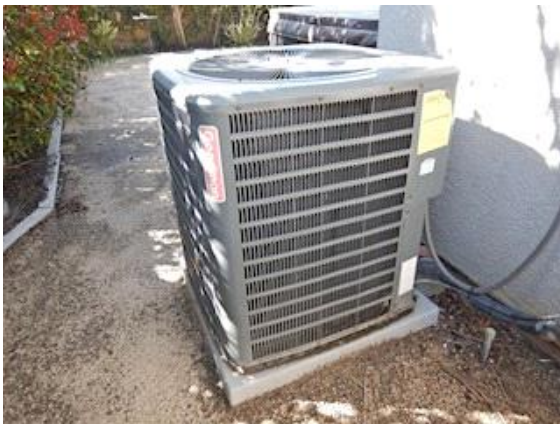
Cooling:

Although the cooling was functional at time of this inspection, the unit was turned on/off. It was rated marginal due to the age of the system. Life expectancy of A/C condensing/compressor units is 10-15 years. This unit is 14 years old.

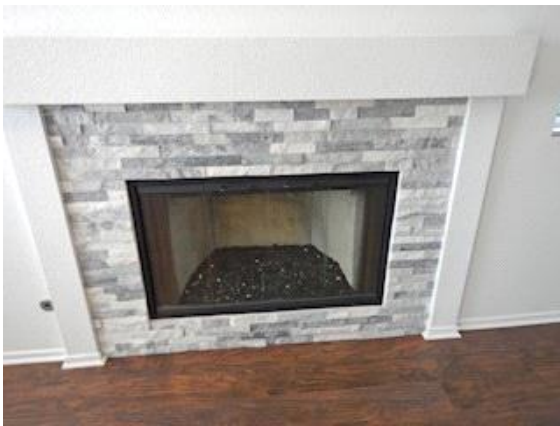
Fireplace/Stove:

Fireplace was in good condition with operational flue damper.

Recommend annual cleaning - Fireplace design and soot / creosote buildup, in most cases, prevents view of chimney liner / cracks.

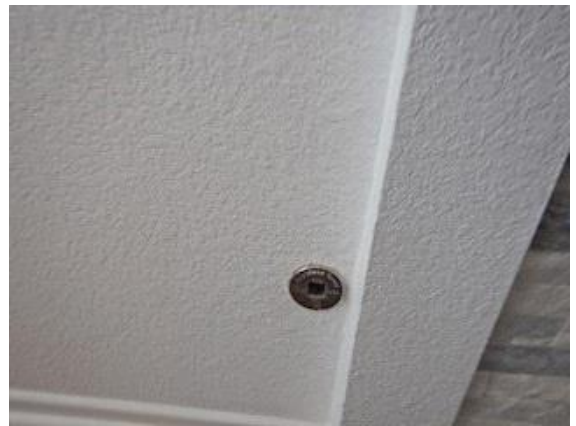
Fireplace/Stove: gas key access

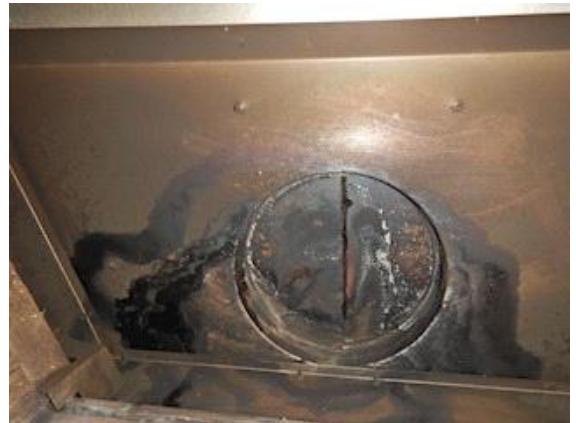
Fireplace/Stove: damper

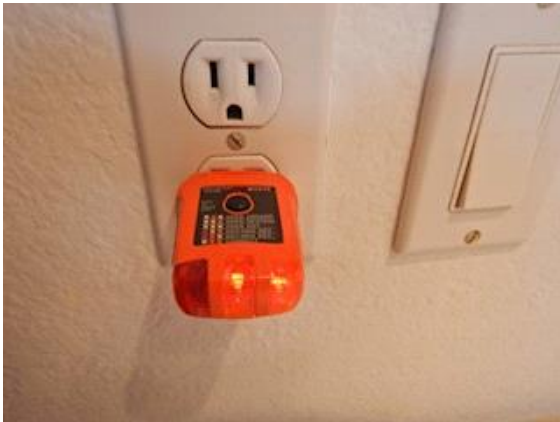
Bathroom 1: the outlet is GFCI protected, the GFCI is located in the garage

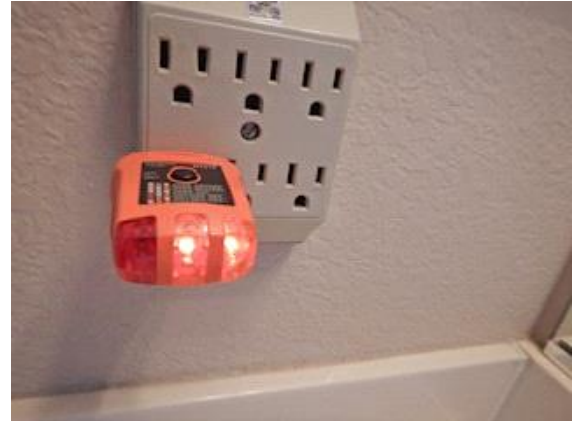
Bathroom 2: the outlet is GFCI protected, the GFCI is located in the garage
