# NATIONAL PROPERTY INSPECTIONS

## COMMERCIAL MASTER TEMPLATE

Property Street Address  
City, TX Zip Code

Client Name  
JULY 27, 2022

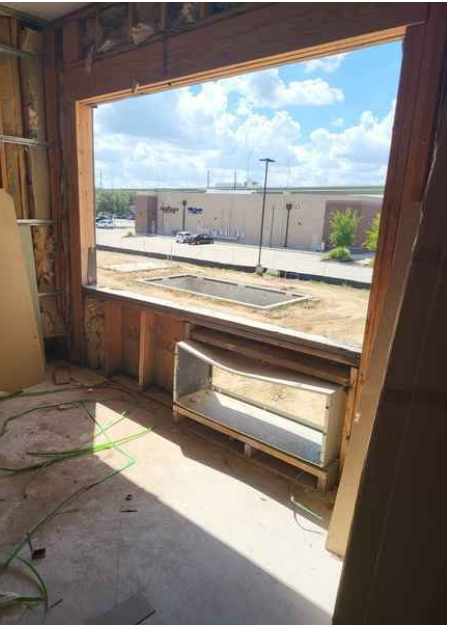
Conventional wood framing

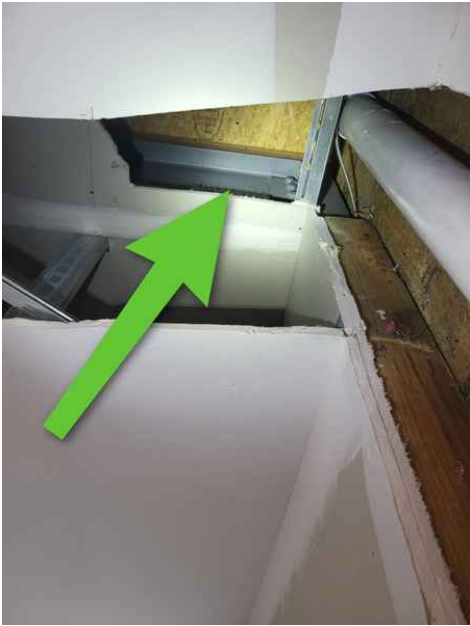
Steel framing

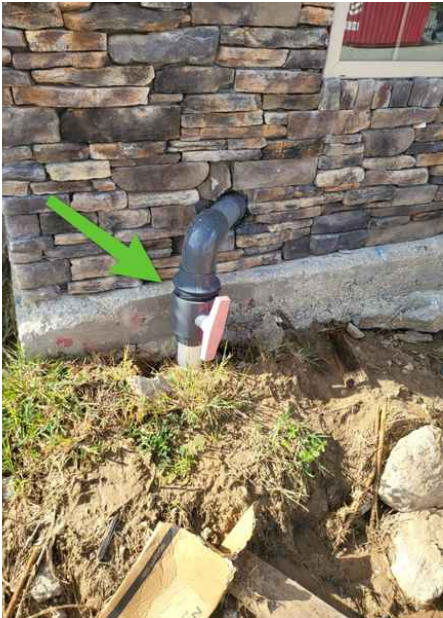
The main water supply shut-off was located in the North East corner.

Main shut-off

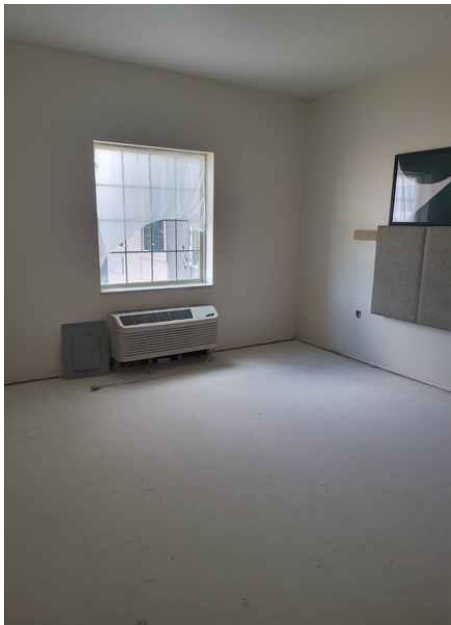
PTAC Unit - RM 202

Below is a representative sampling of the PTAC units installed throughout the structure. Due to no power at the time of inspection, these units were not tested.

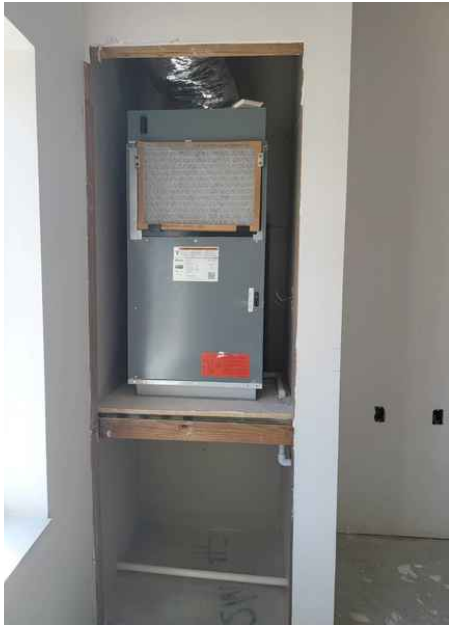
VTAC Unit - RM 101

Below is a representative sampling of the VTAC units installed throughout the structure. Due to no power at the time of inspection, these units were not tested.

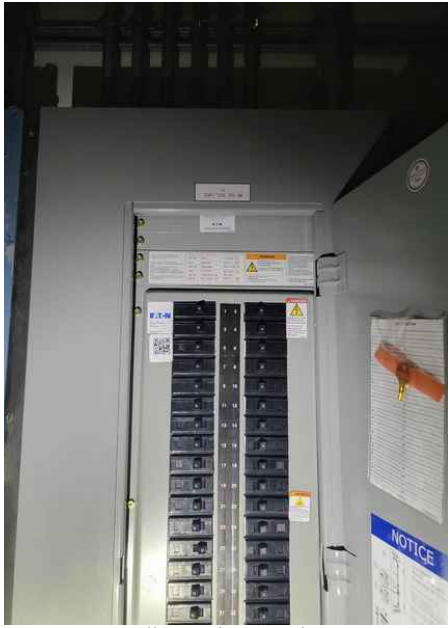
Panelboard - 1st Floor

The 3-phase electrical service utilized a 4-wire configuration. The electrical system is still under construction and can not be evaluated beyond a visual examination. Below are representative pictures of the work completed.

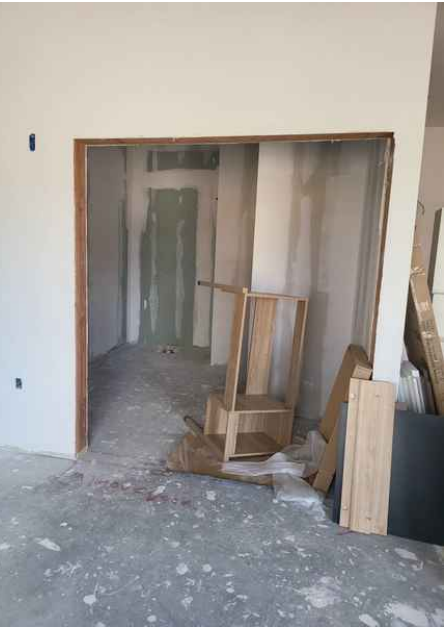
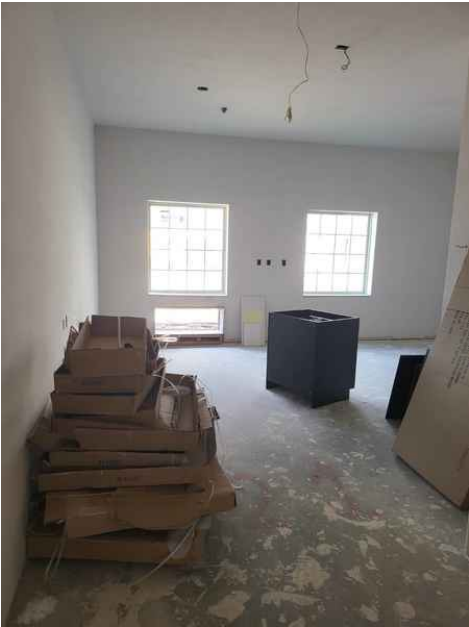
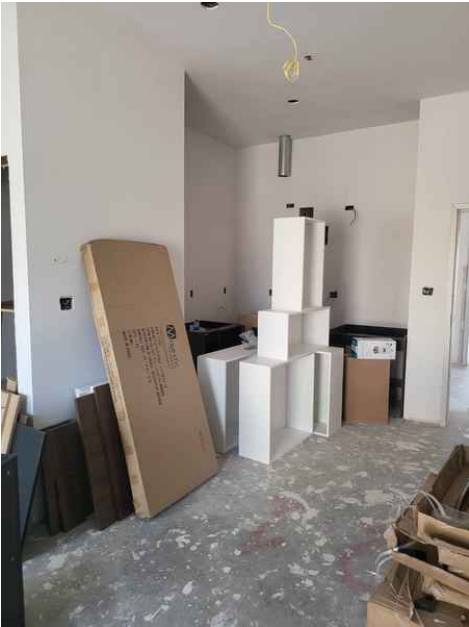
Unit #100

Below are representative pictures of the progress of the construction of each unit.

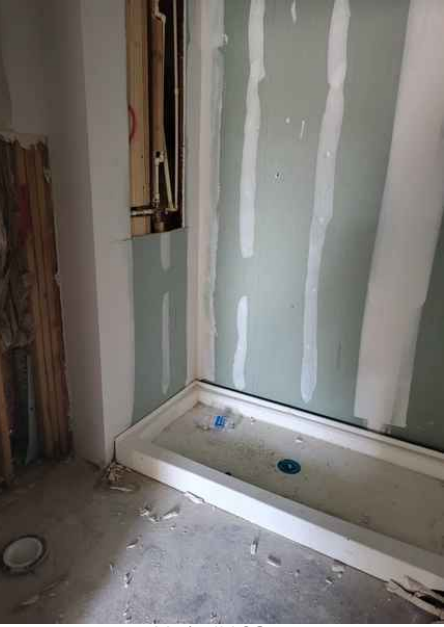
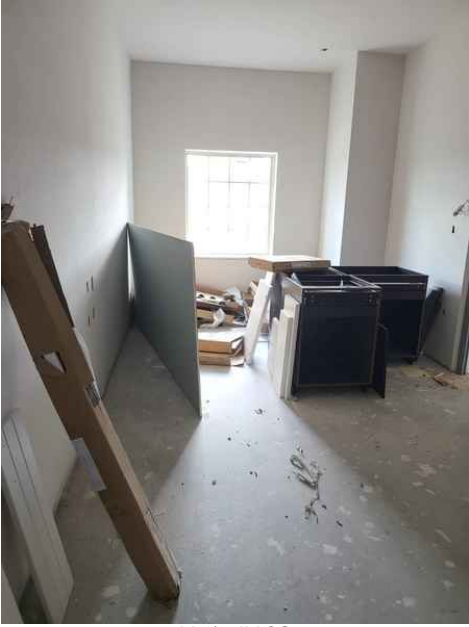
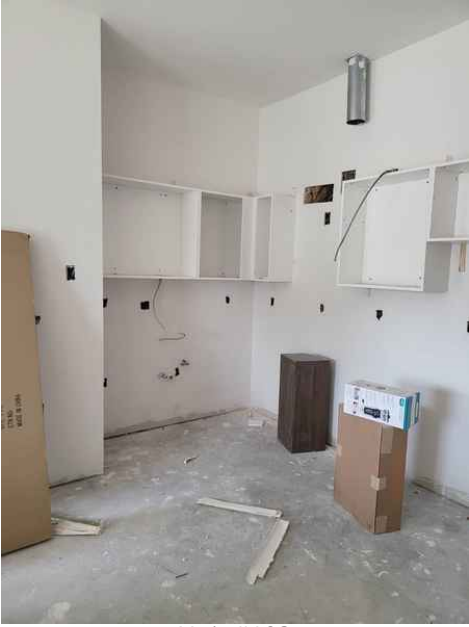
Unit #103

Below are representative pictures of the progress of the construction of each unit.

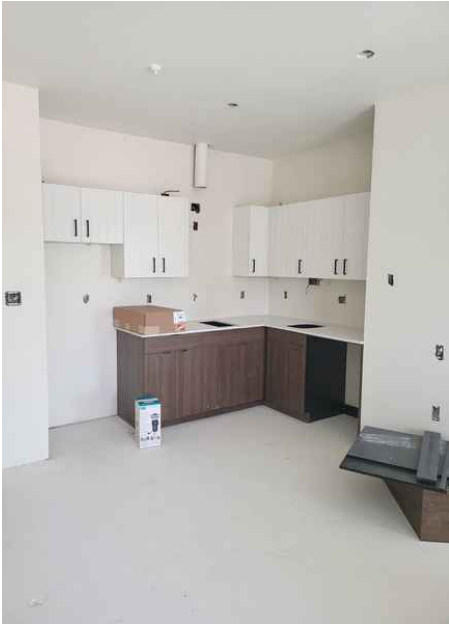
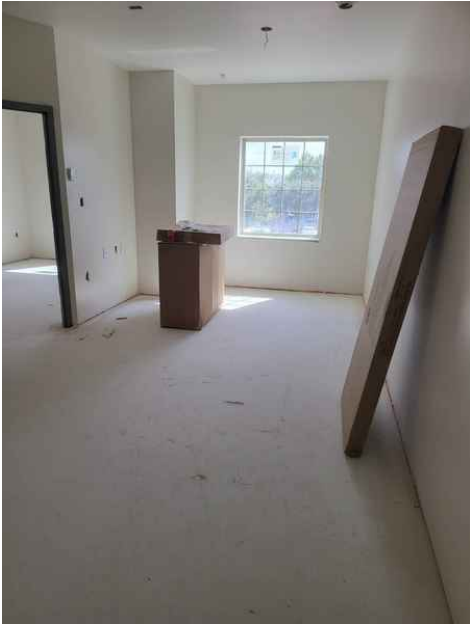
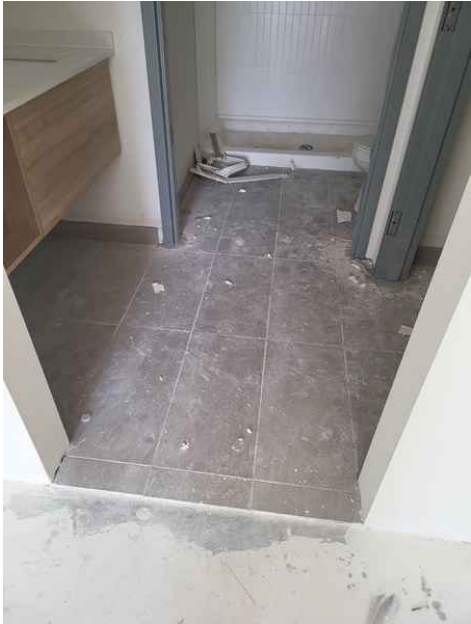
Unit #201

Below are representative pictures of the progress of the construction of each unit.

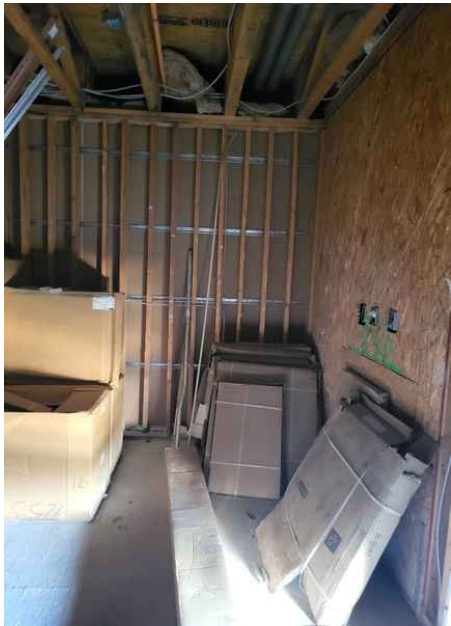
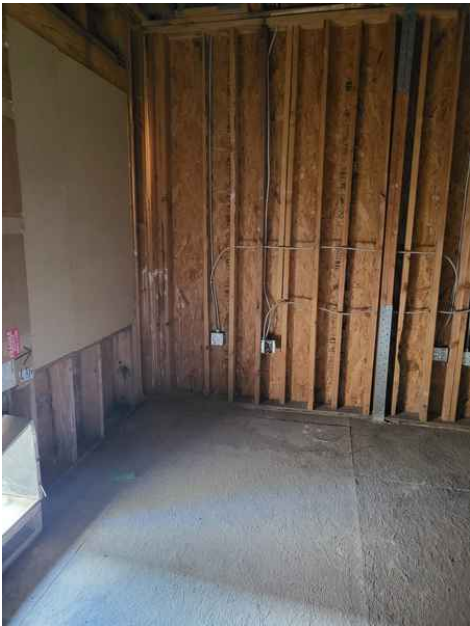
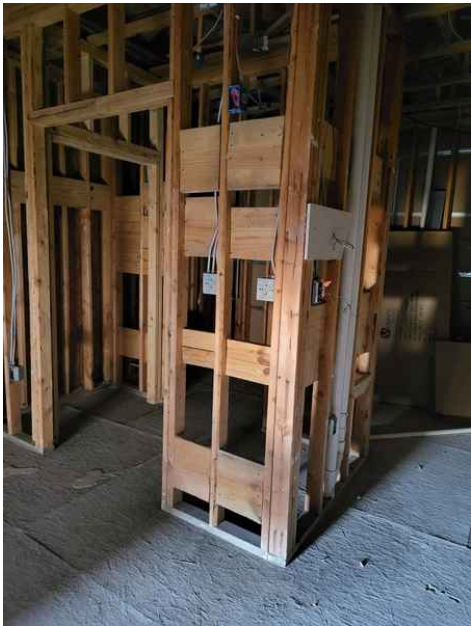
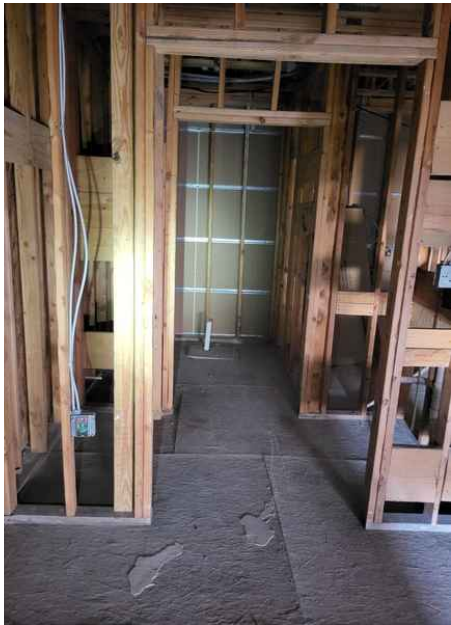
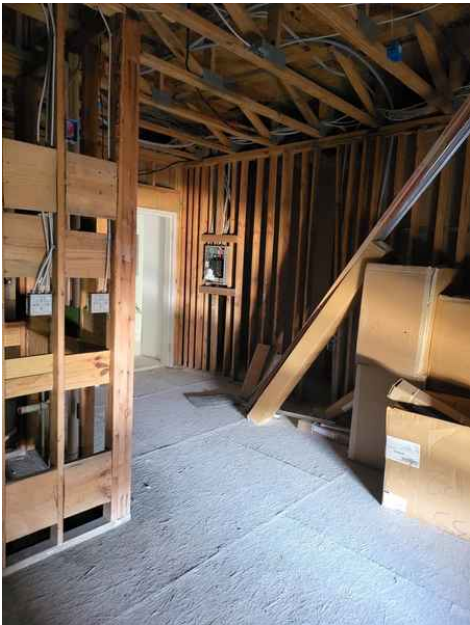
Below are representative pictures of the progress of the construction of each unit.

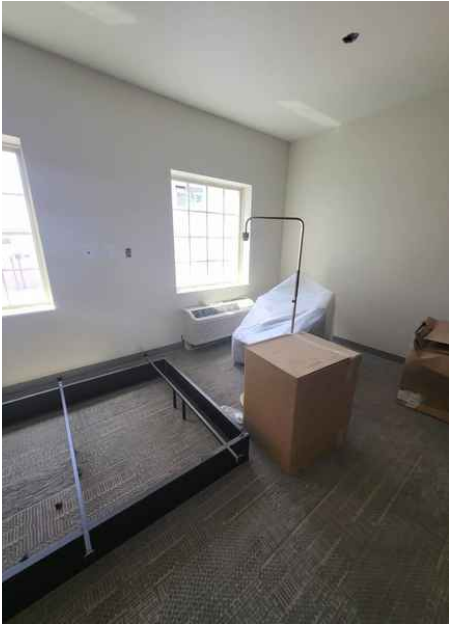
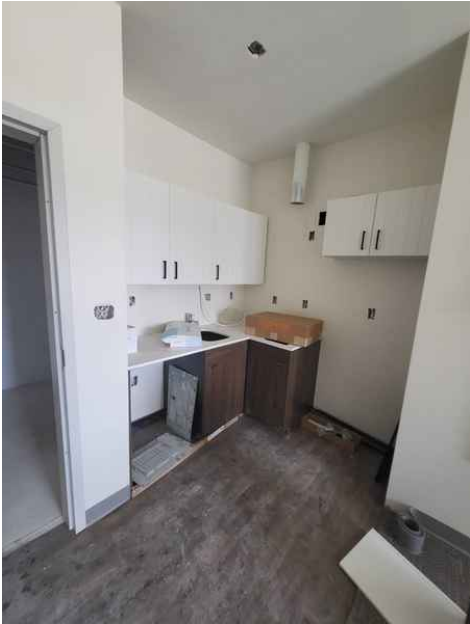
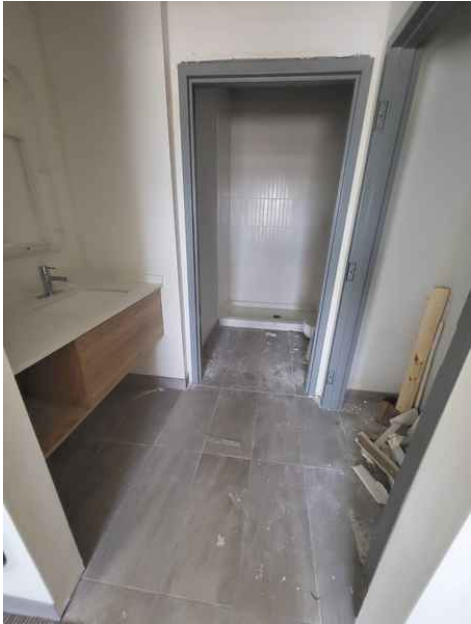
Below are representative pictures of the progress of the construction of each unit.

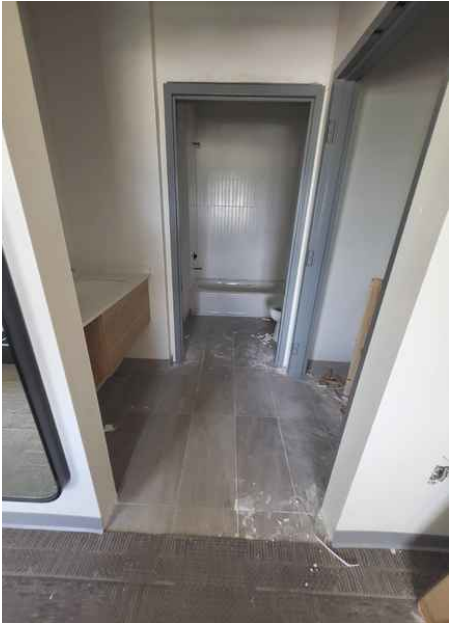
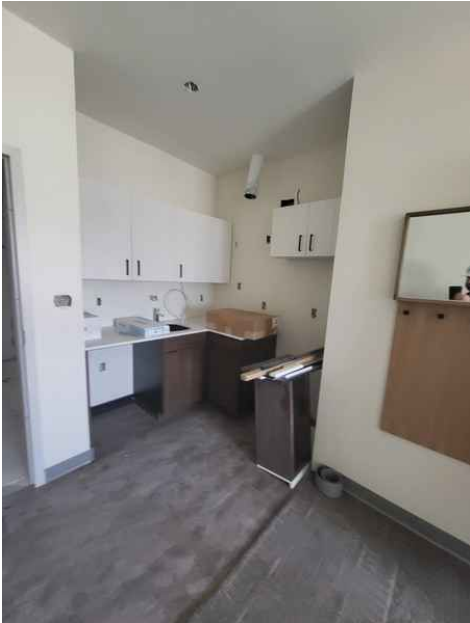
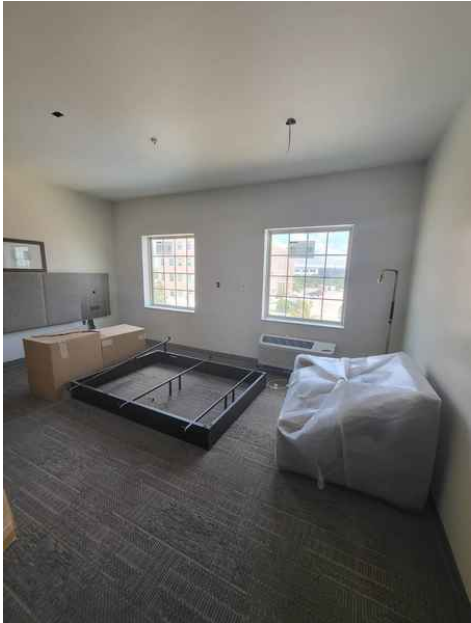
Below are representative pictures of the progress of the construction of each unit.

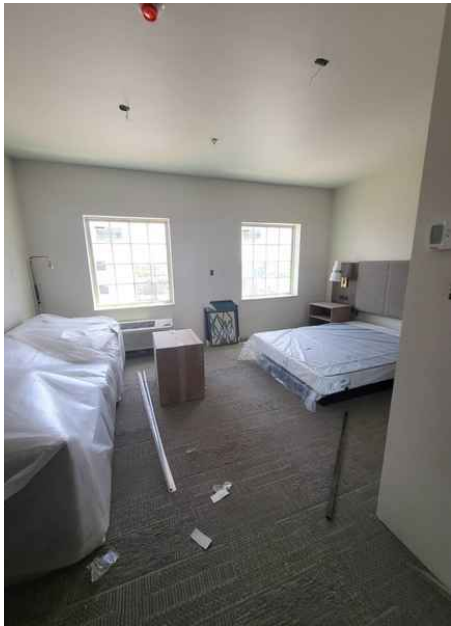
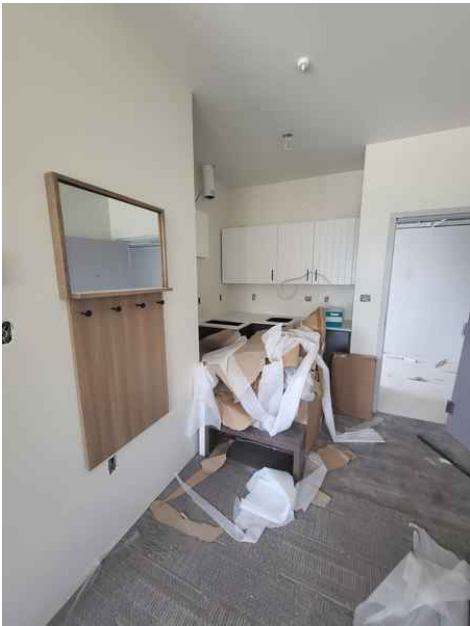
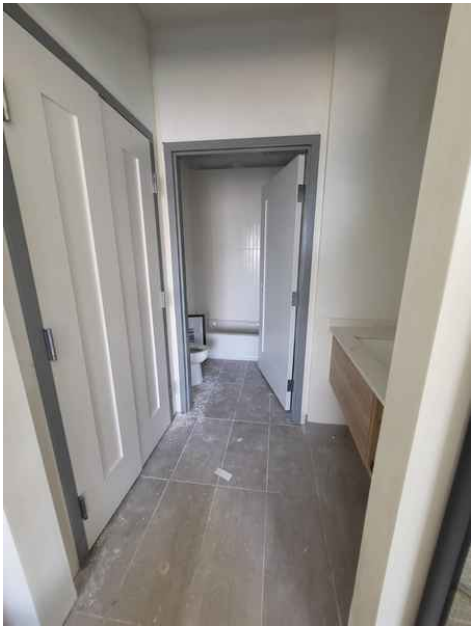
Below are representative pictures of the progress of the construction of each unit.

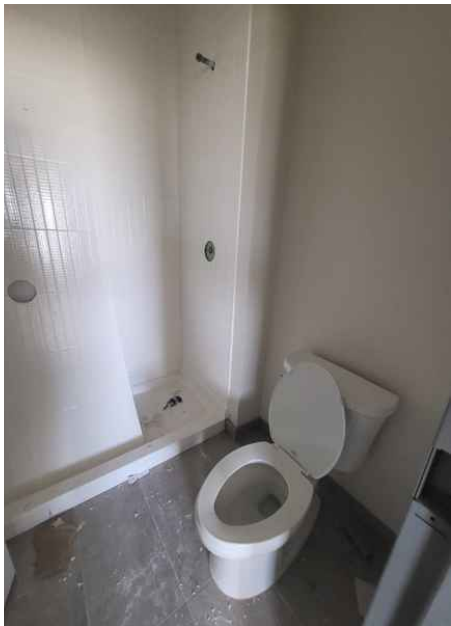
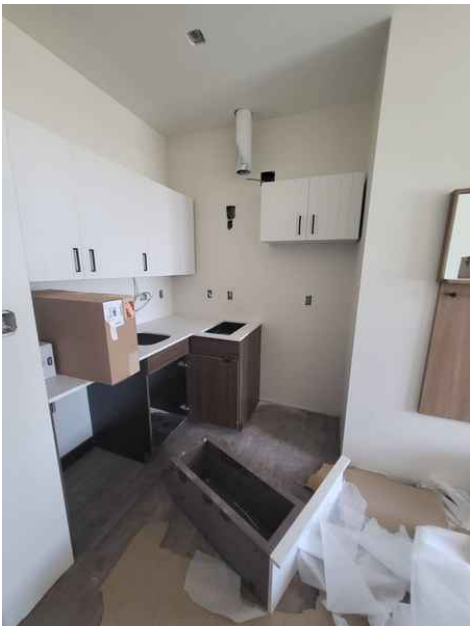
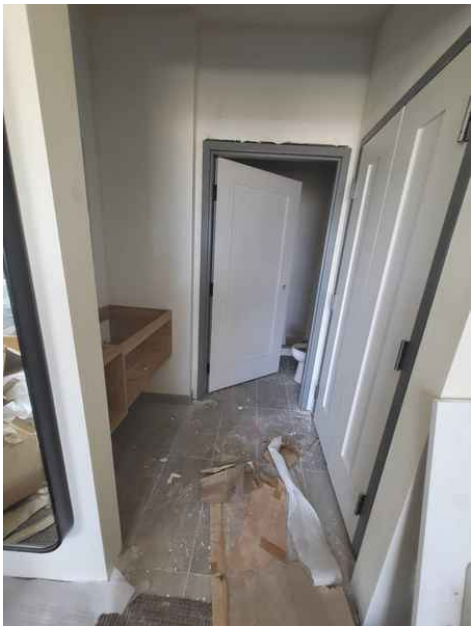
Below are representative pictures of the progress of the construction of each unit.
